ATB 00239-01113 REV1 (1411)

Low Heat From the Driver's-Side Vent

AFFECTED VEHICLES

Year	Model	Trim	VIN Range
2012	CR-V	ALL	All VINs beginning with 5J6, 2HK, and 3CZ
2013-14	CR-V	ALL	ALL

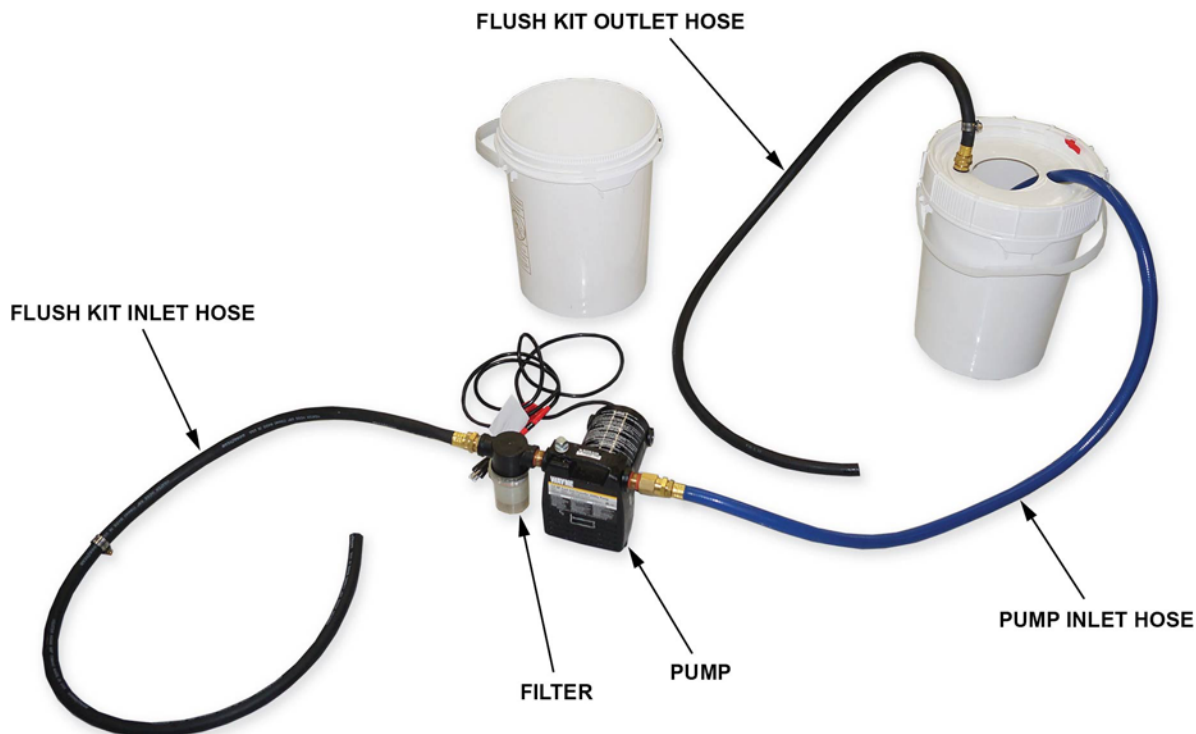
1. Wait until the engine is cool, then remove the radiator cap.
2. Drain the coolant from the radiator.
3. While the coolant is draining, assemble the CR-V Heater Core Flush Kit as shown below.

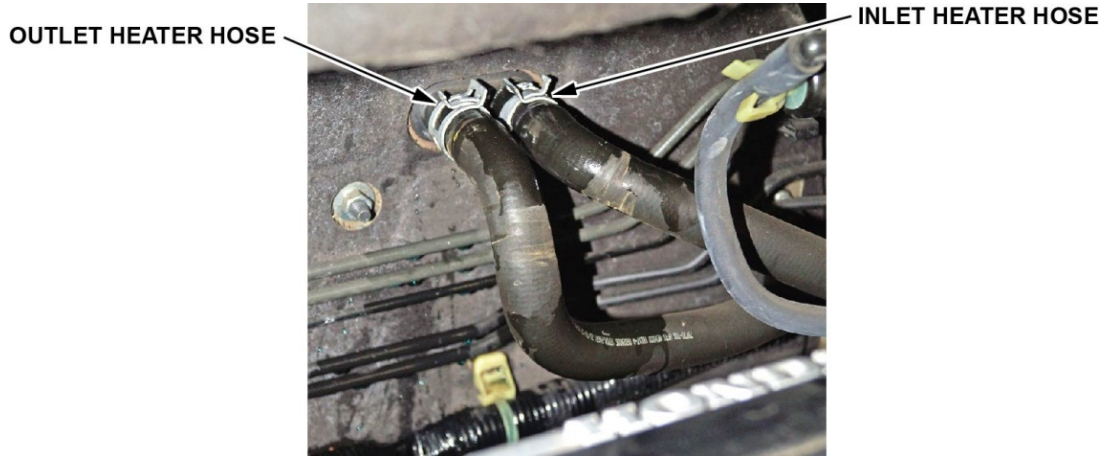
4. After the coolant has drained, tighten the radiator drain plug securely.
5. Disconnect the inlet and outlet heater hoses from the heater core. Do not disconnect the hoses from the engine side. Fold the hoses out of the way.
NOTE: Mark the hoses to make sure they are reconnected properly.

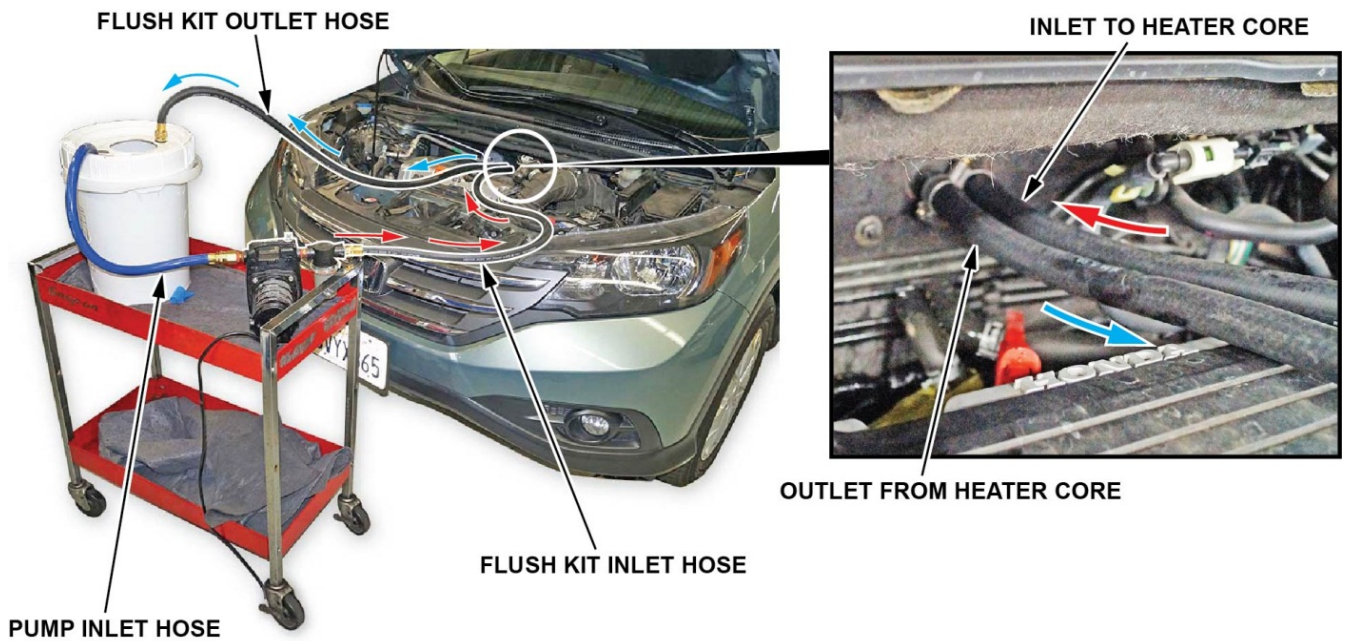
6. Connect the flush kit inlet hose and outlet hose to the heater core as shown.

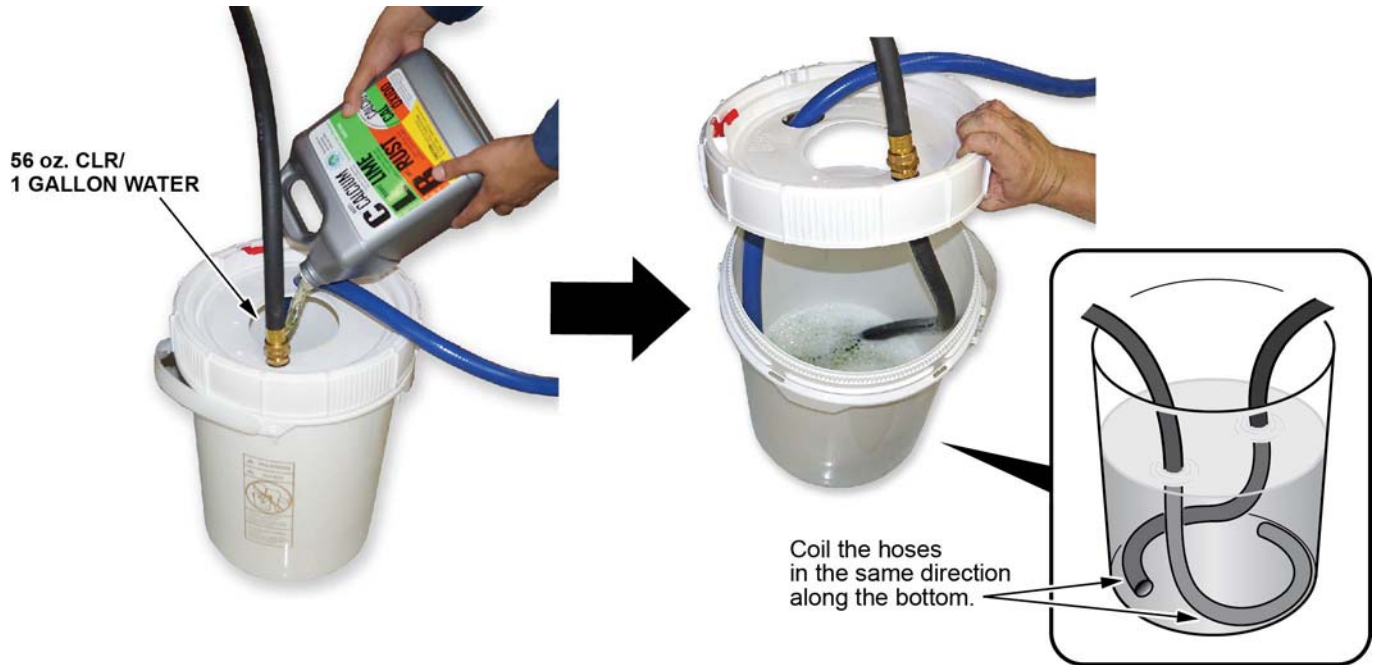
7. Mix 56 oz of CLR with 1 gallon of clean tap water in the provided bucket. Arrange the hoses as shown in the image below. Make sure the inlet hose is coiled along the bottom as shown to prevent it from suctioning the side or bottom of the bucket and preventing the cleaning solution from flowing.

NOTE: Carefully follow the precautions listed on the CLR container.

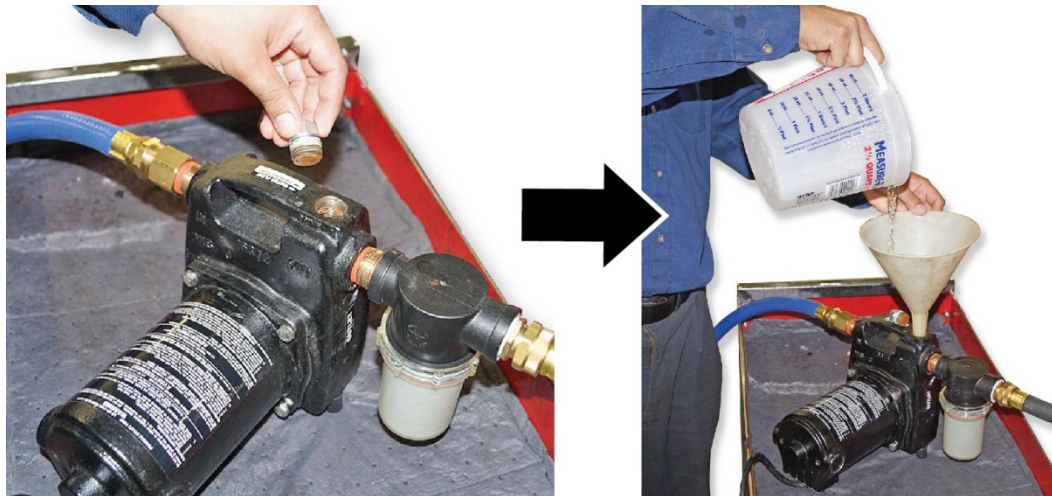
8. Prime the pump before starting it by removing the bolt and adding a cup of water to the pump.

NOTE: Running the pump without priming will cause damage to the internal components of the pump. If the pump fails for any reason, the dealer is responsible for the cost of replacing the pump.

26. If the flush kit will not be used within 4 hours, remove any remaining water from the pump by removing the bolt mentioned in step 8. This will prevent corrosion inside of the pump.

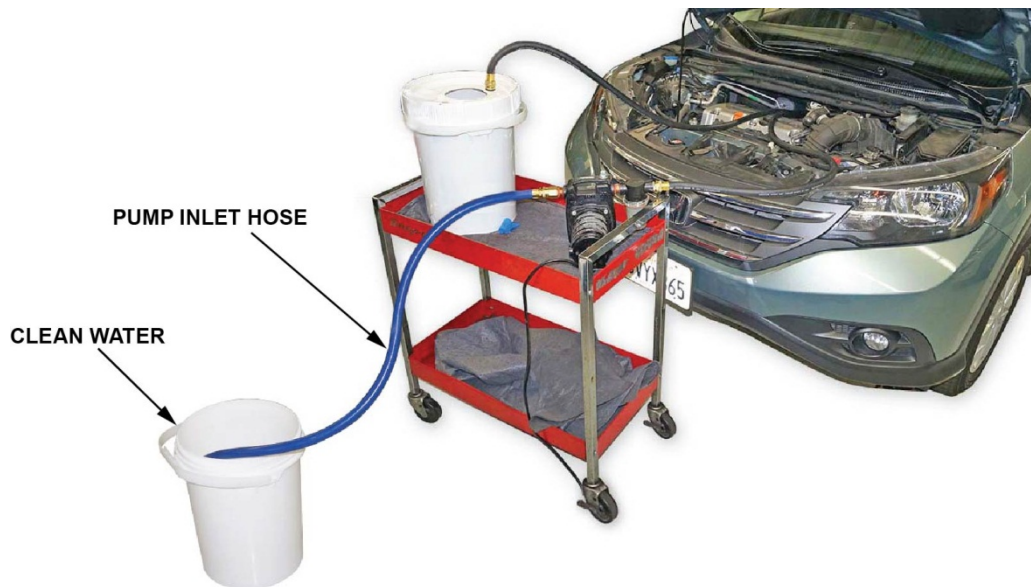
12. Clean the CLR solution from the heater core by flushing it with 30 gallons of clean tap water as follows:

- Fill the second bucket (provided with the kit) and fill it with clean tap water.
- Transfer the pump inlet hose to the bucket of clean tap water and leave the flush kit outlet hose inside the empty bucket (previously used to fill with CLR).
- Run the flush kit until 30 gallons of clean tap water are cycled through the heater core.

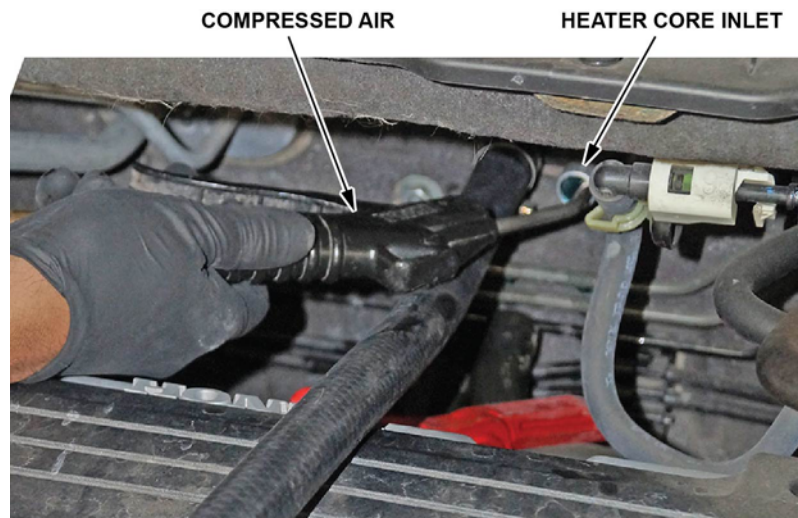
13. Remove any remaining water from the heater core as follows:

- Disconnect the flush kit inlet hose from the heater core inlet.
- Apply compressed air into the heater core inlet with an air chuck until little or no water is coming out the outlet hose.
