## Safety Recall: Driver's Airbag Inflator Can Be Over-Pressurized

(Supersedes 08-093, dated September 12, 2014, to revise the information marked by the black bars)

A manufacturing error can produce over-pressurization of the driver's (front) airbag inflator during airbag deployment. If an affected airbag deploys, the increased internal pressure may cause the inflator casing to rupture. Metal fragments could pass through the airbag cushion material, possibly causing an injury or fatality to vehicle occupants.

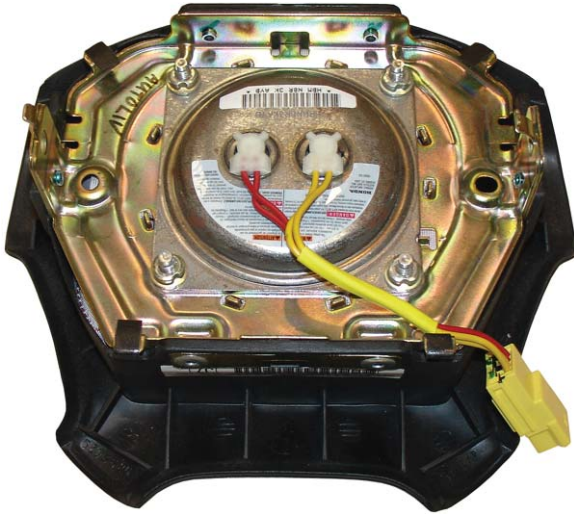
**AUTOLIV (not affected)**

- Determine if the airbag is made by Autoliv or Takata by comparing inflators to those in the images below.

NOTE: The Autoliv serial number label is different from the Takata label.

- If the airbag is made by Autoliv, the airbag is OK. Reinstall the airbag using new Torx bolts.
- If the airbag is made by Takata, go to step 6.

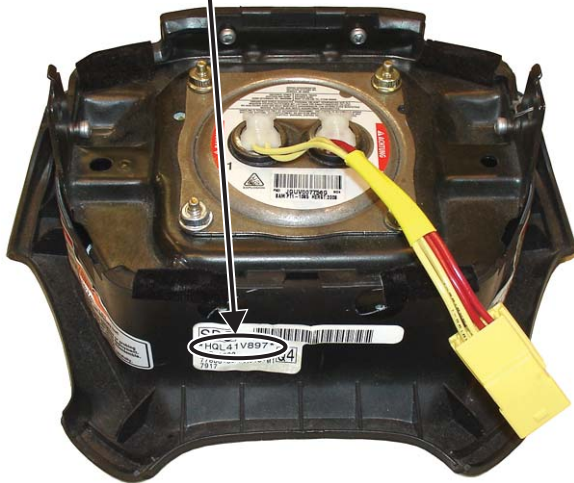
**TAKATA**

Locate serial number here.
