Service Bulletin

14-045

Recall: Driver's Airbag Inflator May Produce Excessive Pressure After Long-Term Exposure to High Absolute Humidity

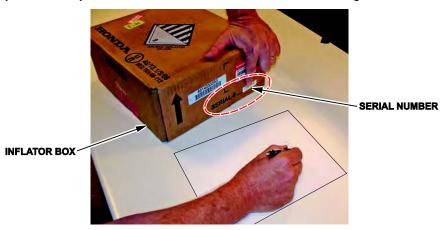
- 1. Remove the driver's airbag.
- 2. Write down the serial number located on the right side of the new inflator's box. For the warranty claim to be paid, your warranty clerk must enter this serial number in the Diagnostic Trouble Codes field on the warranty claim.

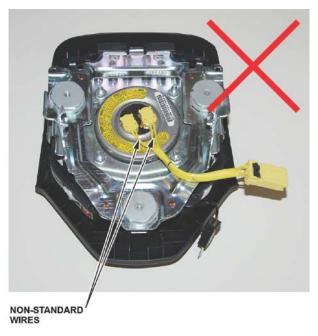
- 3. Place the airbag, face down, on a clean shop towel.
- 4. Visually inspect the airbag and the inflator for any unusual writing or markings.
 - If there is nothing unusual about the airbag or the inflator, go to step 5.
 - If there are any unusual markings, like an incorrect label or a model year written in marker, the airbag and inflator may not be the correct airbag and/or inflator for the vehicle or it may be a counterfeit part. For more information about counterfeit airbags, you can refer to safercar.gov, enter keywords MANAGING COUNTERFEIT, and select Recommended Dealer Guidance for Managing Counterfeit Air Bags from the list. If you suspect that the airbag or inflator is counterfeit, do not continue this procedure. Contact your DPSM for assistance.

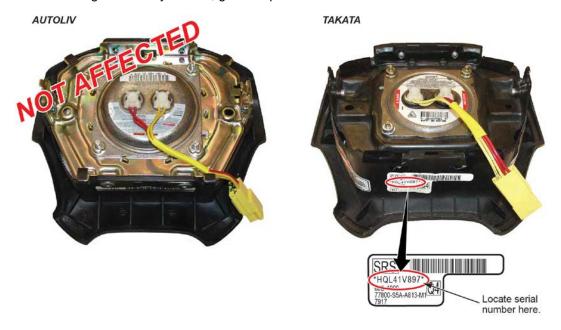
5. *Civic only* - Determine if the airbag is made by Autoliv or Takata by comparing the inflators to those in the images below.

NOTE: The Autoliv serial number label is different from the Takata label; the Autoliv has 11 characters, the Takata has 9.

- If the airbag is made by Autoliv, the airbag is OK. Reinstall the airbag using new Torx bolts. If you already received a replacement inflator, return the unopened kit to American Honda.
- If the airbag is made by Takata, go to step 6.

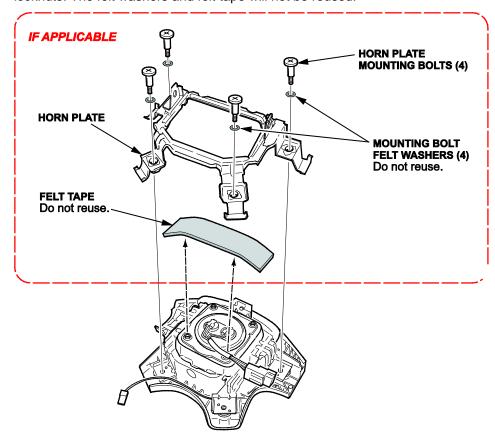
6. If there is no horn plate installed, go to step 7. If there is a horn plate installed, remove the four horn plate mounting bolts, the mounting bolt felt washers, the horn plate, and remove the felt tape covering the lower two inflator locknuts. The felt washers and felt tape will not be reused.

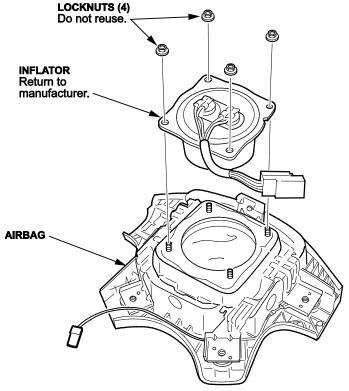
7. Using needle-nose vise grips or a 3/8 in. 6-point socket, remove the four locknuts from the inflator. The locknuts will not be reused.

NOTE: Do not remove the inflator from the airbag until you complete step 7.
