October 31, 2014

ATB 51968-00377 REV2 (1410)

Recall: Front Passenger's Airbag Inflator May Produce Excessive Pressure After Long-Term Exposure To High Absolute Humidity

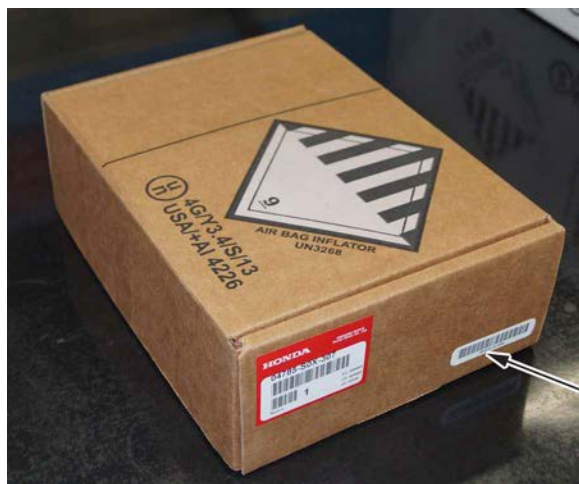
SERIAL NUMBER

- Be careful not to damage any parts when replacing the inflator, and **follow the procedure exactly**.
 - If, before removing the airbag, you suspect that it may be the incorrect airbag for the vehicle or a counterfeit, **do not remove the airbag**. Contact your DPSM for assistance.
- Write down the serial number located on the right side of the new inflator box. For the warranty claim to be paid, your warranty clerk must enter this serial number in the Diagnostic Trouble Codes field on the warranty claim.

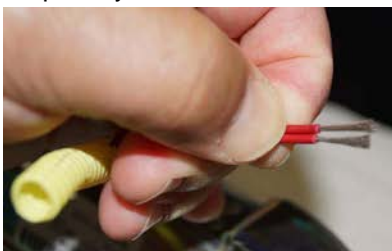
- Strip away about 1 inch of the wire insulation, then twist the wires together.

- Tape the twisted ends with electrical tape.

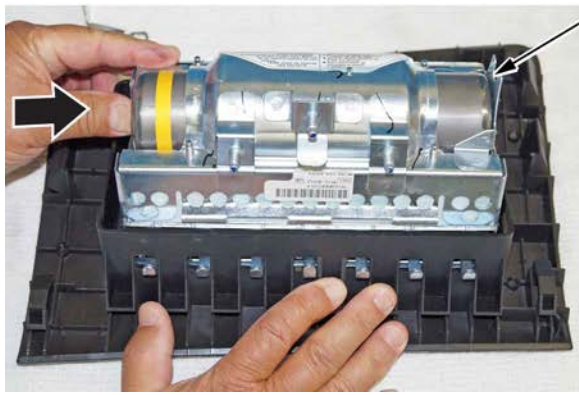
- Slide the inflator in until the “D” aligns with the tab on the inflator bracket. There should be no space or gap between the inflator and bracket.

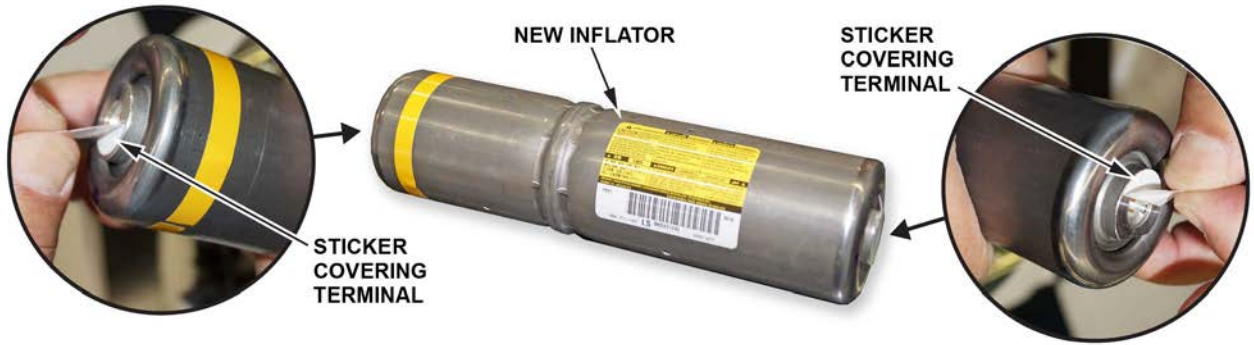
12. Remove the stickers covering the terminals on both sides of the new inflator.

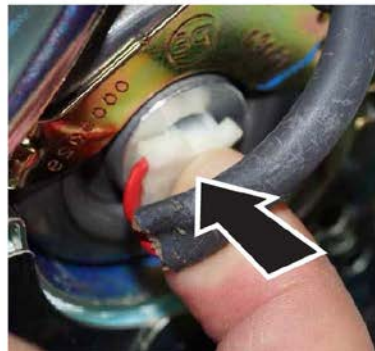
② Press the connector into place until it clicks.
