06899 Version 2

Warranty Extension: TLX Transmission Chirps During 3-4 Shift, Poor Shift Quality, or Engine Overheats Because of Defective ATF Warmer

Year	Model	Trim	VIN Range
2015–16	TLX	All with 9-speed A/T	Check the iN VIN status for eligibility

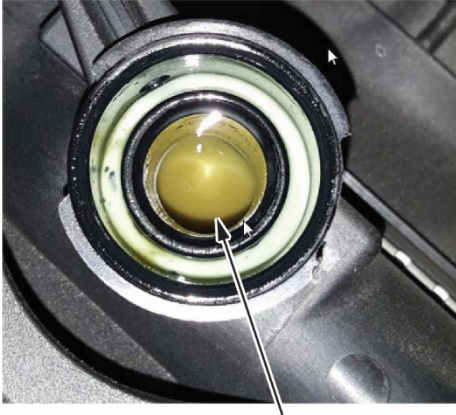
Remove the radiator cap and inspect for ATF in the coolant. If there is coolant contamination, the coolant will look brown.

ATF IN THE COOLING SYSTEM

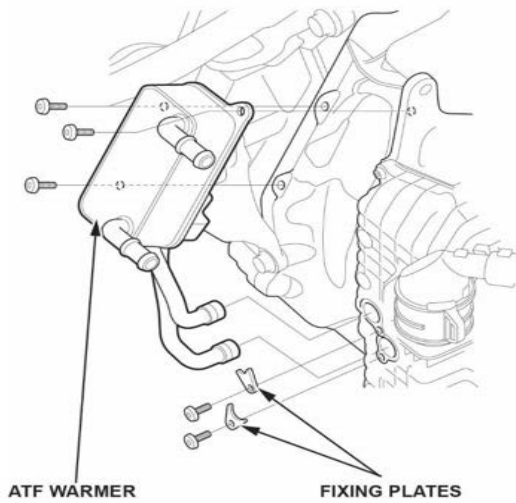
12. Remove the transmission warmer with the fixing plates, and place them on a clean surface.

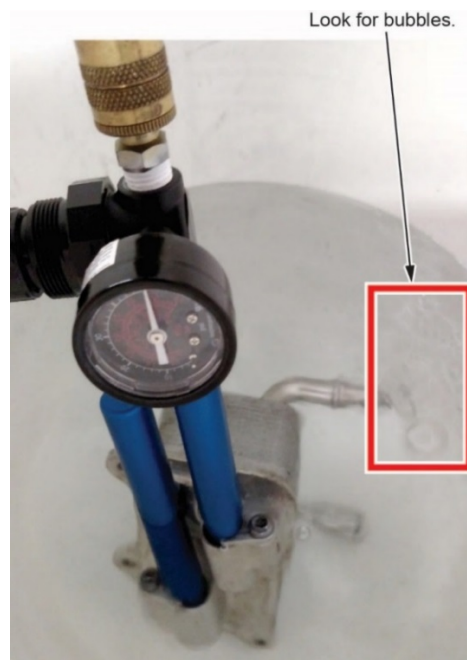
14. Check the transmission warmer for leaks by submerging the warmer completely under the water and watching for bubbles.

NOTE: Some bubbles are normal when the transmission warmer is first submerged and will come to a stop. If there is a leak, there will be a steady stream of bubbles coming from the transmission warmer.

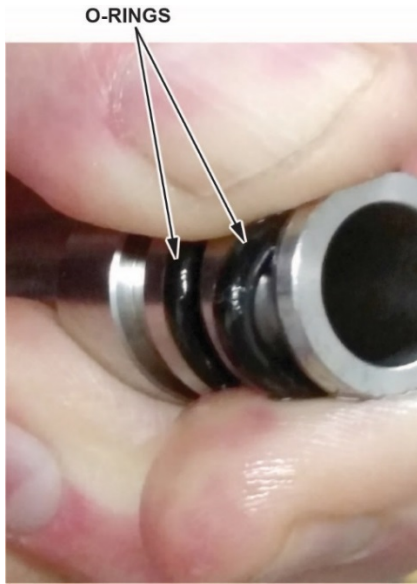
15. Remove the two ATF lines from the transmission warmer, then remove the 8 O-rings on the pipes by gently pushing the O-rings off with your fingers.

- Do not use picks or screwdrivers to remove the O-rings as you may damage the sealing surface.

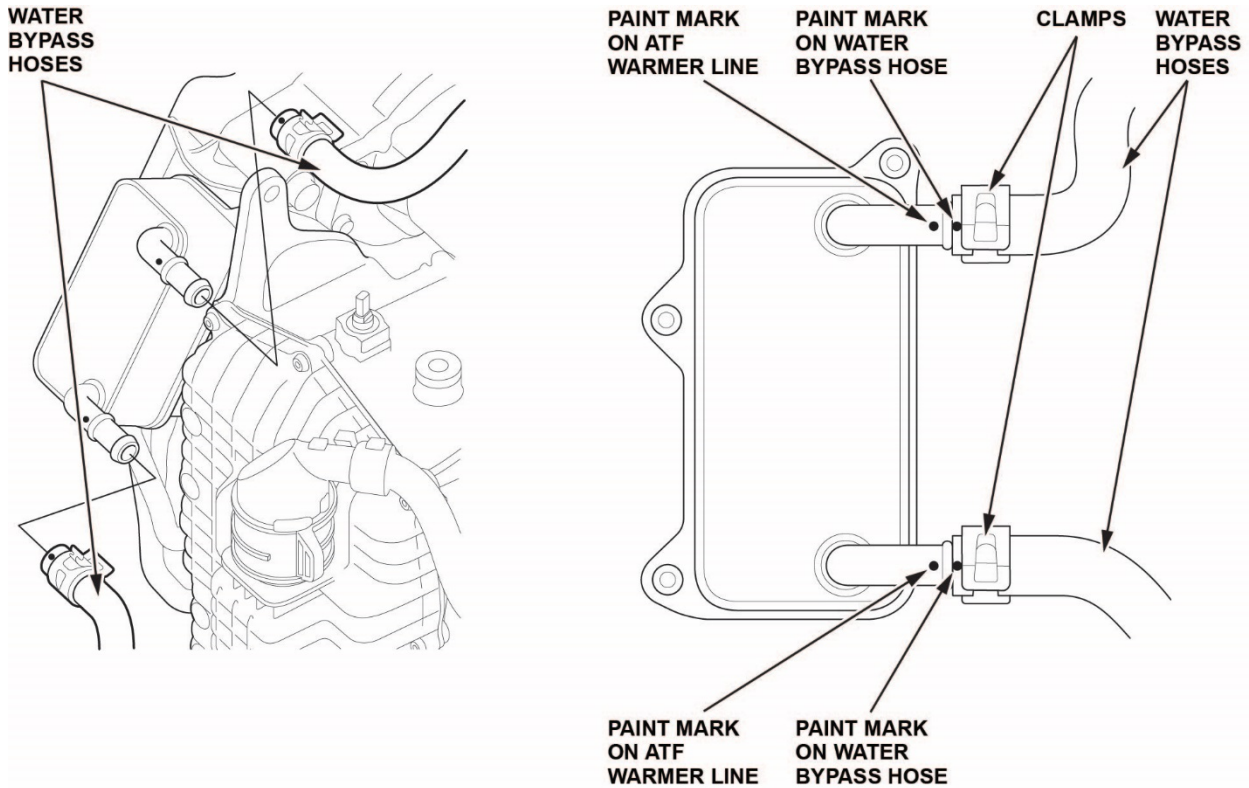
20. Connect the water bypass hoses. Make sure you align the paint marks on the ATF warmer lines with the paint marks on the water bypass hoses as shown. Secure the water bypass hoses with the clamps.

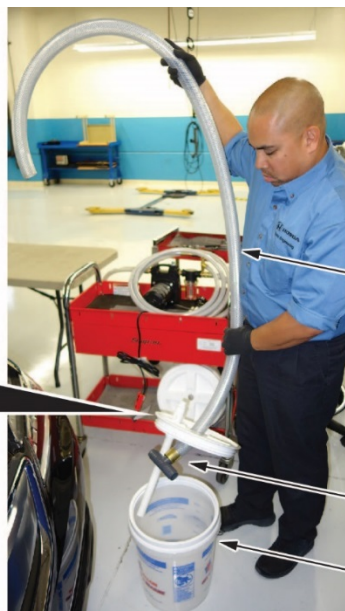
11. From the bucket marked SUPPLY, remove the lid and install the large (1.5 in.) return hose with the T-fitting through the hole in the lid as shown.

ENGINE RETURN HOSE

T-FITTING

SUPPLY BUCKET

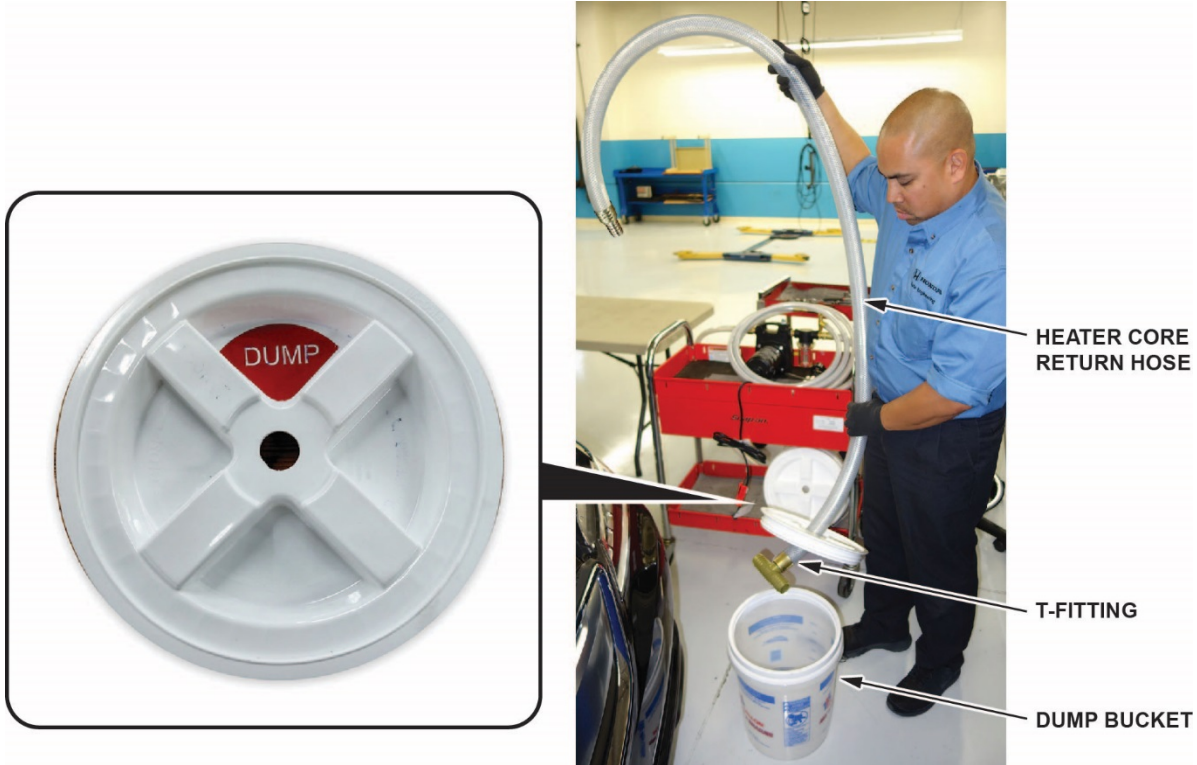
23. Install the heater core return hose through the DUMP bucket lid.
