HYUNDAI NEW THINKING. NEW POSSIBILITIES. Technical Service Bulletin	GROUP CAMPAIGN	NUMBER 16-01-044
	DATE NOVEMBER 2016	MODEL(S) SANTA FE (NC)
SUBJECT: FRONT OUTSIDE DOOR HANDLE REPLACEMENT (SERVICE CAMPAIGN TQQ)

Description: On certain 2017 Santa Fe (NC) vehicles, the PIC button on the front door outside handle(s) may not work properly. This may lead to improper operation of the outside door handle(s).

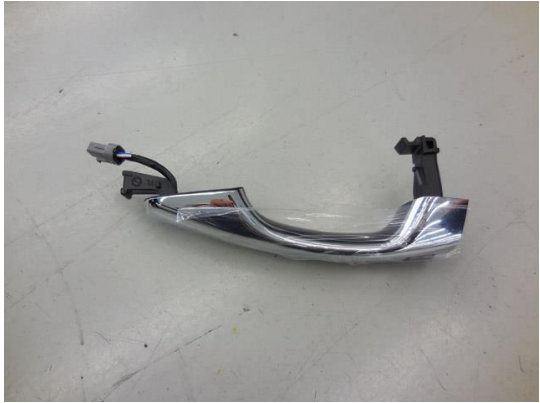
826512W710QQH	OUTSIDE DOOR HANDLE LH (FRONT)
	826612W710QQH	OUTSIDE DOOR HANDLE RH (FRONT)

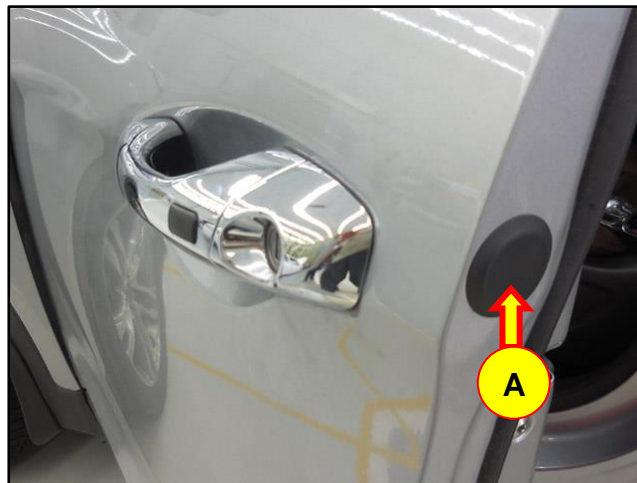
1. Open the driver door and remove the black cover (A) using a trim tool to access the door handle base screw.

Use No-Mar trim tool to prevent damage to the paint.

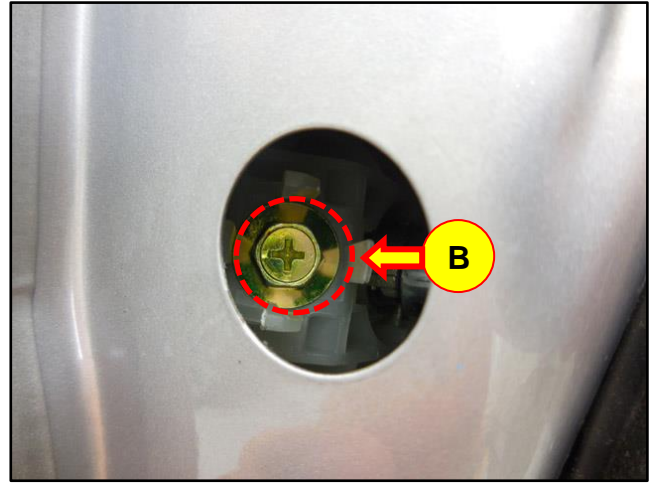
2. Loosen the bolt to remove the door handle.

**Tightening torque: 7.8Nm – 10.8Nm
(0.8 ~ 1.1 kgf.m, 5.8 ~ 7.9 lb-ft)**

Note: Click wrench or Digital torque wrench can be used.

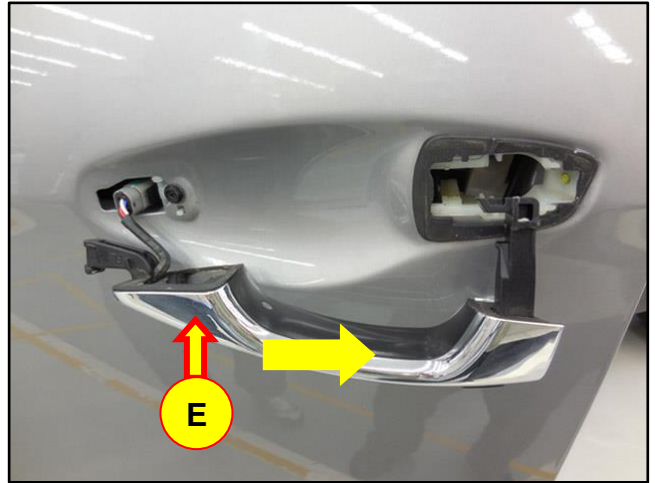
3. To remove the outside handle (E), push in the arrow direction.

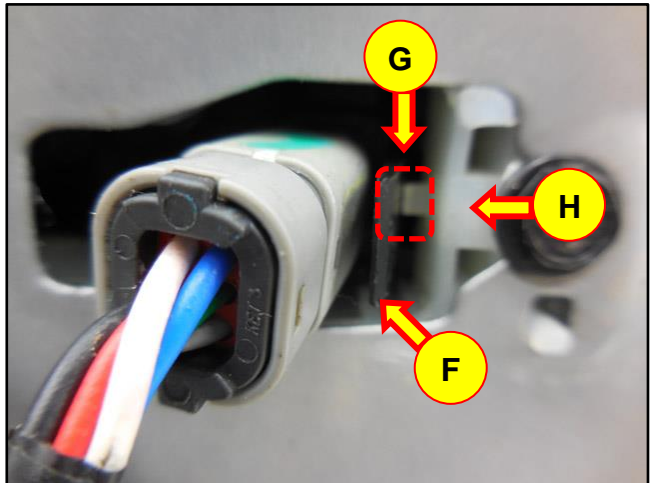
4. Push the protruded base hook (G) towards the base (H) to pull the link connector (F) out using the long nose plier.

Ensure not to scratch the paint and apply protection tape as necessary.

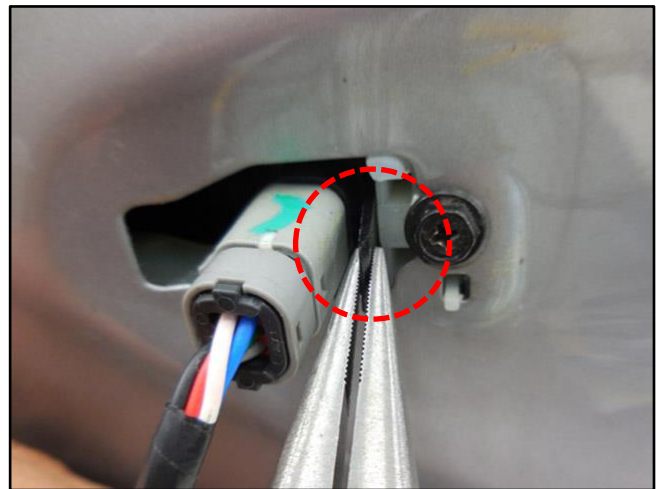
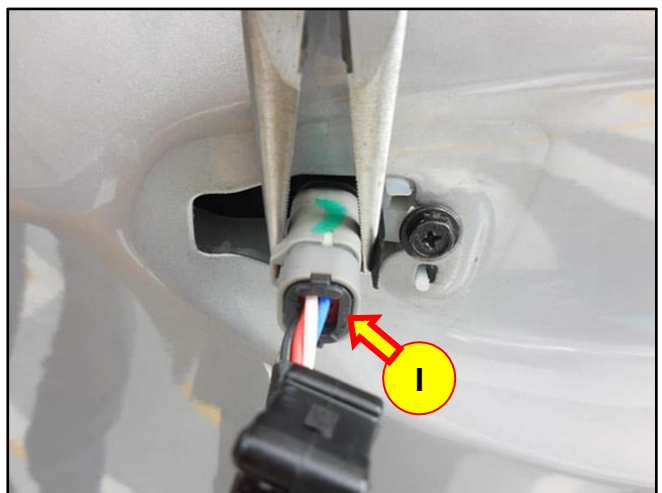
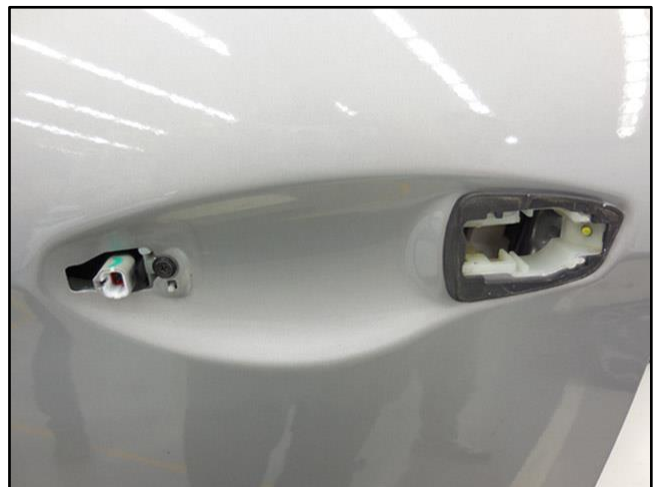
6. Disconnect the outside handle connector (I) by using the long nose plier and remove the outside handle.

Install the new front outside handle.

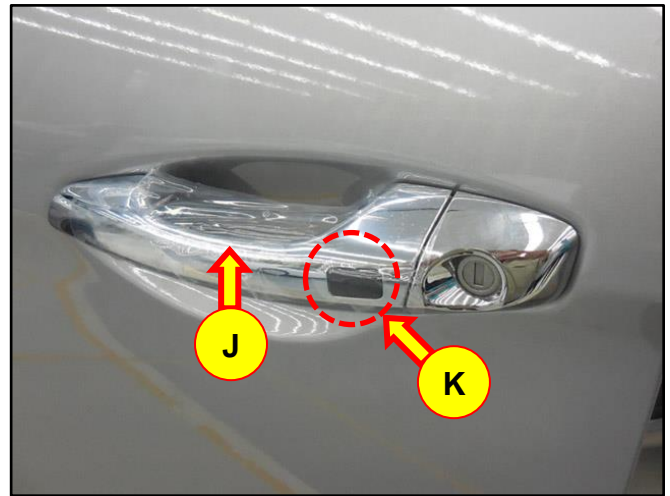
Check the outside handle (J) appearance and PIC button (K) operation.

7. Reinstall all removed parts in reverse order of removal.
