TRD Pro Bumper/Fender Interference

Introduction

Some 2015 – 2017 model year TRD Pro edition 4Runner vehicles may exhibit an abnormal noise when in Reverse with the wheels at or near full lock due to interference between the tire and bumper and/or fender liner. Follow the Repair Procedure in this bulletin to address this condition.

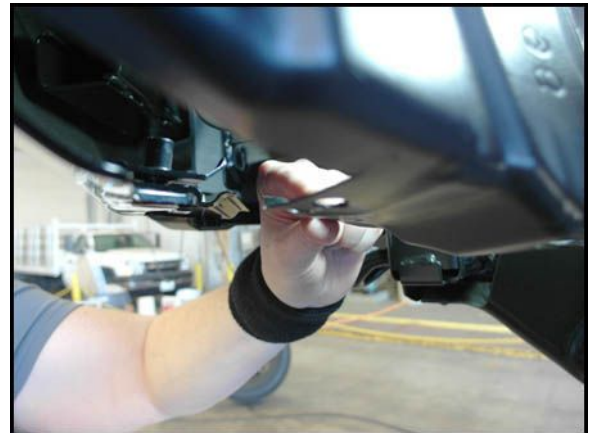
Figure 2.

4. Unclip the fender liner and carefully pull it toward the rear of the vehicle.

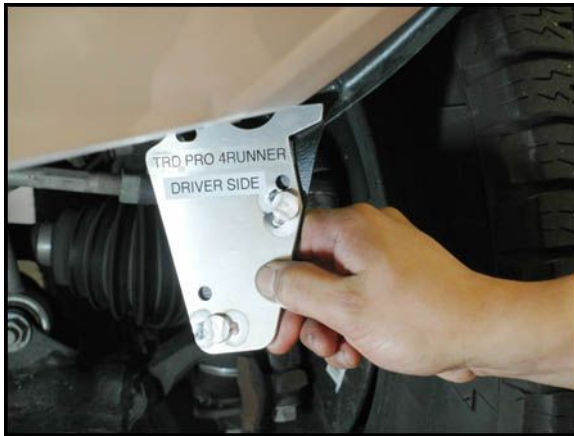
5. Install the driver side (LH) metal fender liner template (from the TRD Pro Trim Kit) on the front side of the fender liner.

Be sure to place the alignment pins into the two existing holes.

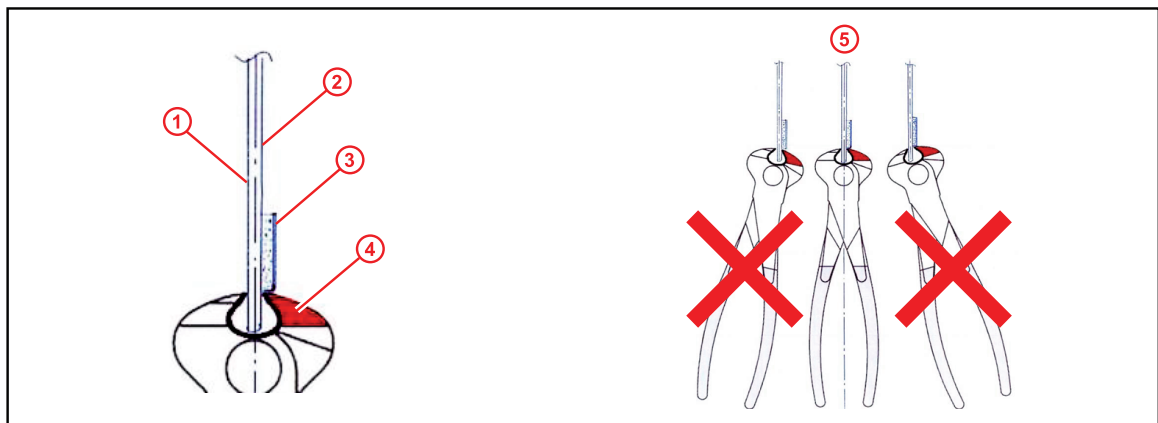
Figure 10.

- When holding the cutting pliers in place, it is important to keep the pliers oriented at a 90 degree angle as shown.

1	Bumper Cover
2	Paint
3	Tape

4	Red Jaw
5	Edge Must Be 90° to Surface
