Emissions Recall

Code: 23Q3

Subject	2.0L TDI Engine (GEN 3) Emissions Control Software – <u>USA ONLY</u>													
Release Date	April 14, 2017													
Revision Summary	Clarified installation position of labels.													
Repair Applicability	The ONLY Vehicles eligible for repair under this action are: <ul style="list-style-type: none"> • Customer owned vehicles • NEW vehicle inventory 													
Affected Vehicles	<p>U.S.A.: 2015 MY Volkswagen 2.0L TDI (Gen 3)</p>

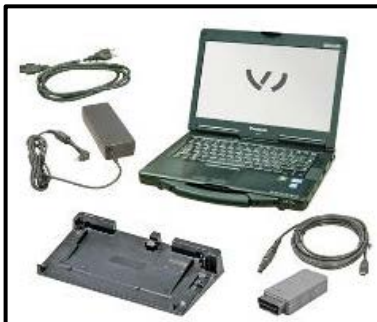
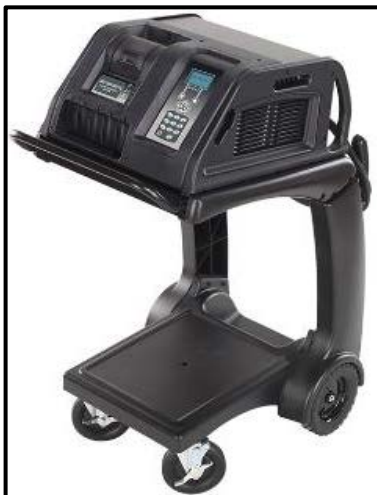
- VAS6150X – Diagnostic Tester (or equivalent)
- VAS5054X – Remote Diagnosis Head (or equivalent)

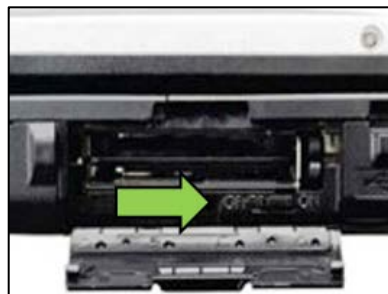
VAS 6150B
(Right side behind WIRELESS door)

- Performing a software update using a Bluetooth connection increases the risk of losing connection during the update, which could result in damage to the control module. It also greatly increases the time required to perform the update. Requests for additional time or parts will be denied if the GFF log shows the update was performed using Bluetooth.
- ✓ **The Bluetooth function of the scan tool is physically switched off <see pictures below>.**

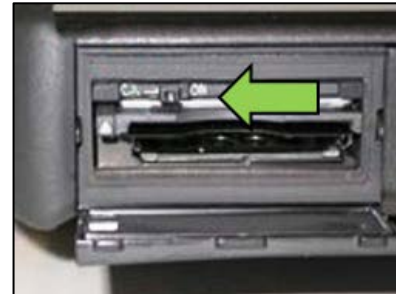
VAS 6150C
(Left side behind SC/EX door)

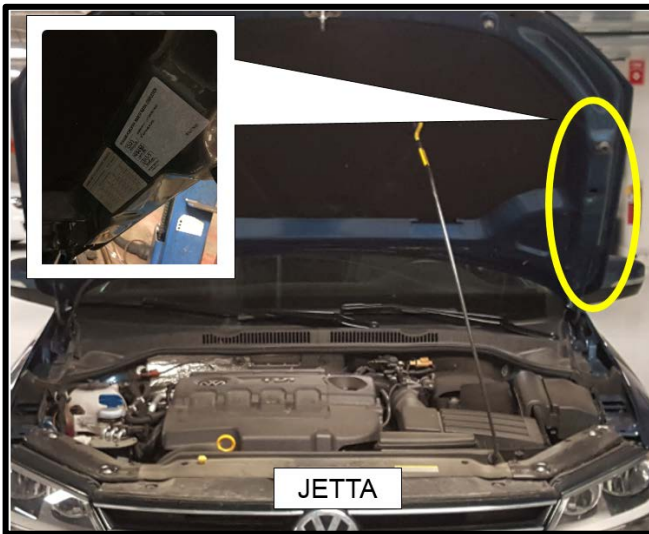
- Open the hood.
- Clean the surface where the label is to be installed <circle>.
- Install the Supplemental Vehicle Emissions Control Information Label, **03L 010 005 J**, in the location shown <circle>.

- The surface where the label is to be installed must be clean, dry, and free from oil residue prior to installing the label.
- Label must NOT cover any existing label(s).
- Label must be installed in locations shown.
- Photo documentation of label installed is required.

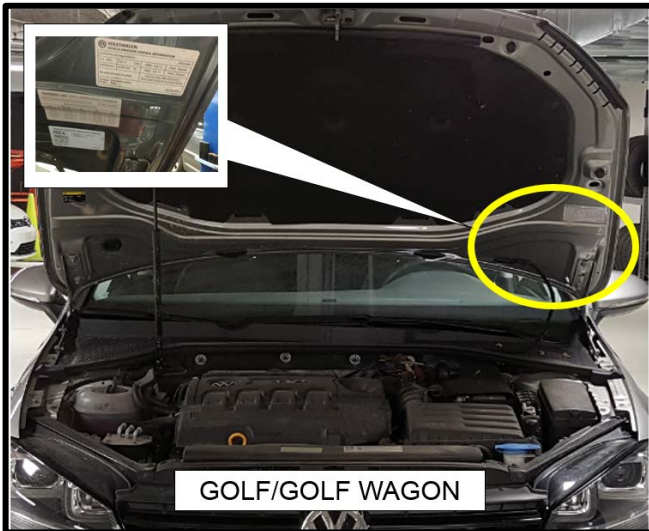
DO NOT Cover existing VECI label!

New Vehicle Emissions Control Information (VECI) label MUST NOT be placed over original VECI label.

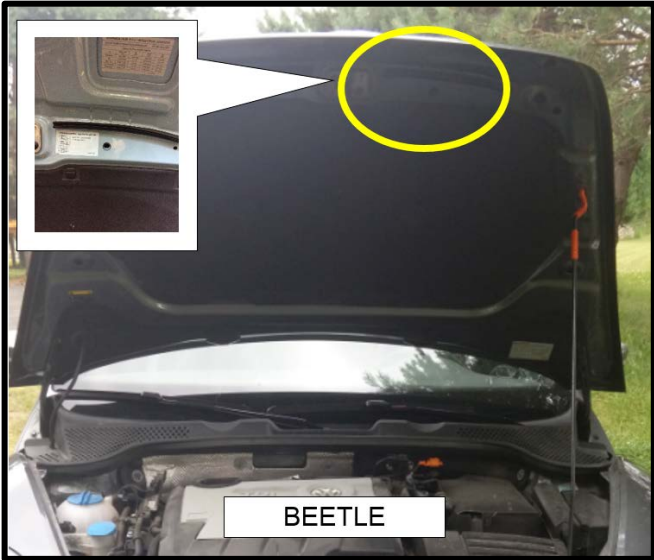
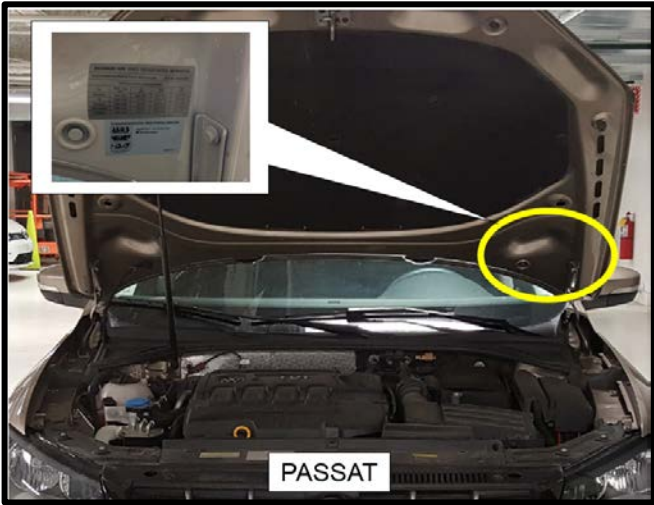
- Clean the surface next to the Vehicle Emission Control Information Label where the TDI Emissions Modification – Proof of Partial Completion Label is to be installed.
- Fill out and install the TDI Emissions Modification – Proof of Partial Completion Label, part number **CAMP TDI 2016_3A**.

Place the label next to the Vehicle Emission Control Information Label.

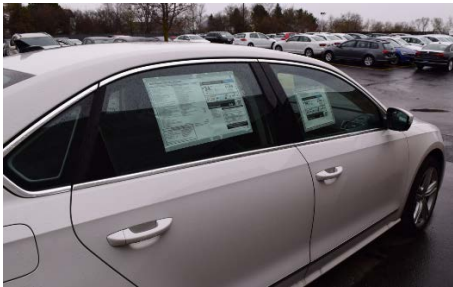
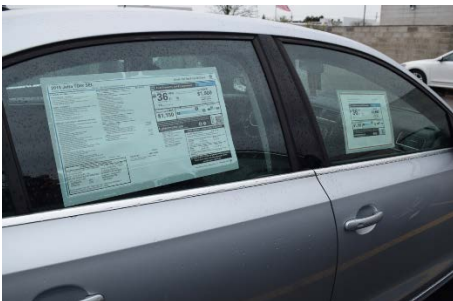
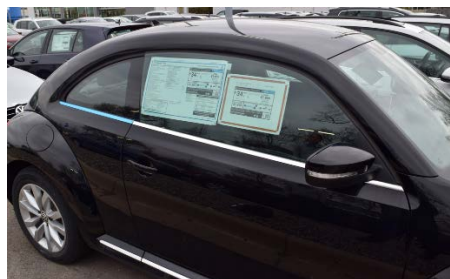
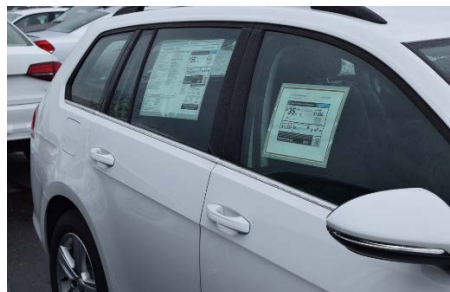
- Examples of properly Installed Monroney and Fuel Economy Labels <pictured left> on various vehicle models.

- Remove original Monroney Label and discard.
- Install new Monroney Label <example pictured left> on the rear passenger side window <example pictured below>.

- Install new Fuel Economy Label <example pictured left> to the right of the new Monroney Label. If necessary, use the passenger front window <examples pictured below>.

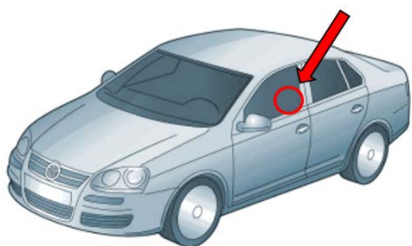
- Place the “more information” permanent window sticker <pictured left> on the front driver-side window in the lower right corner of the window <arrow>. Install the sticker from the inside of the window.
 - Affix the “more information” sticker to the front driver-side window as necessary either above, beside, or under any other required State and/or Local Labels (example, California Prop 65).
