ITB16-048

VOLUNTARY SERVICE CAMPAIGN 2013 JX35 AND 2014 QX60; CVT

CAMPAIGN ID #: PC501**APPLIED VEHICLE:** 2013 JX (L50)
2014 QX60 (L50)**Check Service COMM to confirm campaign eligibility.**

Infiniti is conducting this voluntary service campaign on certain specific 2013 JX35 and 2014 QX60 vehicles to reprogram the TCM and, if needed, inspect and replace the CVT or CVT control valve. This service will be performed at no charge to the customer for parts or labor.

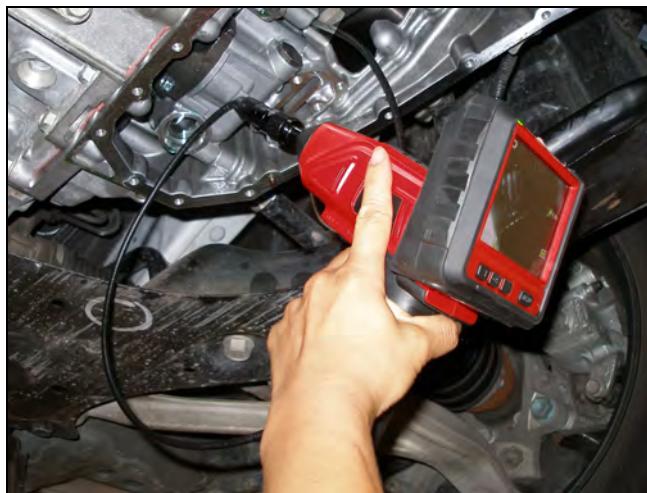
Figure 2C

CAUTION: If the tire is rotated in the rearward rotation, the camera lens may get caught between the chain and pulley.

- Holding the borescope with one hand allows for turning the tire with the other hand (see Figure 2C).

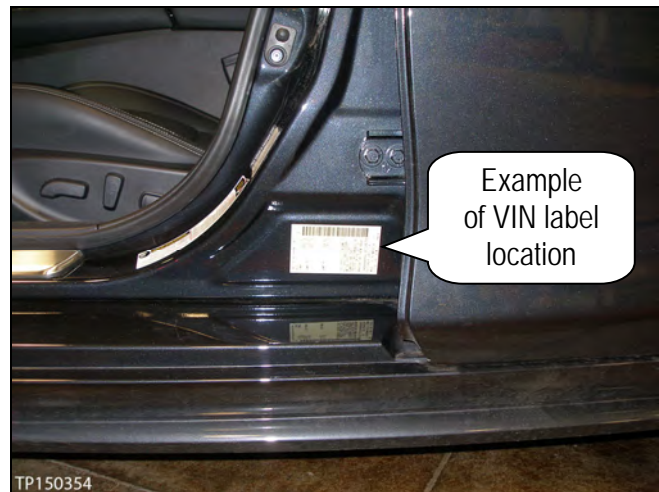
Figure 3C

- Use borescope J-51951 to record a 15 second or less continuous video of the most severe evidence of **chain slip/damage** and the **VIN** on the F.M.V.S.S. certification label (VIN label).
- For best picture, the camera lens should be about 10 mm away from the object being recorded.

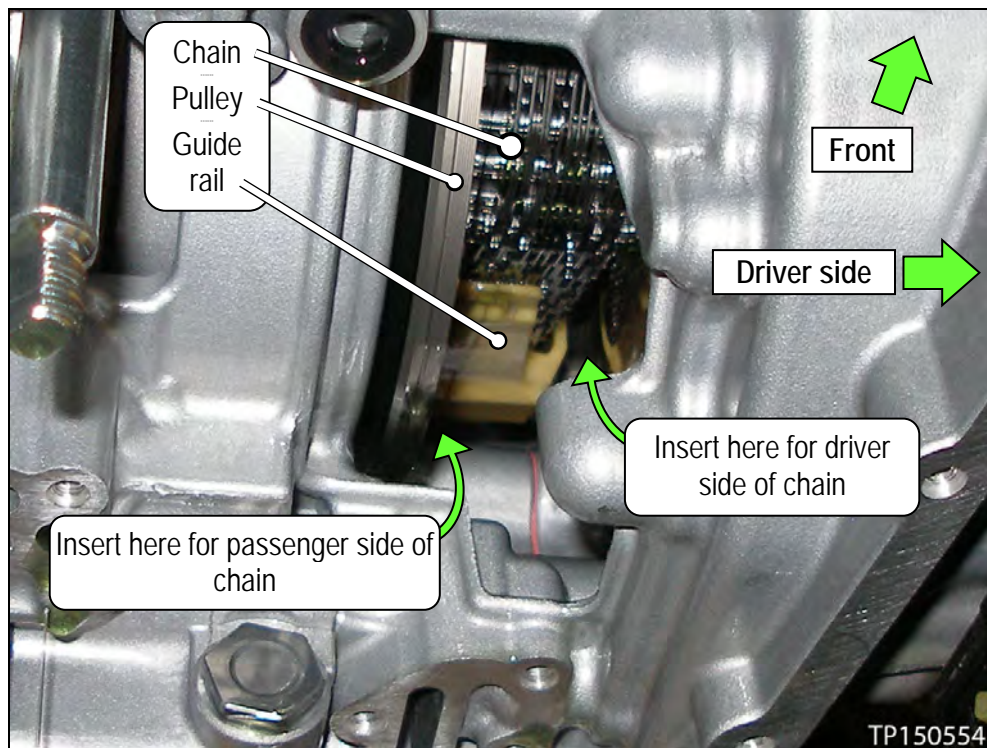
- Insert the camera lens behind the pulley between the guide rail and the pulley where shown in Figure 4C (see also Figure 5C – 8C).
- Insert approximately 8-9 inches, and then view the side of the chain that contacts the pulley.

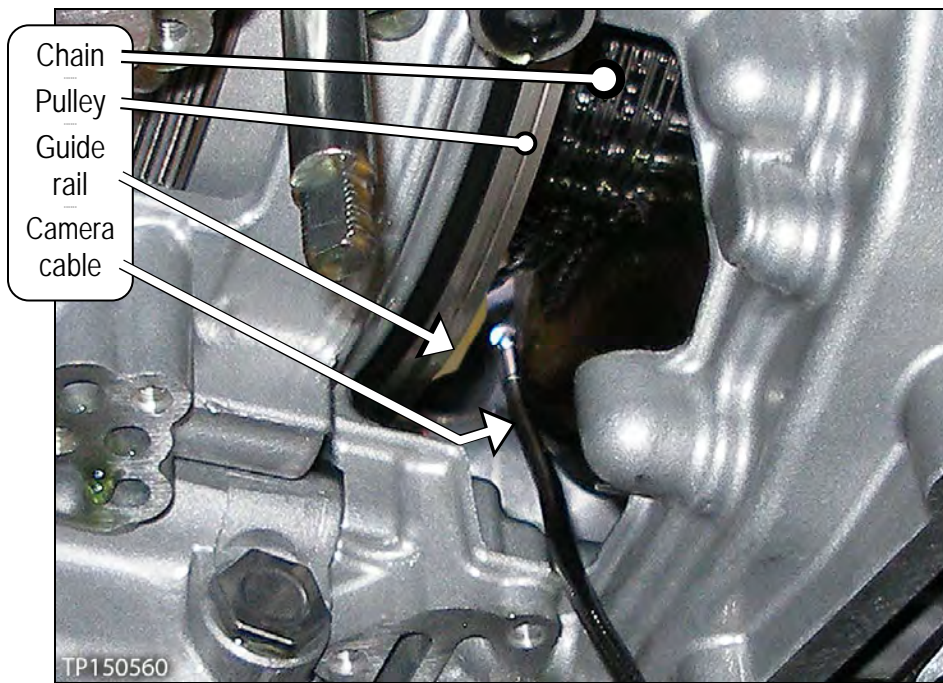
- Figure 5C shows where to insert the camera lens on the driver side of the chain.

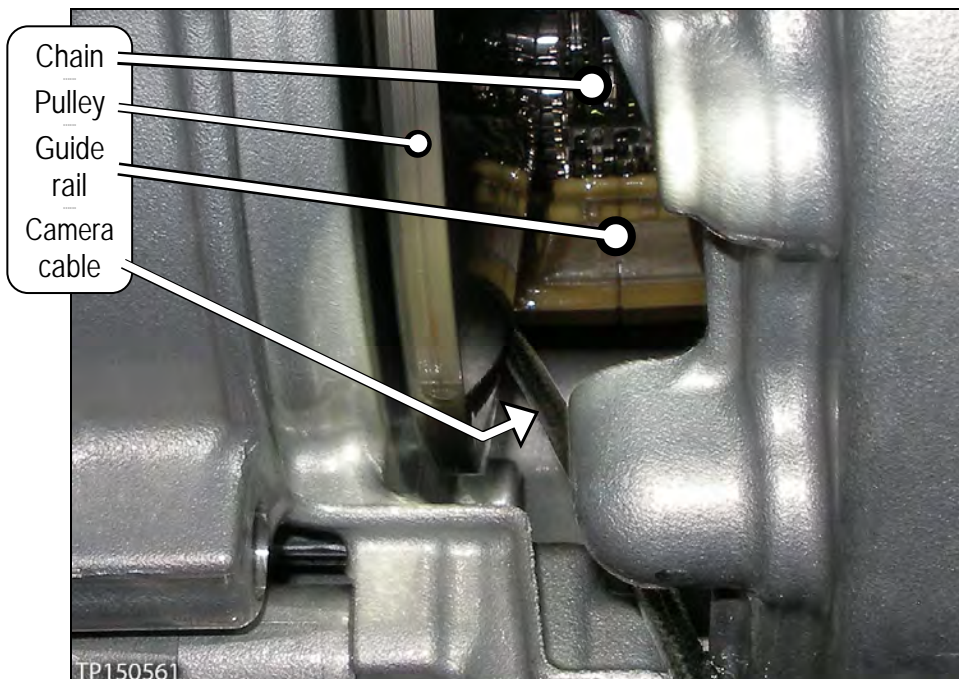
- Figure 6C shows where to insert the camera lens on the passenger side of the chain.

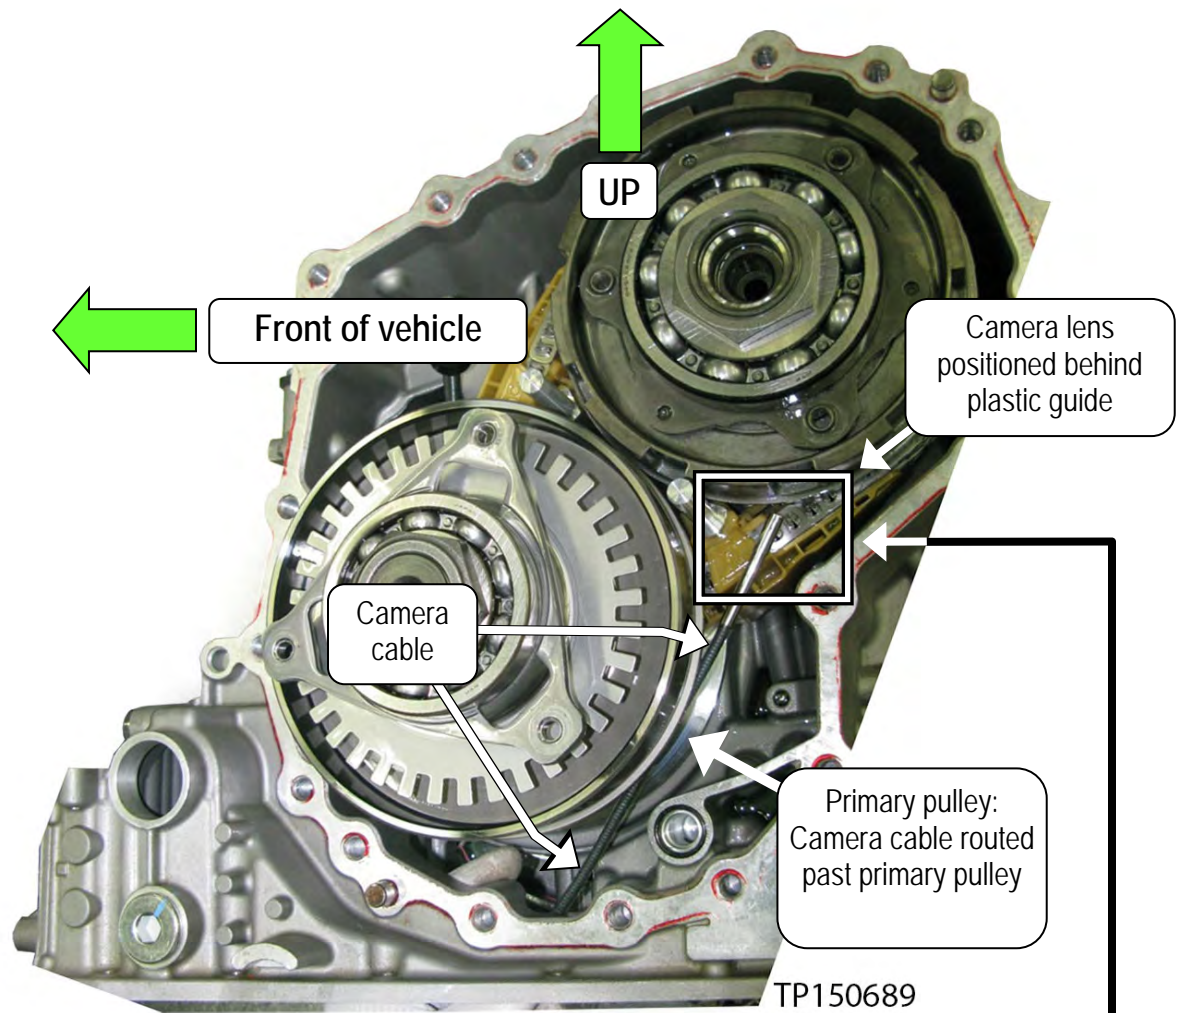
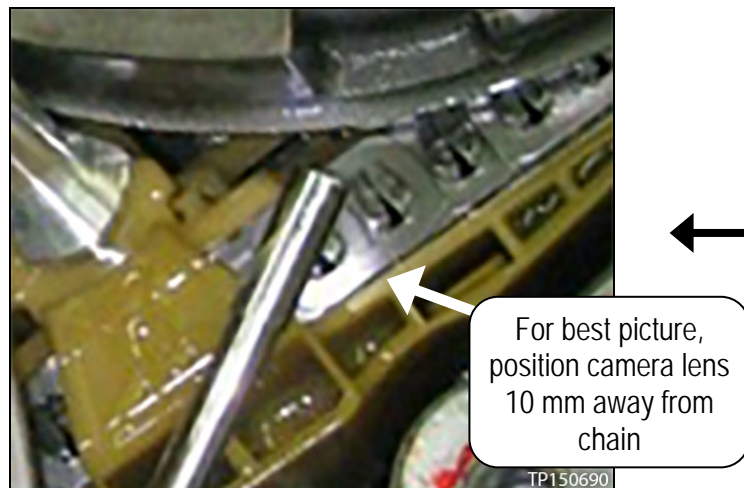
Figure 7C

- Figures 7C and 8C show the routing and location of the camera.

NOTE: The CVT's side cover was removed for easier viewing of camera location. The side cover is not to be removed at any time during this procedure.

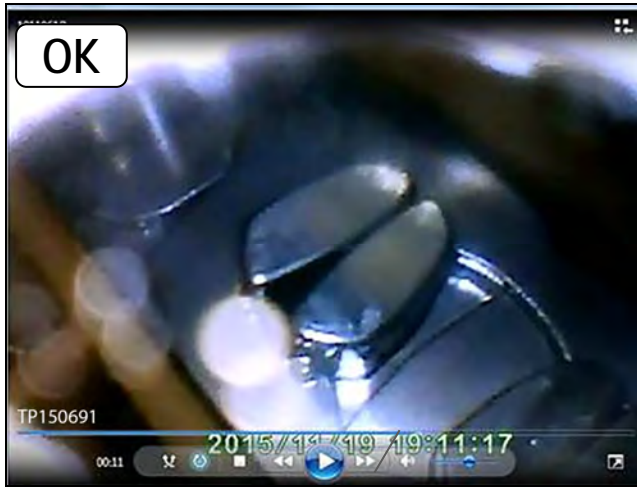
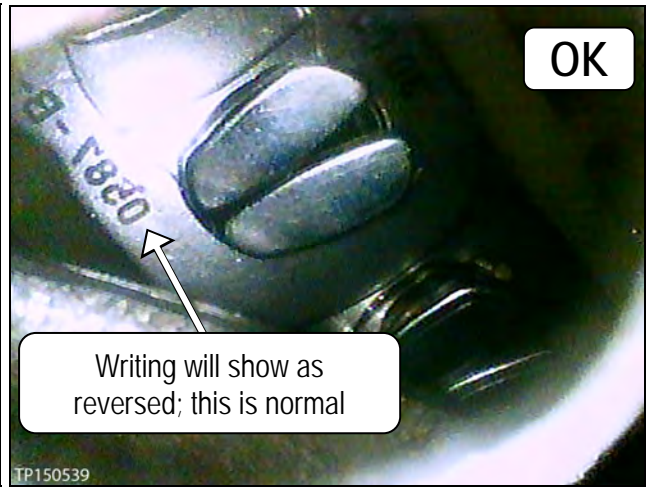
NOTE: Reference the photos on pages 22 – 24 for examples of chain slippage and for comparison to the vehicle you are working on.

Photos in Figure 12C and 13C were taken with borescope J-51951.

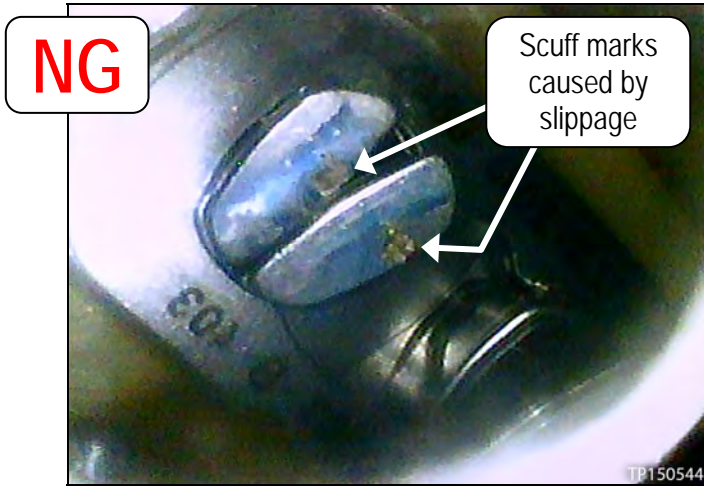
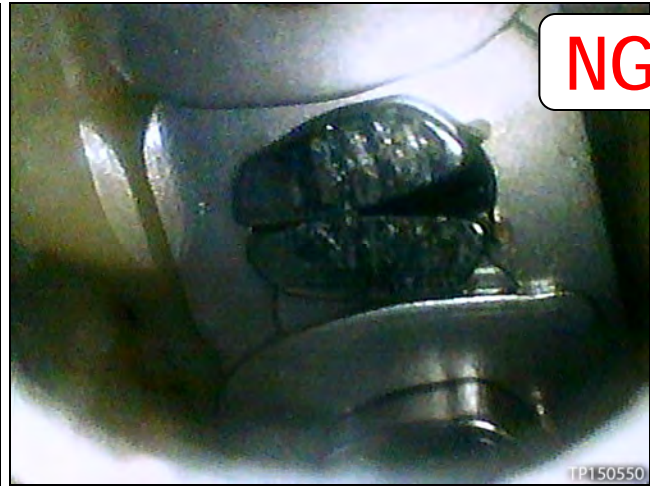
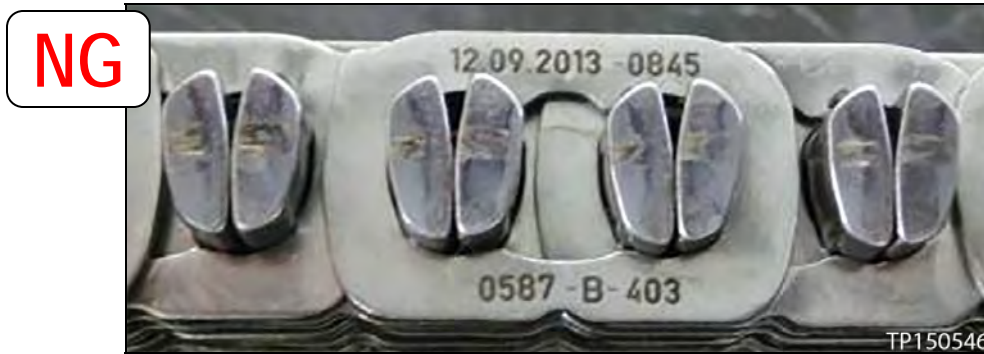
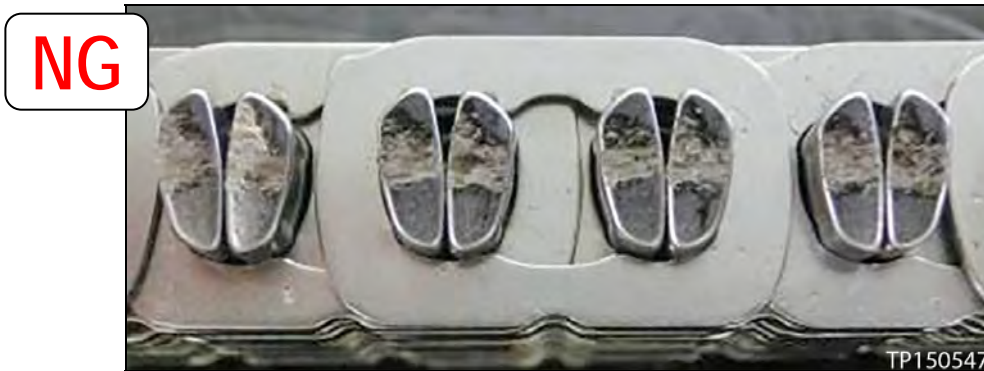
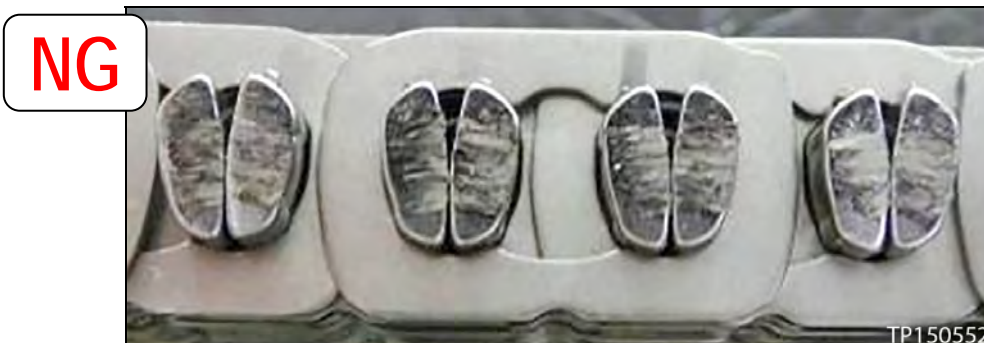
Pictures in Figure 16C – 20C were taken with borescope J-51951.

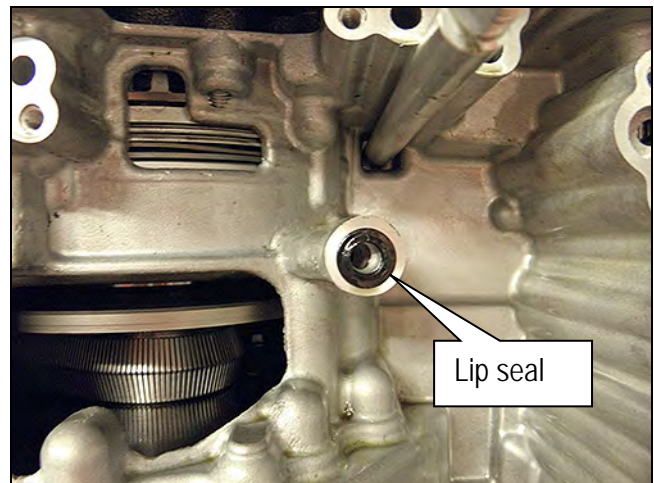
Figure 2D

4. Install a new lip seal.
 - Do NOT reuse the old lip seal.
 - Apply a small amount of petroleum jelly to the lip seal to keep it in place on the CVT.

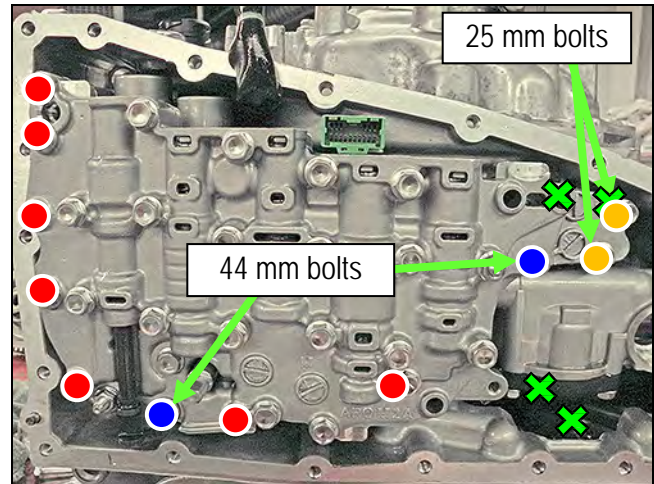
Figure 3D

CAUTION: The two 25 mm bolts are installed WITHOUT the strainer bracket.

➤ Bolt torque: 7.9 N·m (0.81 kg·m, 70 in·lb.)

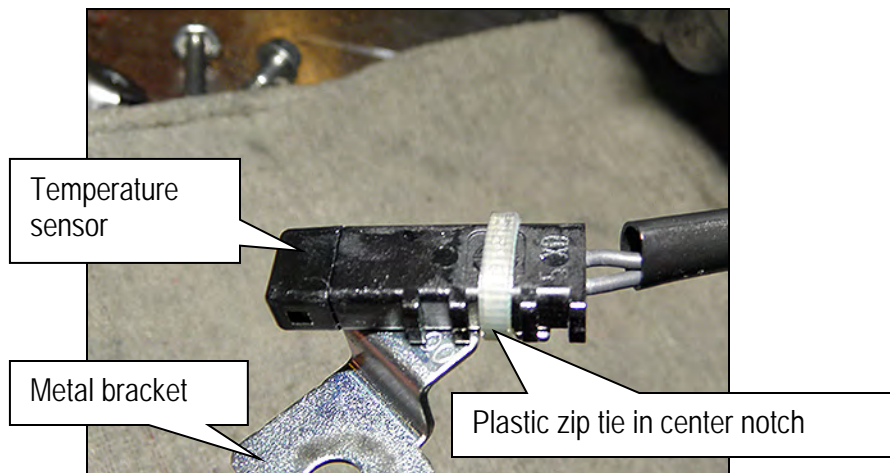
Figure 6D

CAUTION: Cut the plastic zip tie over the metal bracket to avoid damage to the temperature sensor.

IMPORTANT: Locate the plastic zip tie at the **center notch** of three notches on the temperature sensor.

- d. Cut off excess zip tie.

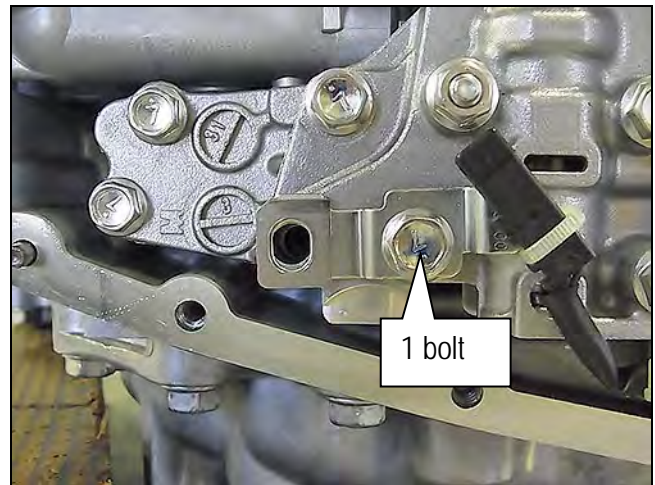
Figure 8D

8. Install the CVT fluid temperature sensor bracket to the valve body with one (1) bolt (Figure 8D).

- Bolt torque: 7.9 N·m (0.81 kg-m, 70 in-lb.)
- Bolt length: 54 mm

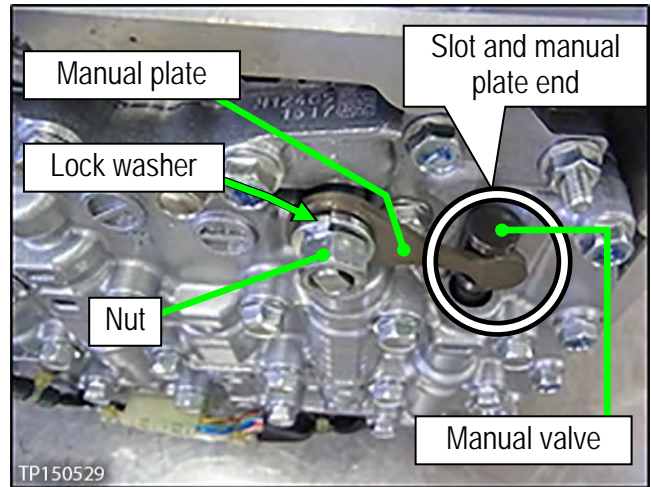
Figure 10D

10. Install the manual plate, lock washer, and nut.

- Reuse the existing manual plate, lock washer, and nut.
- Nut torque: 22.1 N•m (2.3 Kg-m, 16 ft-lb.)

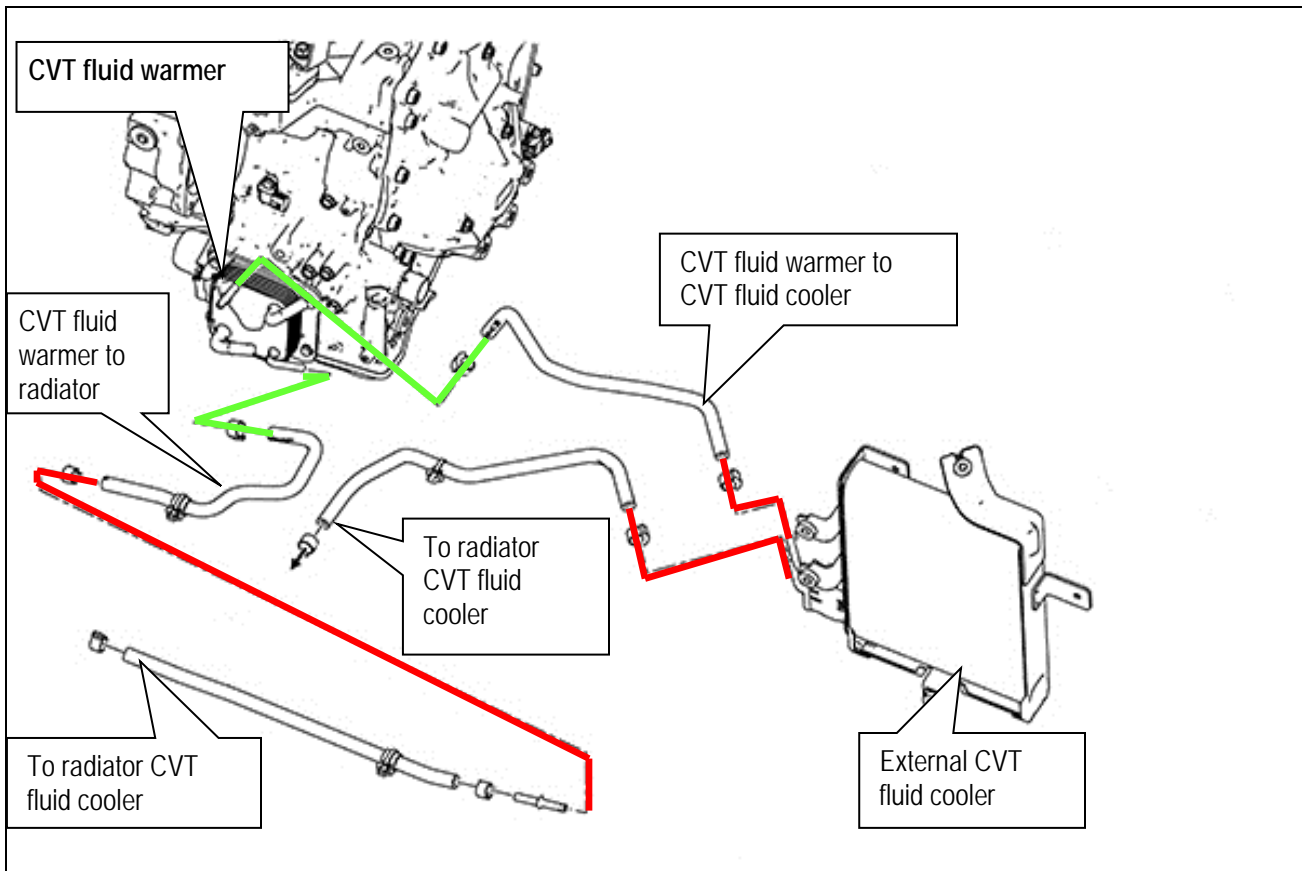
Figure 2E

- Place an oil drain pan under the CVT warmer.
- Disconnect the CVT fluid inlet and outlet rubber hoses from the CVT fluid warmer (Figure 2E) and discard the spring clamps.

NOTE: The two hoses that have been removed from the CVT fluid warmer will be used to flush the radiator based cooler; first in one direction and then the other.

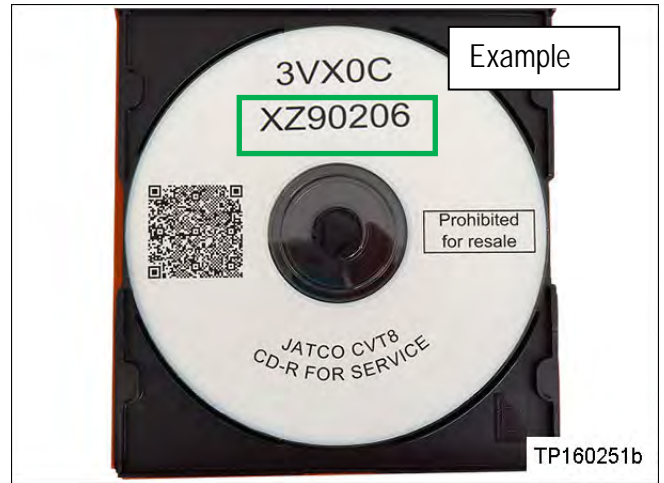
Figure A

- Disc (CD) provided with the new CVT.

IMPORTANT: All three of the above numbers must be the same (they must match).

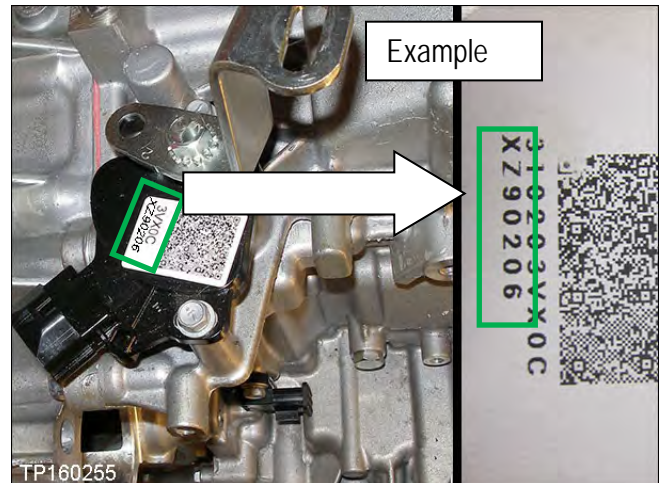
Figure B

- QR label on the new CVT.

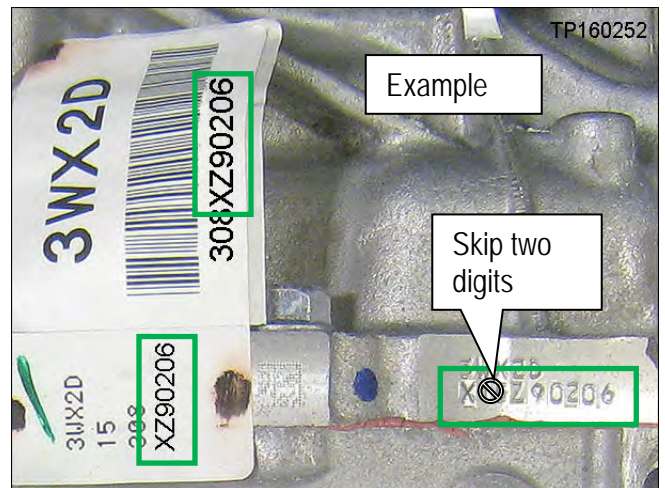
Figure C

- Calibration file number on the CVT case or label.

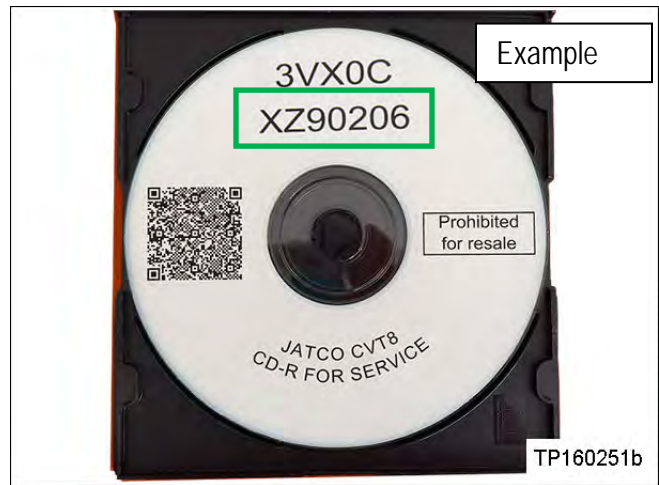
Figure D

- Disc (CD) provided with the new valve body.

IMPORTANT: All three of the above numbers must be the same (they must match).

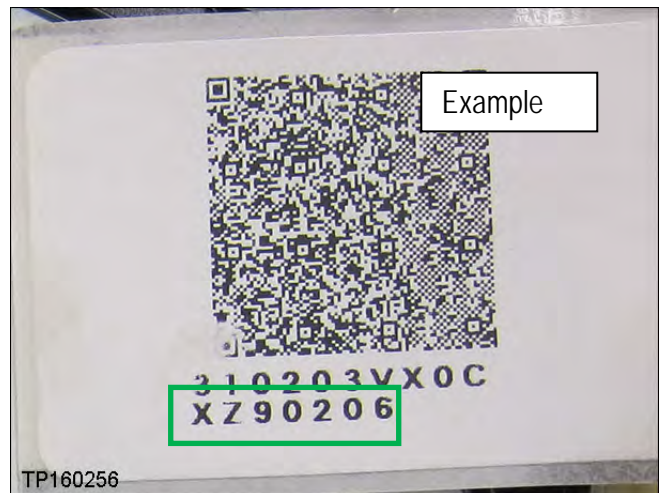
Figure E

- QR label provided with the new valve body.

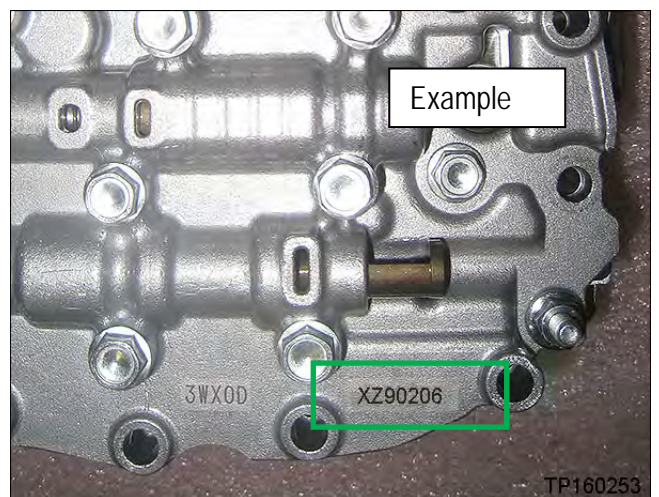
Figure F

- Calibration file number on the valve body.
