Technical Bulletin

26 16 01 February 25, 2016 2039436 Supersedes Technical Bulletin V261506 dated July 14, 2015 to update labor operation.

Ad Blue Warning and or MIL ON - Ad Blue Leakage at Reductant Injector

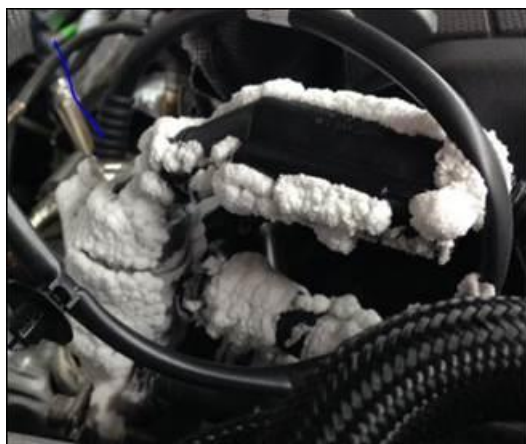
Welding process issues of the reductant line connector to the supply line may cause Ad Blue leakage at the reductant injector.

Inspect the connection of the reductant supply line connector at the reductant injector in the engine compartment. If white crystalized (dried) Ad Blue is found at the reductant injector (see Figure 1 & 2), it will be necessary to replace the reductant supply line.

Thoroughly clean the area of the reductant supply line connection with water to remove the crystalized Ad Blue.
Replace the reductant supply line.

It is not necessary to replace the reductant injector.
