Volkswagen

Service Information

Number: VSE-16-02

Subject: T10542/2 – Threaded Stud from High Voltage Adapter Set – **Special Notice**

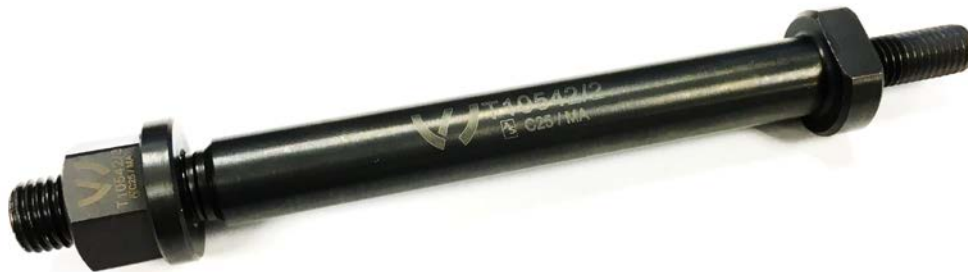
The T10542/2 Threaded Studs included in the T10542 adapter set sold by Matra do not meet the specified design. There are two T10542/2 Threaded Studs in each T10542 Adapter set.

We would like to explicitly state that using the non-replaced version entails a risk of injury that may lead to bodily harm. For this reason, the affected T10542/2 Threaded Studs may not be used under any circumstances!

The procedure for High-Voltage Battery, Lifting in ElsaPro has been updated to no longer require the use of T10542/2 – Threaded Studs and T10542/3 - Nuts from the T10542 – High-Voltage Adapter Set. These two components of T10542 need to be disposed of immediately.

There has been a change to the items supplied with kit T10542 due to a modified repair procedure for removing and installing the High-Voltage battery in the Audi A3 e-tron®. The T10542-ERG Kit updates the T10542 to the T10542A level. Follow the updated procedure in ElsaPro for proper usage of the T10542A Tool Kit.
