Technical Bulletin

85 16 01 March 8, 2016 **2041609** Supersedes Technical Bulletin V851503 dated October 7, 2015 to add additional model years.

Fresh Air Blower Inoperative

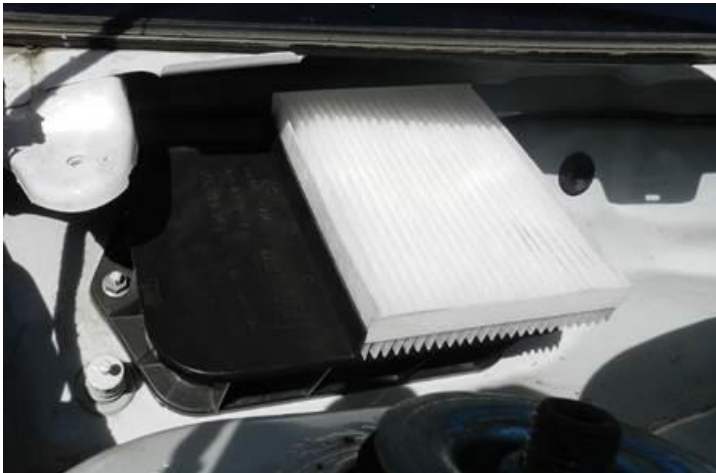
Figure 1: example Jetta: filter housing (part number 5C6 819 343). Figure 2) red arrows mark the mounting points of the clips (part number 7L6 133 847 A).

- Remove and inspect the blower motor, see Repair Manual Group 68 Storage Compartments and Covers in Elsa.
- Replace the blower motor **only** if the following conditions are found:
 - Noise from blower bearings.
 - Blower motor is hard to turn or binding.
- On vehicles equipped with manual HVAC system, replace the resistor for the fresh air blower if required.
- Remove the plenum chamber cover.
- Remove the air intake grille according to the repair manual.
- Position the filter housing (part number 5C6 819 343) with 3 clips (part number 7L6 133 847 A) on the induction flange, see figure 1 and 2, red arrows.

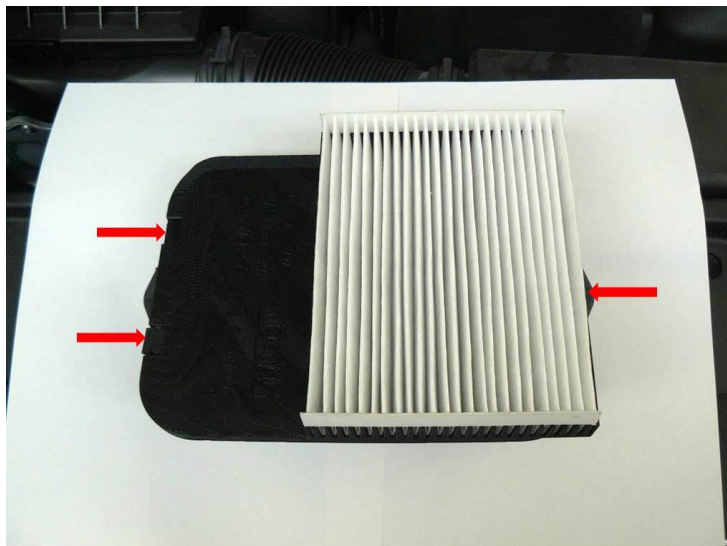
Figure 2: Figure 2) red arrows mark the mounting points of the clips.

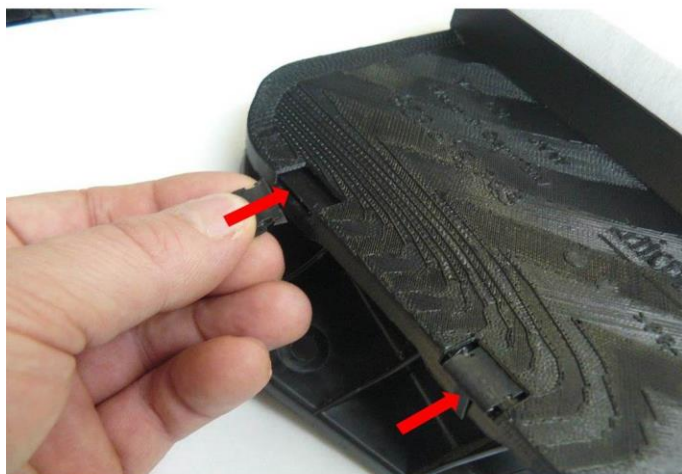
Figure 3: example Jetta: attachment of the filter housing on the air intake grille with clips part number 7L6 133 847 A (red arrows).

- Re-install the air intake grille with filter housing according to the repair manual.
