# Technical Bulletin

| Model(s) | Year | Eng. Code | Trans. Code | VIN Range From | VIN Range To |
|---|---|---|---|---|---|
| Golf/GTI,Golf SportWagen | 2015-2016 | All | All | All | All |

**87 15 18** December 16, 2015 **2038368** Supersedes Technical Bulletin V871517 dated November 24, 2015 to update the vehicle model years applicable and to add N280 valve inspection R.O. documentation.

### Air Conditioning Does Not Cool and or Compressor is Noisy

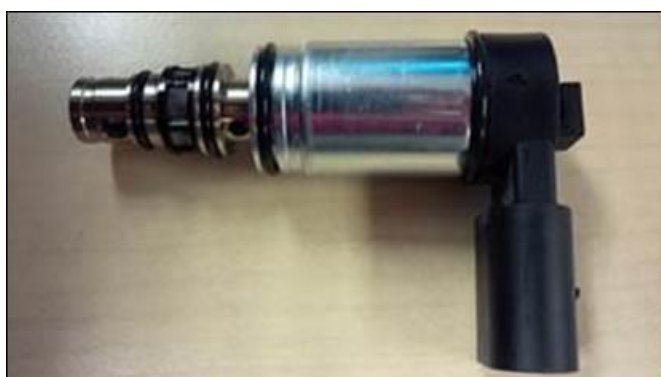
**Figure 1** N280 Refrigerant Regulating Valve  
5Q0260839A

The condition may be caused by a faulty N280 valve (Figure 1). The internal components of the valve can be obstructed and incapable of full function. This loss of refrigerant regulation from N280 can cause noise from the A/C compressor and/or affect the HVAC cooling.

The condition may be caused by a faulty A/C compressor regulator valve N280 (Sanden). The internal components of the valve can be obstructed and incapable of full function. This loss of refrigerant regulation from N280 can cause noise from the air conditioning compressor and/or affect the HVAC cooling.

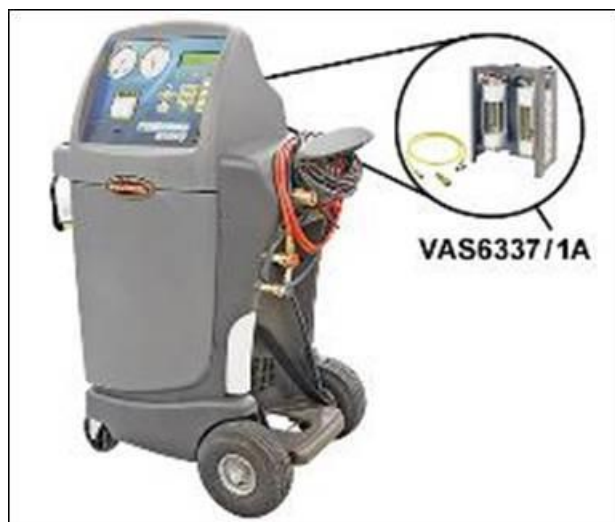
**Figure 4.** Robinair A/C Service Unit.

Connect both the refrigerant service station (Figure 4) and the diagnostic tester to the vehicle.

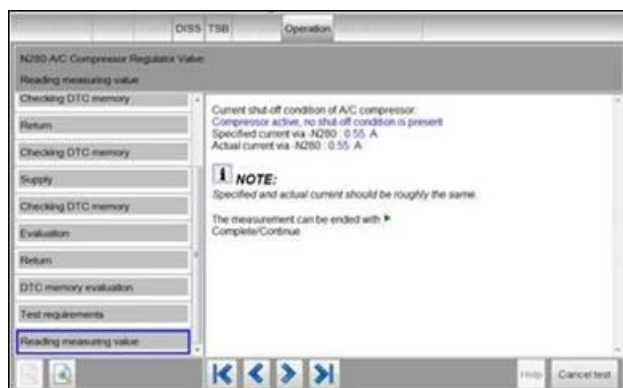
**Figure 5.** Checking N280 signal value Measuring Value Block.

Monitor the measuring value for the air conditioner compressor regulating valve N280 signal (Figure 5).

The actual and specified values will be plausible and will show a normal regulating range of current for cooling request (0.400 A – 0.820 A).

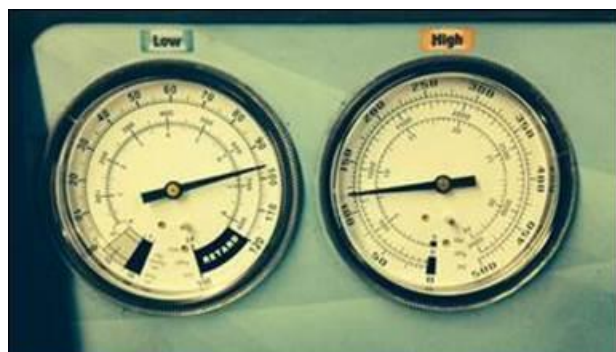
**Figure 6.** Equalized pressure condition.

After verifying the compressor should be on and operating. Check the gauge readings on the Robinair service station to verify equalized pressure readings on the high and low sides of the circuit (no pressure generation from the compressor) (Figure 6).

**! Note: If the gauge readings are showing normal compressor operation per the Elsa Repair Manual, this bulletin does not apply and further diagnosis is required.**

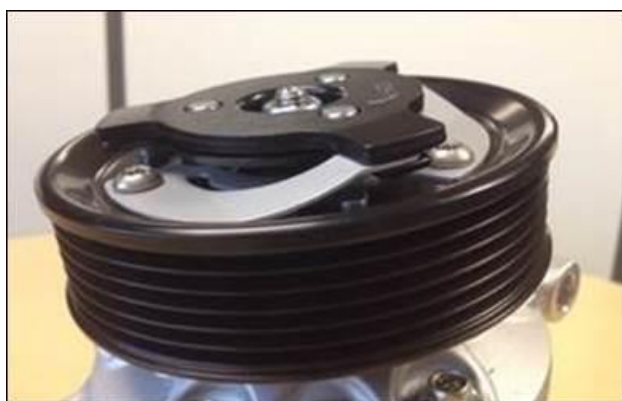
**Figure 7b.** Example of torque limiter over load protection still intact.

Check that the compressor torque limiter has not been activated (Figure 7b).

**!** **Note: If the torque limiter has been released the N280 regulating valve is not at fault. The compressor needs to be replaced.**

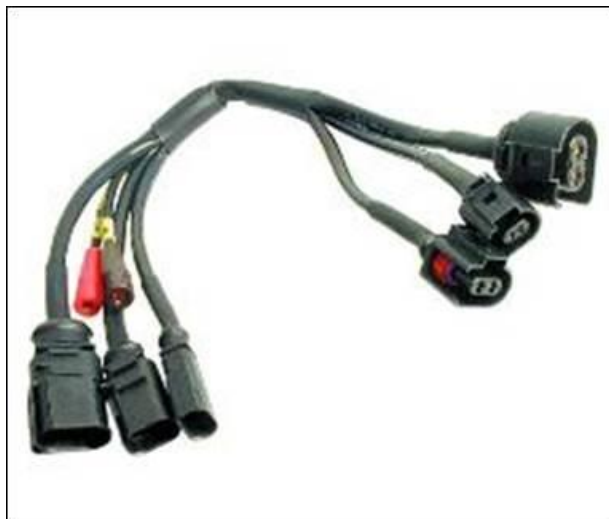
**Figure 8.** VAS 5256 breakout harness.

Shut off the engine. Connect the breakout harness VAS 5256 (Figure 8) between the N280 valve and its connector.

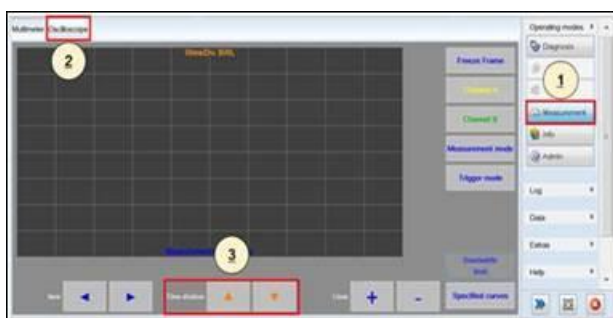
**Figure 9.** Select Measurements from operating mode menu”.

Go to Operating Mode “Measurements” to check the N280 signal from the control module.

Select Measurements.

Select oscilloscope.

Change time division to 2ms/Div (Figure 9).

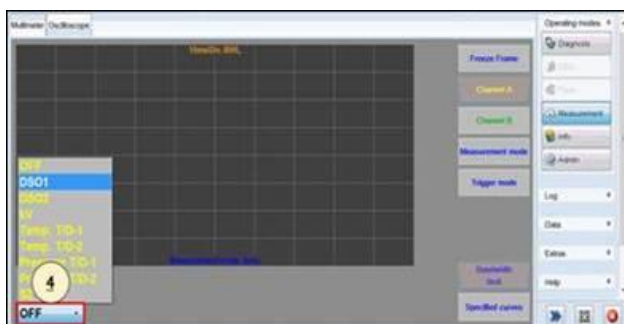
**Figure 10.** Setting up DSO channel”.

Select the correct DSO channel according the test leads hooked to the vehicle (Figure 10).

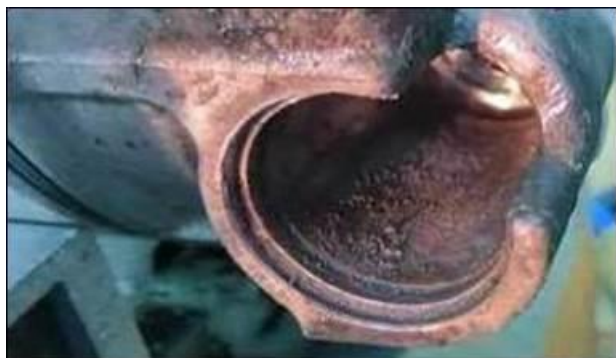
**Figure 13.** Corrosion in the N280 valve bore.

Assess the condition of the N280 valve bore and the valve filter screen (Figure 13). If severe contamination is found in valve bore there is a risk of damaging the replacement valve on installation. In these cases the A/C compressor must be replaced.

**A slight amount of debris or corrosion does not present a risk and does not justify replacement of the AC compressor.**

- If little or no corrosion or contamination is found perform Repair Procedure A: Replacing the N280 regulating valve.
- If corrosion and contamination is found, perform Repair Procedure B: A/C compressor replacement.
- **Document the all workshop findings of this procedure on the repair order.**

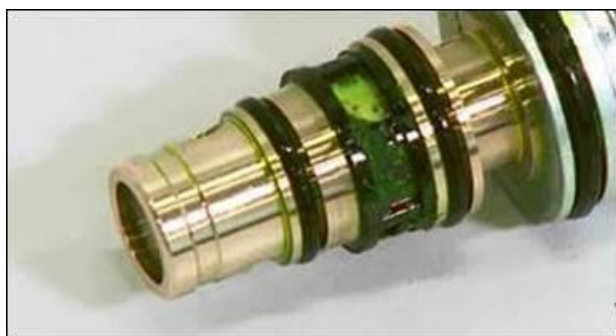
**Figure 14:** Severe contamination at the N280 valve filter screen.

Should severe contamination be found at the valve filter screen (Figure 14) and A/C compressor replacement becomes necessary, ensure that the refrigerant circuit is flushed in the course of repair.

**Small random particles on the filter screen does not constitute “severe” contamination and does not justify replacement of the A/C compressor.**

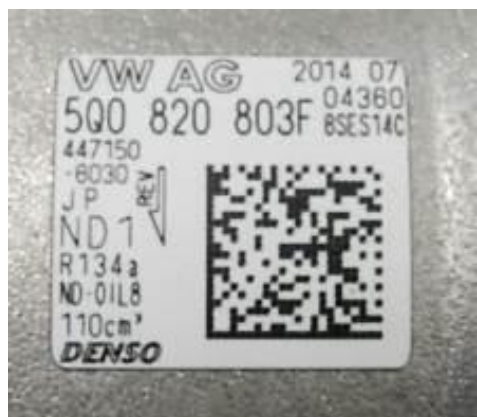
**Figure 14:** Denso compressor 5Q0820803F

MY2015 GTI/Golf, SportWagen production have Sanden compressors 5Q0820803C, 5Q0820803E and 5Q0820803G.

The replacement compressor is Denso 5Q0820803F

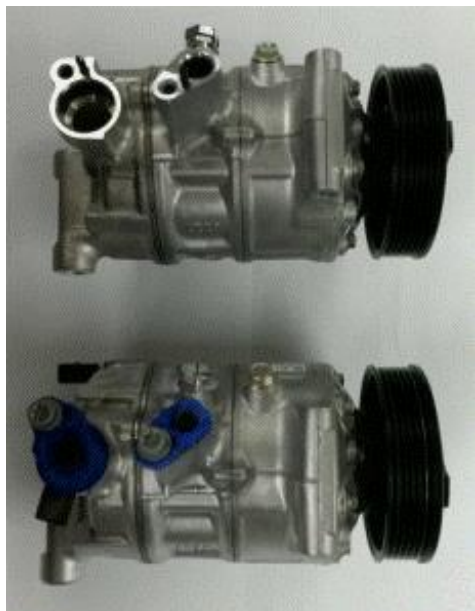
Figure 15

When installing a new compressor transfer the compressor shipping caps to the original compressor as shown in Fig 15.

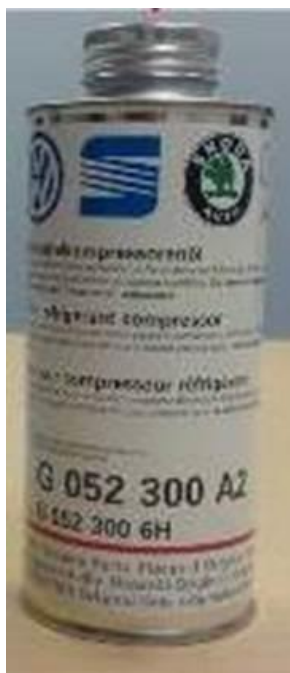
Figure 16: Denso compressor manufacturer PAG oil G 052 300 A2.

The replacement Denso compressor will come with the specified type of PAG oil G 052 300 A2 (Figure 16).

**The compressor comes with a full charge of oil for the entire refrigerant circuit. However the amount of PAG oil supplied with the replacement compressor may not be the exact amount to replenish the refrigerant circuit. Drain and measure the PAG oil in the replacement compressor to determine the required amount. If the amount needs to be adjusted, do so using the correct type of PAG oil specified in ETKA. Refer to Elsa for the correct oil capacity for the compressor being installed.**

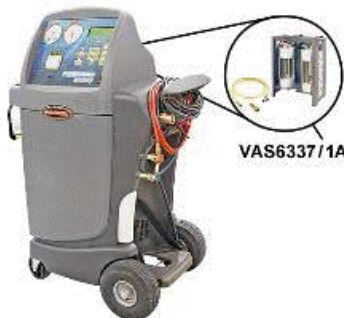
| Tool Description | Tool No: |
|---|---|
| <p data-bbox="389 619 503 651">VAS6337/1A</p> <p data-bbox="138 829 462 861"><b>Robinair A/C Service Unit</b></p> | <p data-bbox="1063 493 1226 525"><b>TOOL NO:</b></p> <p data-bbox="1063 493 1226 525"><b>ROB134APF</b></p> |

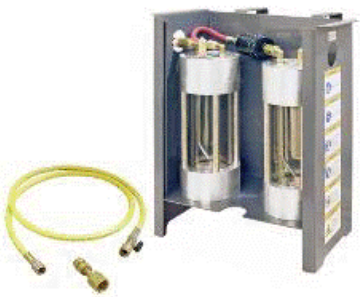
| Tool Description | Tool No: |
|---|---|
| <p data-bbox="138 1228 495 1260"><b>Air Conditioning Flush Tool</b></p> | <p data-bbox="1063 892 1226 924"><b>VAS 6337/1A</b></p> |

The flushing procedure can be found in Elsa at: Heating, Ventilation & Air Conditioning>>Refrigerant R134a Servicing >>00 General Technical Data>> Refrigerant circuit removing contaminates>>Refrigerant Circuit, Cleaning (Flushing), with Refrigerant R134a. The procedure is also described in Technical Service Bulletin 2019947.

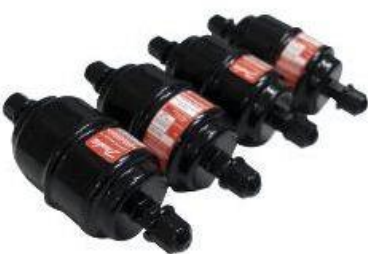
| Tool Description | Tool No: |
|---|---|
| <p data-bbox="138 1291 738 1323"><b>Air Conditioning System Flushing Device Filter</b></p> | <p data-bbox="1015 1291 1274 1323"><b>Behr - BAI783400103</b></p> |

| Outside Material: A/C Flush Machine Behr filter, Part No. BA1783400103 | \$4.25 total per A/C System Flush which accompanies a repair (this amount equals ¼ of the cost of the A/C flush machine filter) |
