Technical Service Bulletin

46 Brake noise analysis and handling

46 14 67 2034181/5 January 21, 2014. Supersedes Technical Service Bulletin Group 46 number 14-64 dated January 2, 2014 for reasons listed below.

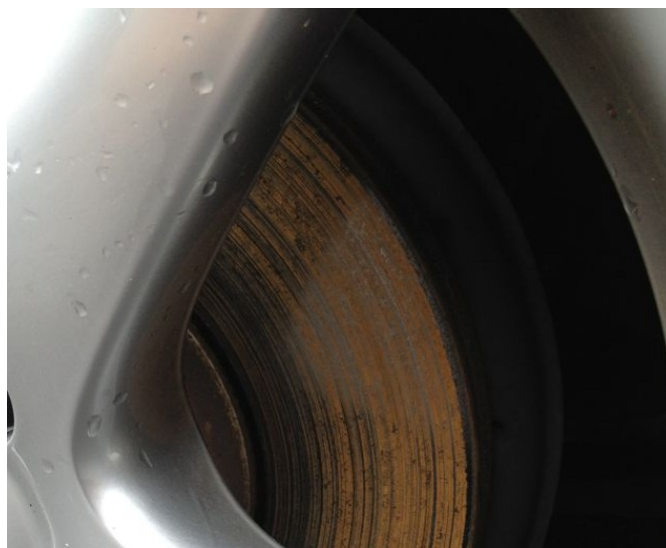
1. Brake discs or brake pads are close to or below their wear limit.
2. Aftermarket pads or discs have been installed.
3. There is debris (such as small stones, grit, road salt, or sand) between brake disc and brake pad.
4. Discs are covered with rust. Rust can form when the vehicle has not been driven for a long period of time (Figure 1).

Figure 1. Disc covered with rust.

- Fill out as much information as possible in the questionnaire. Some fields are mandatory.
4. Clean the brake pads and discs:
 1. With careful consideration of the traffic situation, perform between 2 and 5 ABS stops from speeds above 50 mph. Between each ABS stop, allow the brake components to cool by driving the vehicle for more than one minute at speeds greater than 50 mph.

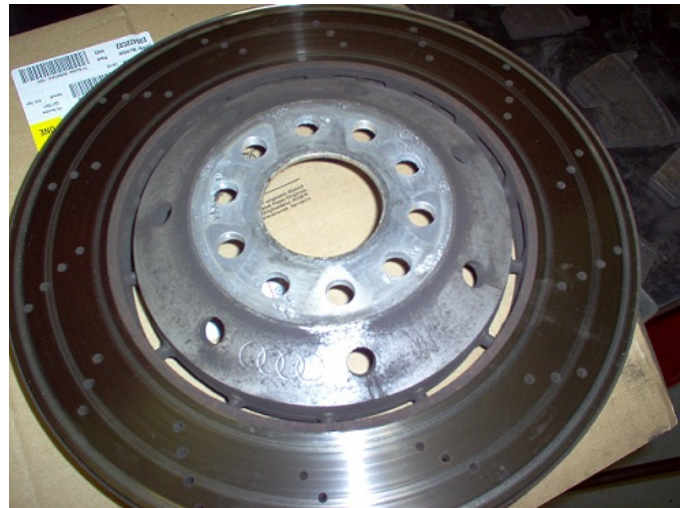
5. Discs are grooved (Figure 2).

Figure 2. Grooved disc.

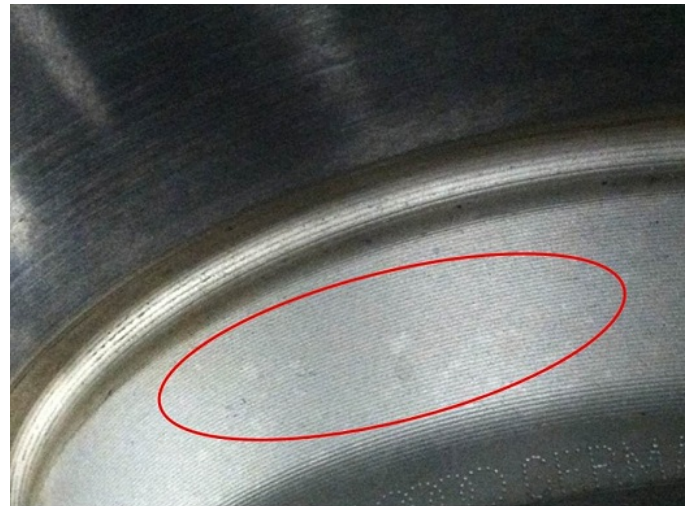
6. There is chemical contamination on the braking surface of the brake disc due to wheel or tire cleaner being sprayed directly onto the brake disc (Figure 3 and Figure 4).

Figure 4. Small spots and discoloration due to chemical contamination from cleaner that was sprayed directly onto the disc.

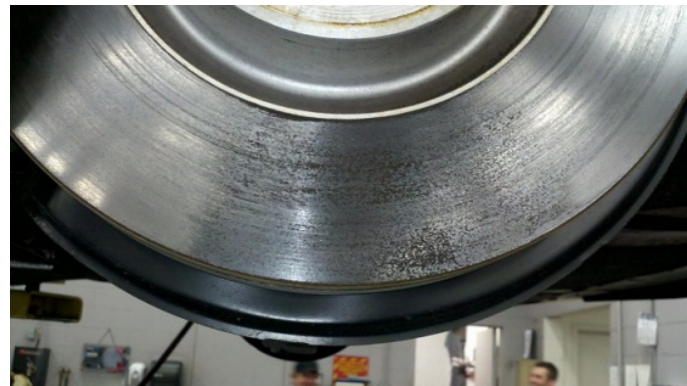
7. There are “pad marks” on the brake disc as a result of brake pad material transferring to the discs (Figure 5). Pad marks can occur when a vehicle has been parked for long periods of time in a wet or snowy environment.

Figure 5. Brake pad material has transferred to the discs.
