# Tech Tips

TT 80-15-01

2015 Jetta 2.0I TDI (CVCA engine code) - Vibration/Rattle on acceleration, under mild/medium load

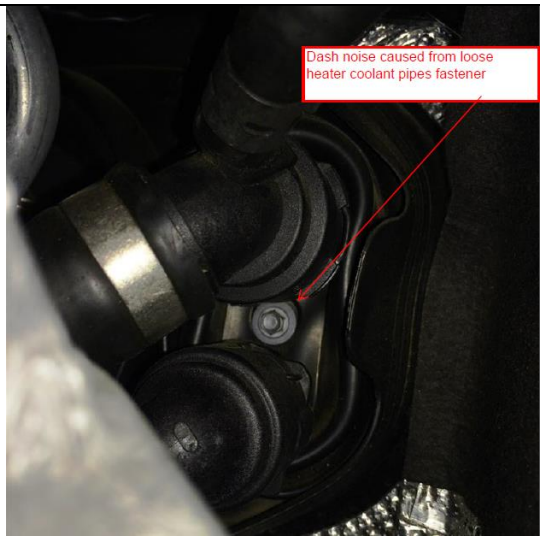
The Heater core pipe fastener may be loose allowing pipes to contact the bulk head causing a vibration. Inspect the fastener in the engine compartment that holds the heater core tubes to the air box assembly.

<p>Inspect the heater core tube fastener</p> <ul style="list-style-type: none"><li>• If loose re-torque to 1.5Nm</li><li>• If screw is missing order substitute fastener WHT004564. Install and torque to 1.8Nm.</li></ul> <p><b>Note:</b></p> <p>Do not over torque the fastener. The plastic around the tubes may become deformed and damaged.</p>

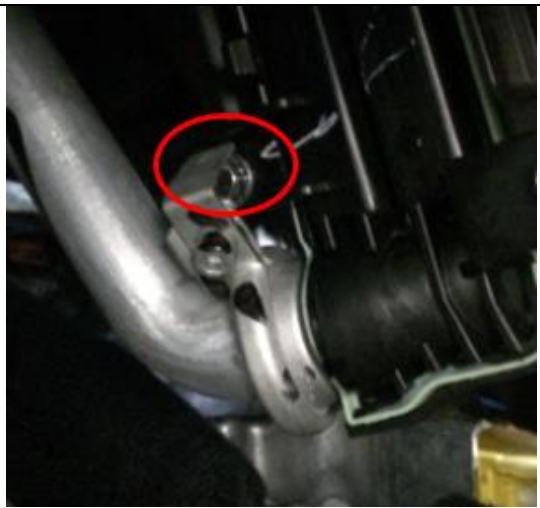
<p>Inspect the heater core clamps are not contacting the air box. Adjust the clamps away from the air box assembly. Tighten clamp screws 2Nm.</p>
