# Technical Service Bulletin

## 85 Defroster outlet trim deformed

85 13 18 2033426/2 June 4, 2013. Supersedes Technical Service Bulletin Group 85 number 13-15 dated March 29, 2013 for reasons listed below.

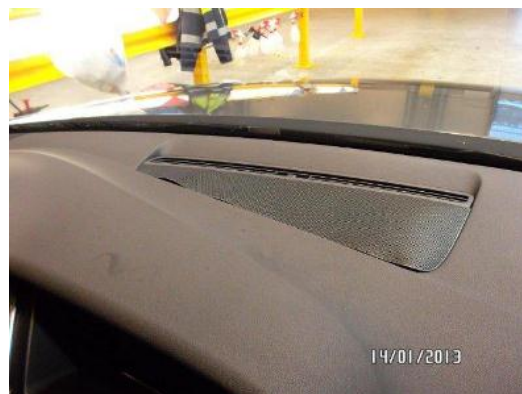
The trim panel at the defroster vent on the instrument panel is deformed (Figure 1).

**Figure 1.** Deformed defroster vent trim panel.

The trim panel is composed of a material which expands in a moist condition. The instrument panel restricts this expansion which leads to deformation of the trim.

Replace the defroster vent trim panel.
