Technical Service Bulletin

66 Wind noise from exterior rear view mirror base or at lane change assist lamp

66 13 28 2029586/3 April 10, 2013. Supersedes Technical Service Bulletin Group 66 number 12-23 dated August 3, 2012 for reasons listed below.

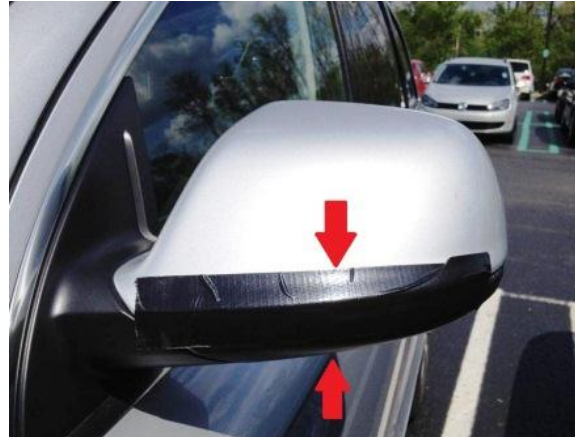
Figure 1. Tape applied to horizontal seam.

1. Apply tape to the horizontal seam between the mirror mount assembly and the painted cover (Figure 1) to determine if the noise is coming from the mirror base.
 - If the mirror base is not the source of the noise, move to step 2.
 - If the mirror base is the source of the noise, replace the mirror base according to the ElsaWeb Repair manual: *Body >> Body Exterior >> 66 Exterior Equipment >> Removal and Installation >> Exterior rearview mirror >> Exterior rearview mirror.*

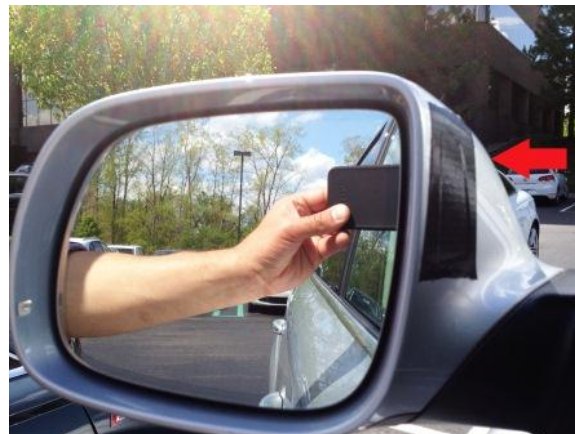
Figure 2. Tape applied over the lane change assist lens.

2. If the vehicle is equipped with lane change assist, remove the first piece of tape, then apply tape to cover the lane change assist marker lens (Figure 2) to determine if the lane change assist lamp is the source of the noise.
 - If the lane change assist lamp is the source of the noise, replace one or both of the lamps according to the ElsaWeb Repair manual: *Electrical System >> Electrical Equipment >> 96 Interior Lights, Switches >> Removal and Installation >> Lane Change Assistance >> Lane Change Assistance Warning Lamp in Exterior mirror.*
