ROADSTER 2012-6 Possible Water Infiltration in Radio Module (RT)_000030255_WCN61Y012S10_en

Product: **Roadster**
 Bulletin type: **Warranty Campaign**
 Bulletin no: **2012-6** (rbg2012-007 en AG)
 Revision no:
 Revision date:
 Campaign no.: **2011-0014**
2012-0005
 Publication date: **May 30th, 2012**
 Subject: **Spyder™ RT – Possible Water Infiltration in Radio Module**

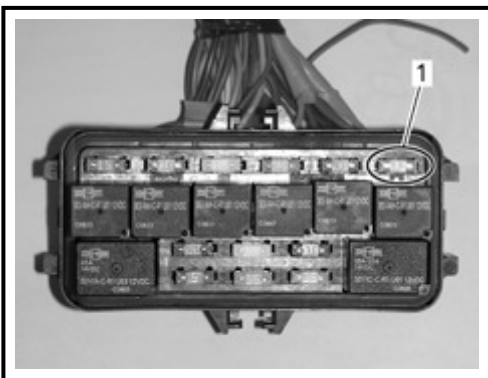
FRONT FUSE BOX

1. Make sure the ignition key is OFF and the cluster is shut down.
2. In the front fuse box, remove fuse 6.

1. Fuse 6

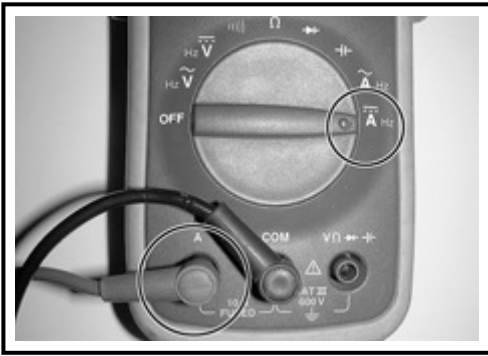
3. On the multimeter, connect the red probe in the A connector.
4. Select DC A.

NOTE: Make sure to use a range that allows enough precision.

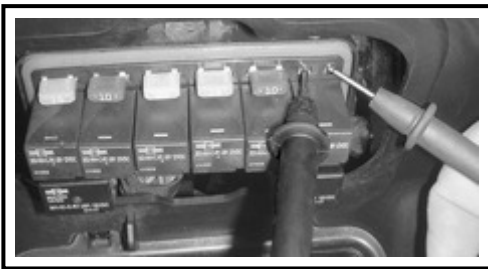
5. Touch each fuse connector with the multimeter probes and wait for a reading to appear.

NOTICE Do not insert multimeter probes in the fuse box terminals.

RADIO MODULE CURRENT DRAW TEST	
Result	Action
.010 A (10 mA) OR LESS	Current draw is normal. Proceed with the rest of the bulletin
MORE THAN 10 mA (.010 A)	Replace radio module, then proceed with the rest of the bulletin

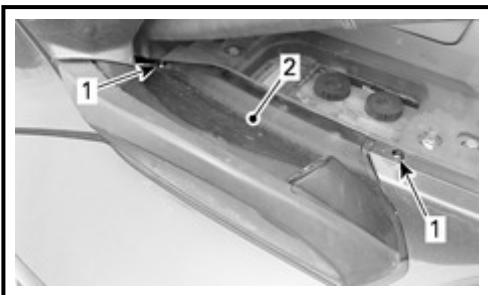
1. Remove the radio access panel screws.

- 1. Screws
- 2. Radio access cover

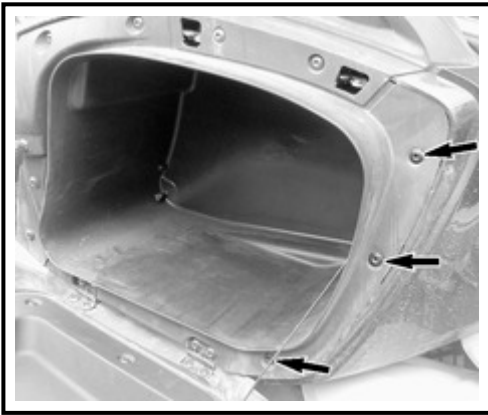
2. Remove the screws shown.

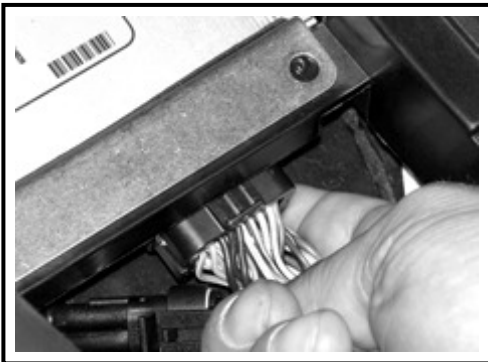
32-PIN CONNECTOR SHOWN

4. Disconnect the 32-pin connector (and 26-pin connector if applicable).

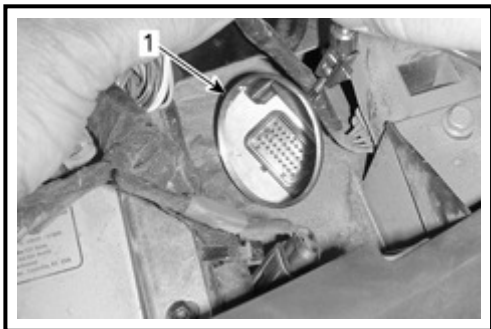
MODULE SIDE VERIFICATION USING A MIRROR

5. Check for signs of corrosion around terminals (on BOTH module and connector sides).

1. Mirror

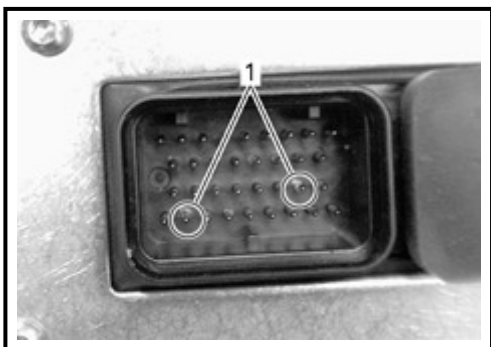
32-PIN CONNECTOR (MODULE SIDE SHOWN)

1. Corrosion

RADIO MODULE Electrical Connectors Inspection	
Result	Action
NO visible sign of corrosion	Proceed with the rest of the bulletin (Radio module is good)
Visible signs of corrosion	Replace radio module, then proceed with the rest of the bulletin

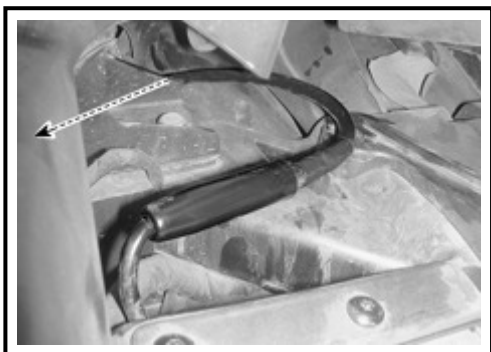
LONG CABLE (GOES DOWN TOWARDS REAR)

1. Visually follow the antenna cable towards rear of the vehicle.
2. Identify the cable length as follows.

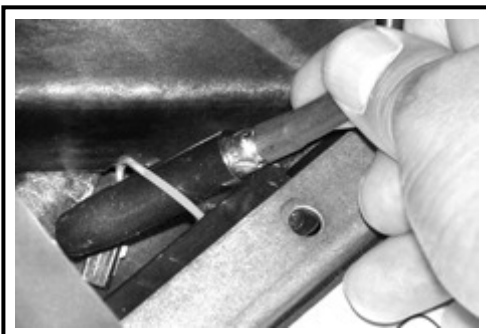
1. Disconnect the antenna cable.

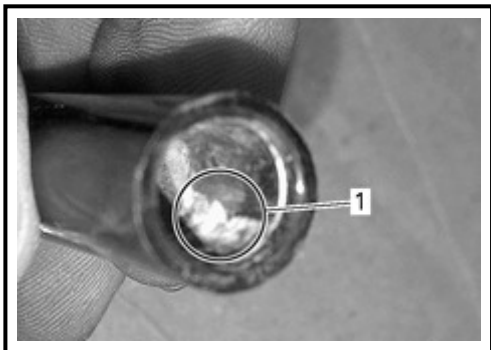
ANTENNA CONNECTOR

2. Check socket for corrosion.

1. Corrosion

If corrosion is found, clean the socket using a wire brush and compressed air.

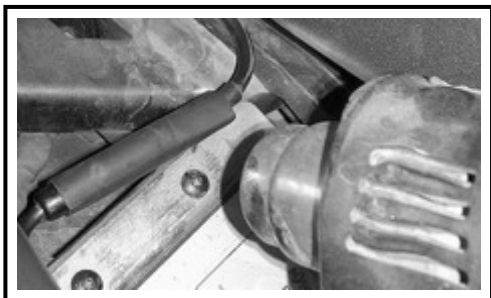
5. Connect the antenna wire, making sure it goes all the way in.

6. Seal the connectors by heating the shrink tubing.
