Technical Service Bulletin

44 Model Year 2013 & 2014 Alignment - Repair Authorization

44 13 39 2030275/6 July 12, 2013. Supersedes Technical Service Bulletin Group 44 number 13-37 dated February 25, 2013 for reasons listed below.

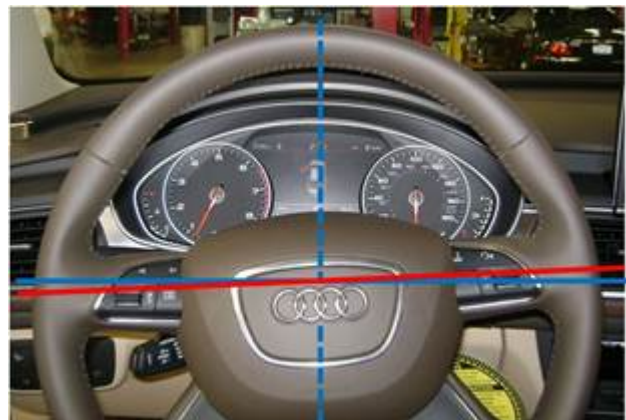
- Vehicle pulls – left or right
- Steering wheel not leveled or off-center (Figure 1).

Figure 1. Steering wheel not leveled (off-center)

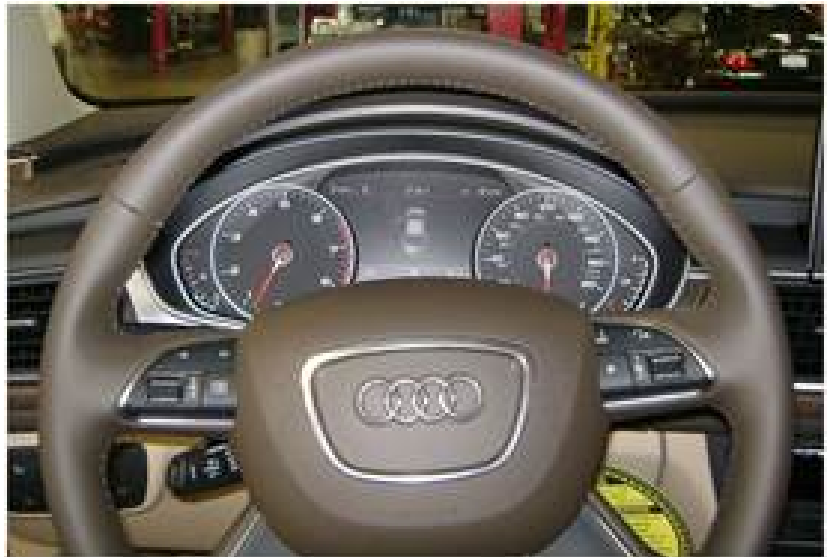
Figure 3. Example of a steering wheel not leveled (off-center) condition.

- b. Prior to proceeding to the next step, check the steering wheel level. If the steering wheel is not leveled (off-center) by any degree, take a photo of the steering wheel (Figure 3).

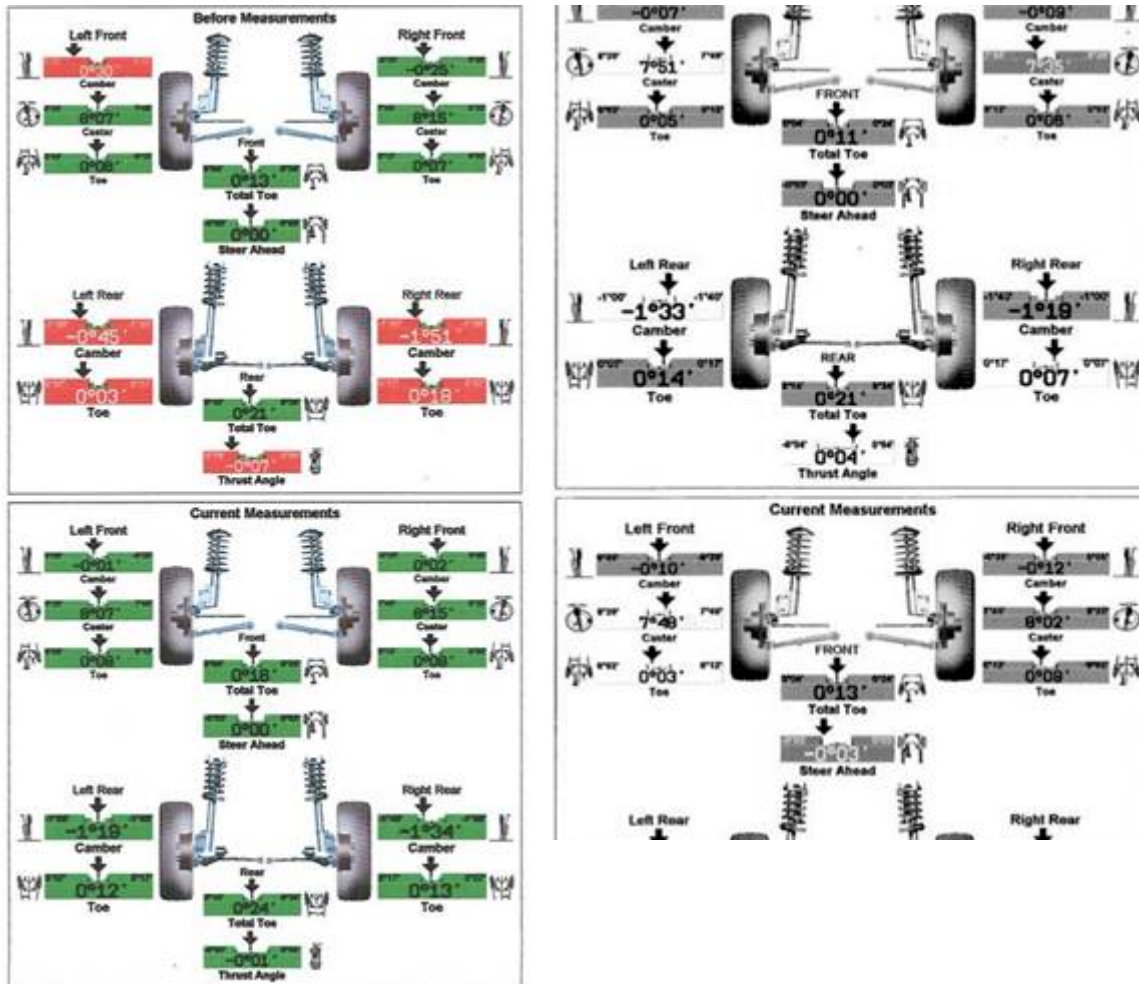
Examples of ACCEPTABLE scanned copies with all alignment values easy to read:

Figure 4. Examples of acceptable copies.

5. Continue with alignment procedure and adjust as necessary.
6. Email a scanned copy of the before *and* after alignment measurements along with a photo of the steering wheel (only if not leveled) to **alignment@audi.com**. If you are not able to email these documents to this email address then attach them to the TACS ticket.
- a. Email must include the following information:
- VIN
 - Repair Order number or claim ID
 - Mileage (from Repair Order)
 - Dealer Code
- b. Photo of the steering wheel should be a JPEG file and must clearly show how much the steering wheel is off-center (Figure 3).
- c. The before and after alignment measurements must be a scanned copy of the original in either PDF or JPEG format. Do *not* fax or send a photocopy of the documents. Please see the following examples of acceptable and unacceptable copies (Figure 4 and Figure 5).
