Cabriolet-specific issues

Cabriolet-specific issues — A5 Cabriolet

1.) Luggage compartment lid does not open — convertible roof not in end position

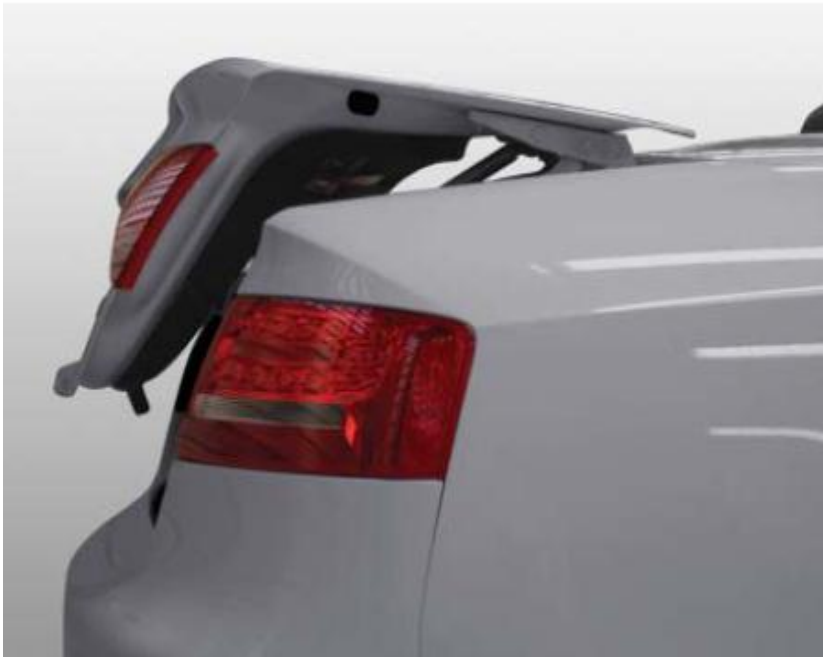
The luggage compartment lid cannot be opened using the grip (soft touch function).

After briefly actuating the convertible roof switch, the luggage compartment lid can now be opened using the grip.

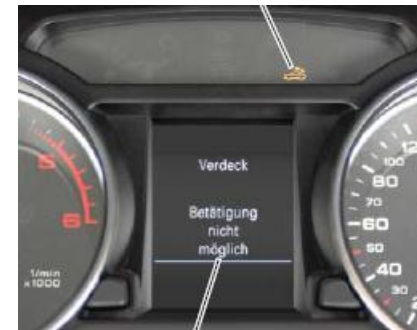
*) Note:

=> Lights up in the event that switch E 137 is actuated:

- While convertible roof is moving
- Convertible roof not in end position (...terminal 15 on with ...)

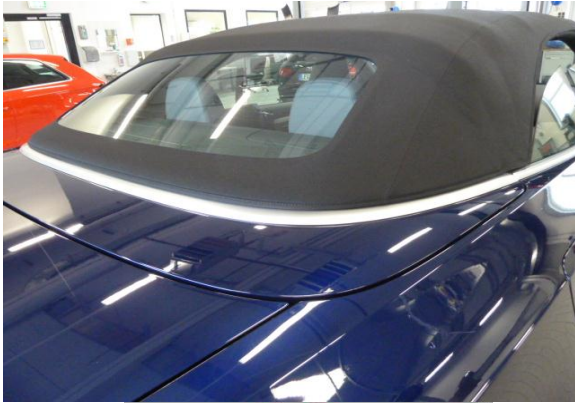
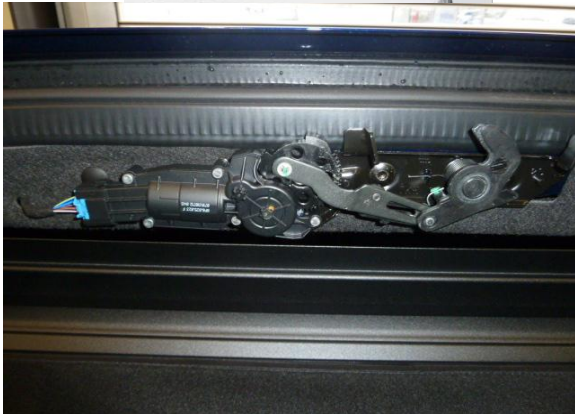
The gear wheel with cams in the motor for the convertible roof compartment lid lock V222 is not positioned centrally.

The cams within the gear wheel actuate microswitches F293 and F404 to varying extents. The tappet of the cam for microswitch F404 (switch for convertible roof compartment lid locking mechanism, locked) is sometimes not actuated far enough to trigger the switch point.

=> The convertible roof compartment lid is not recognized as being locked even though it is physically closed.

=> e.g. convertible roof not in end position!

=> Convertible top operation is not possible!!!

=> The luggage compartment lid cannot be opened!!!

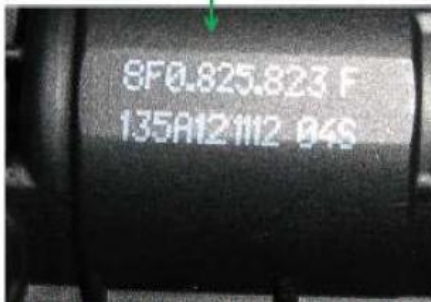
Ab Produktionsdatum 12.11.12 sind korrigierte Grundplatten verbaut worden

Prägung des Herstelldatums der Grundplatte -> KW45/ 2012

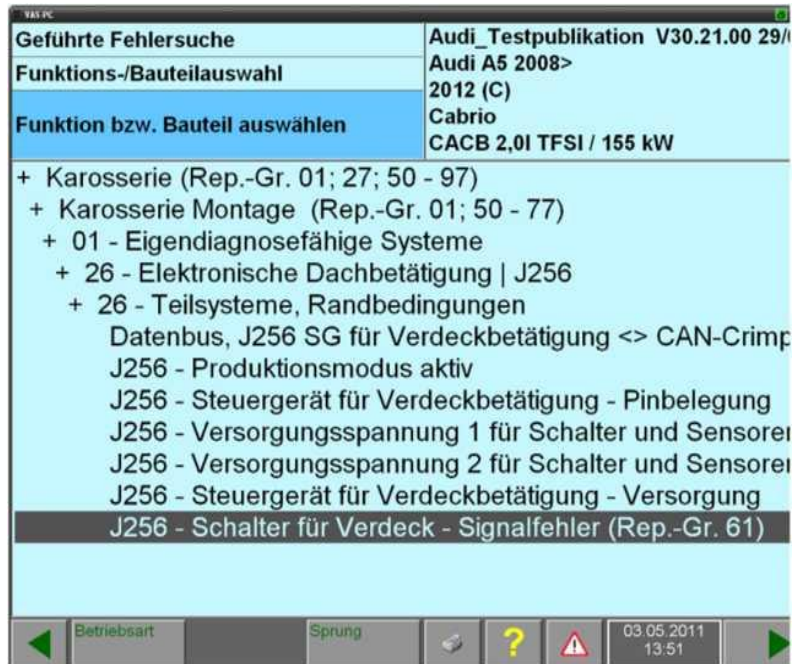
The switch positions of switch F404 and F293 can be checked in the relevant position by connecting the VAS tester to the vehicle.

Checking the switch position helps to ensure that the electrical switch contact is reliable after replacing locking mechanism 8F0 825 823F, and allows the contact to be read in convertible roof control unit J256.

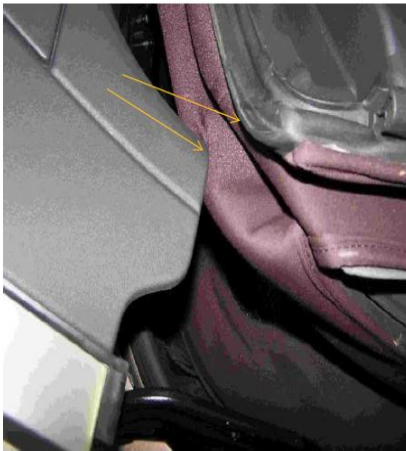
1.) Kollision: Verdeck – Verdeckkastendeckel (VDKD) beim Öffnungsvorgang

Beim Öffnungsvorgang streift die Verdeckspitze und/oder auch folgende Stofffalten am aufgestellten Verdeckkastendeckel (VDKD).

Dies kann bis zum Abbruch des Verdecklaufes bzw. zu starken Beschädigungen führen.

Beim Schließvorgang kann es ebenso zum Kontakt kommen, ist aber in der aktuellen Situation (Verdeckspitze und/oder folgende Stofffalten gleiten über den geneigten VDKD zurück) zuerst unkritisch bis es erneut zum Schließvorgang kommt.

- Collision between convertible roof and convertible roof compartment lid (seven-joint hinge)

Achten Sie präventiv auf Beschädigungen an der Verdeckspitze sowie am VDKD.
