# Technical Service Bulletin

## 66 Wind noise from exterior rear view mirror

66 14 44 2026997/4 December 19, 2014. Supersedes Technical Service Bulletin Group 66 number 13-35 dated October 3, 2013 for reasons listed below.

Model(s)	Year	VIN Range	Vehicle-Specific Equipment
Q5	2015	All	Not Applicable
Q7	2015	All	Not Applicable

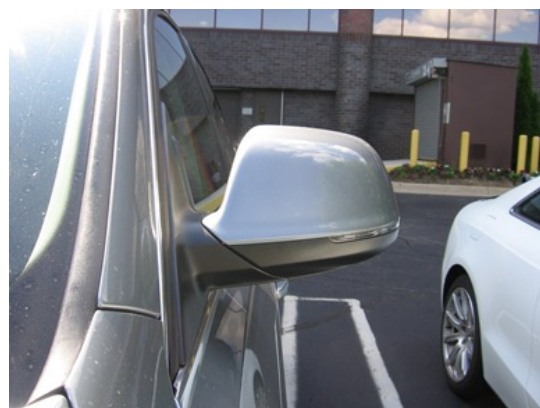
Figure 1. Exterior rear view mirror.

Customer may report hearing wind noise from the front door area. After diagnosis, it is determined that the source of the wind noise is the exterior rear view mirrors (Figure 1).

Throughout the development of the Audi Q5 and Audi Q7, various features have been added to the exterior rear view mirrors. The added features include the turn signal lamp, side assist lamp, perimeter lamp, etc. As the complexity of the exterior rear view mirror increases, the mirrors become more susceptible to wind noise.

1. Verify the customer's complaint by test driving the vehicle. Confirm by way of diagnosis (e.g. taping off of seams, changing mirror angle, etc.) that the source of the wind noise is one or both exterior rear view mirrors.

2. Do not disassemble the mirror assembly in any way (including the mirror glass), as the complete mirror assembly will be requested for shipment to the WPRC in Auburn Hills for analysis and testing.

3. If the vehicle is within the New Vehicle Limited Warranty, and the exterior rear view mirror(s) have been confirmed as the root cause, order all of the components that comprise the mirror assembly, including the mirror glass.

6. After the parts have arrived, assemble the new mirror assembly so that it is ready to install when the customer returns. This will significantly reduce the amount of time the customer's vehicle is down for this repair.

7. After the replacing the complete mirror assembly, securely package the original mirror. It will be requested for submission under the model year 2014 100% parts submission process.
