BTB 51970-52552 REV1 (1409)

Recall: Driver's Airbag Inflator May Produce Excessive Pressure After Long-Term Exposure to High Absolute Humidity

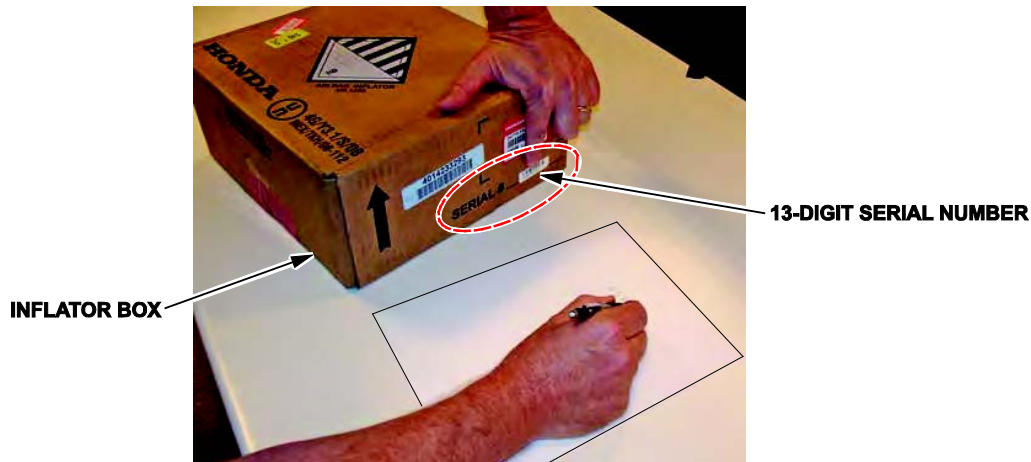
- Be careful not to damage any parts when replacing the inflator, and **follow the procedure exactly**.
 - If, before removing the airbag, you suspect that it may be the incorrect airbag for the vehicle or a counterfeit, **do not remove the airbag**. Contact your DPSM for assistance.
1. Remove the driver's airbag.
 2. Write down the 13-digit serial number located on the right side of the new inflator's box. For the warranty claim to be paid, your warranty clerk must enter this 13-digit serial number in the Diagnostic Trouble Codes field on the warranty claim.

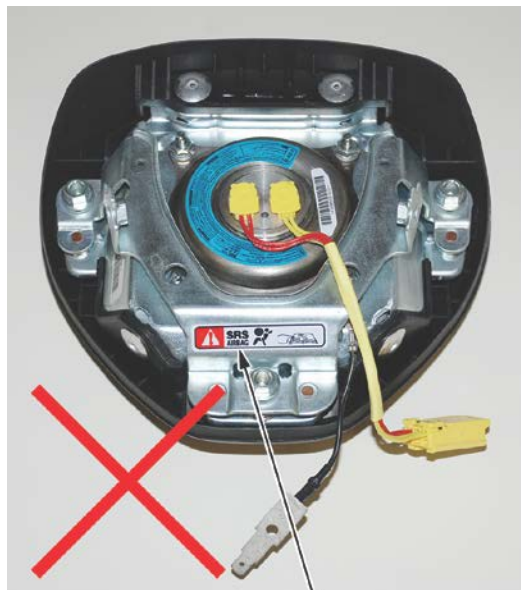
NON-STANDARD
SAFETY LABEL

3. Place the airbag, face down, on a clean shop towel.
4. Visually inspect the airbag and the inflator for any unusual writing or markings.
 - If there is nothing unusual about the airbag or the inflator, go to step 5.
 - If there are any unusual markings, like an incorrect label or a model year written in marker, the airbag and inflator may not be the correct airbag and/or inflator for the vehicle or it may be a counterfeit part. For more information about counterfeit airbags, you can refer to safercar.gov, enter keywords **MANAGING COUNTERFEIT**, and select **Recommended Dealer Guidance for Managing Counterfeit Air Bags** from the list. **If you suspect that the airbag or inflator is counterfeit, do not continue this procedure.** Contact your DPSM for assistance.

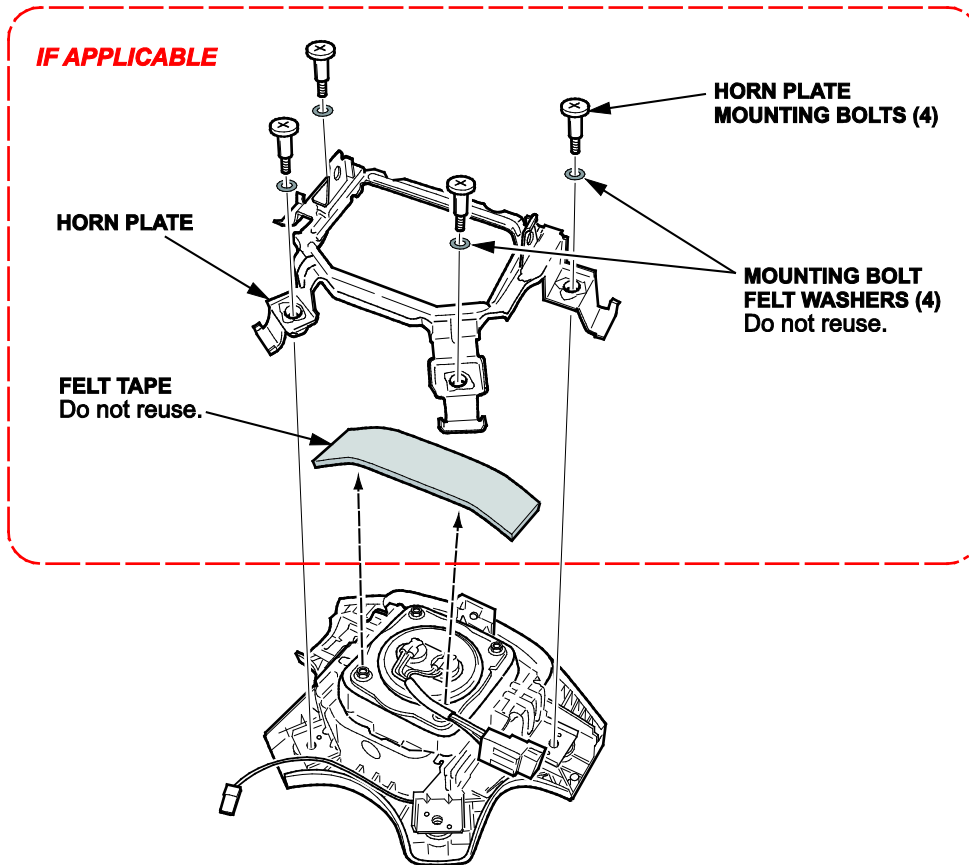
5. If there is no horn plate installed, go to step 7. If there is a horn plate installed, remove the four horn plate mounting bolts, the mounting bolt felt washers, the horn plate, and remove the felt tape covering the lower two inflator locknuts. The felt washers and felt tape will not be reused.

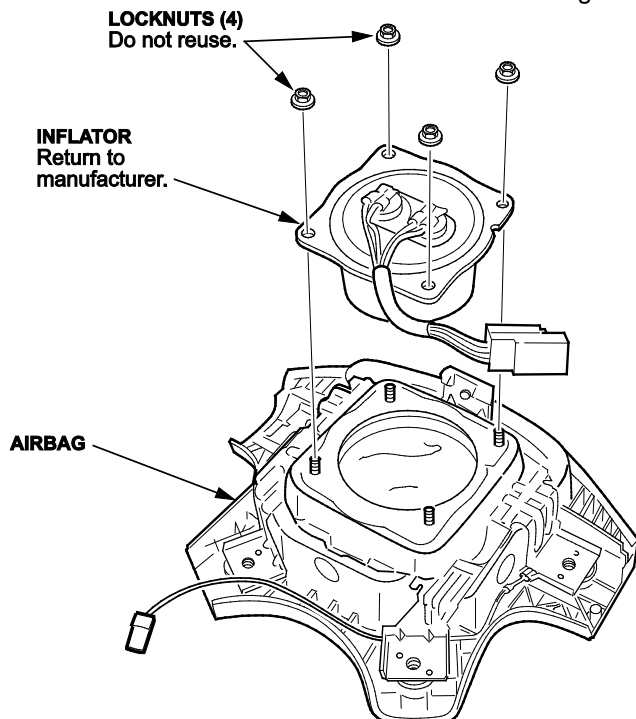
6. Using needle-nose vise grips, remove the four locknuts from the inflator. The locknuts will not be reused.

NOTE: Do not remove the inflator from the airbag until you complete step 7.
