BTB 51969-52551 REV1 (1409)

Recall: Front Passenger's Airbag Inflator May Produce Excessive Pressure After Long-Term Exposure To High Absolute Humidity

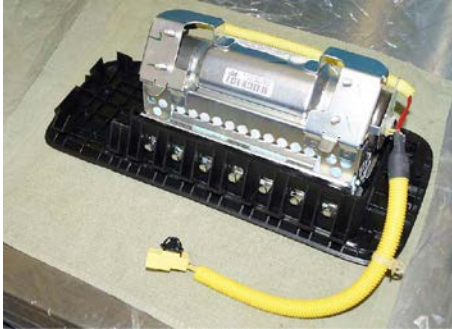
3. Place the airbag face-down on a clean shop towel as shown.

- The orientation of the airbag is critical because if the inflator is installed incorrectly, the harness will be too short when you reinstall the airbag.
- The brackets between the various models are similar but may differ from the example shown.

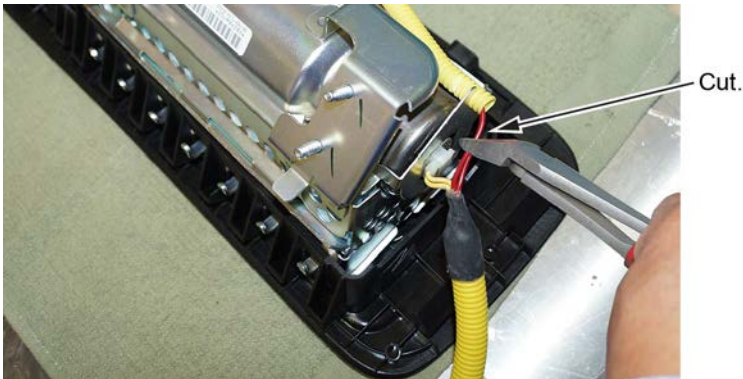
6. Short the red wires.

NOTE: You must cut and short the wires as indicated to prevent accidental deployment.

- Cut the red wires as shown.

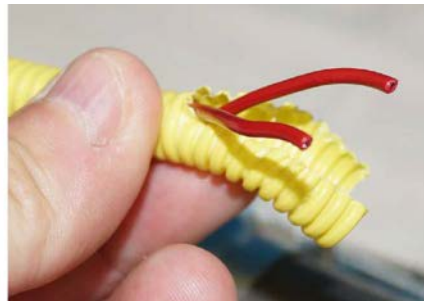
- Cut about 2 inches of the corrugated tube, then pull out the two red wires.

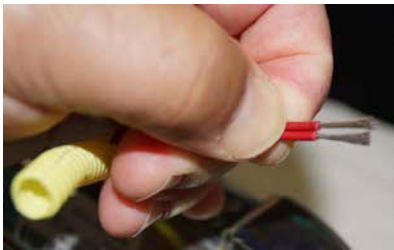
- Strip away about 1 inch of the wire insulation, then twist the wires together.

- Tape the twisted ends with electrical tape.

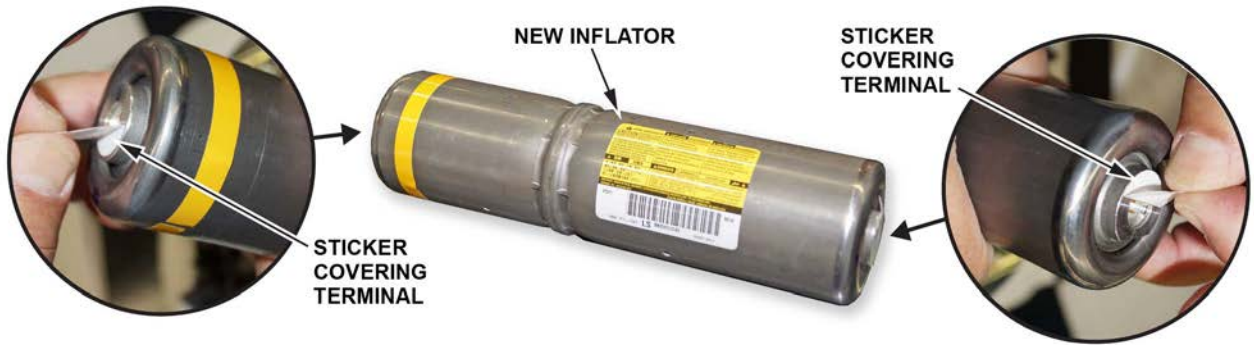
12. Remove the stickers covering the terminals on both sides of the new inflator.

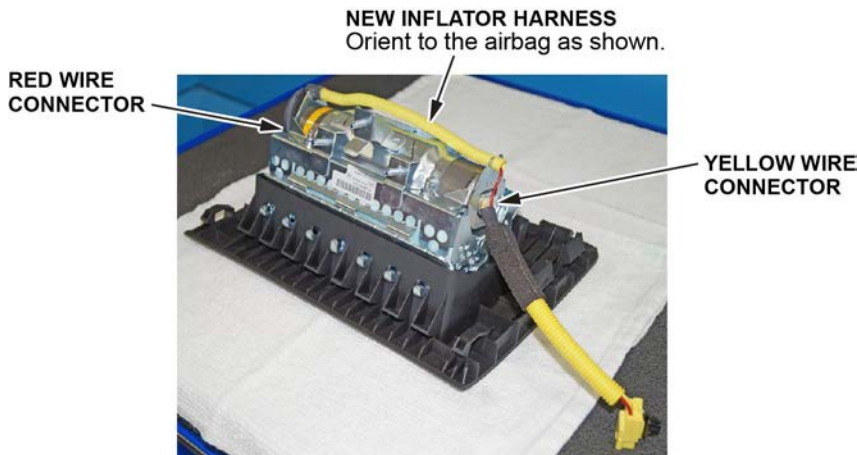
13. Install the new inflator harness.

- Make sure the airbag and harness are aligned as shown.
NOTE: Make sure you have the orientation correct as shown below. If you connect the harness incorrectly, the harness cannot be removed, and you will not be able to reinstall the airbag because the harness will be too short.
