**HYUNDAI**  
**Technical Service Bulletin**

GROUP <b>CAMPAIGN</b>	NUMBER <b>17-01-067</b>
DATE <b>NOVEMBER, 2017</b>	MODEL(S) <b>ELANTRA TOURING (FD)</b>

**SUBJECT:** INSTRUMENT CLUSTER LCD SCREEN INSPECTION AND REPLACEMENT (SERVICE CAMPAIGN T2N)

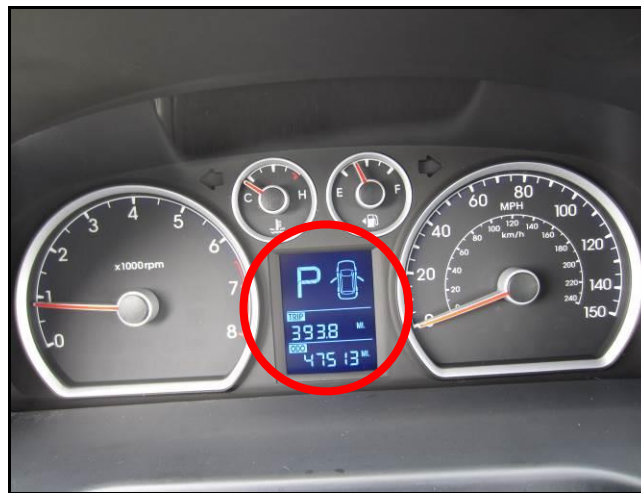
**Description:** On certain 2012 Elantra Touring (FD), the LCD screen display in the cluster may exhibit no illumination. If there is no illumination, the odometer, gear selection, and door ajar information will not be visible by the driver.

This bulletin describes the service procedure to replace the LCD screen to correct the display condition.

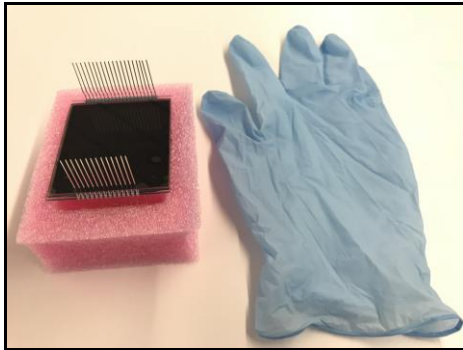
<p>96420-2L300QQH (Automatic Transmission) (20 pins top row, 14 pins bottom row)</p>	1

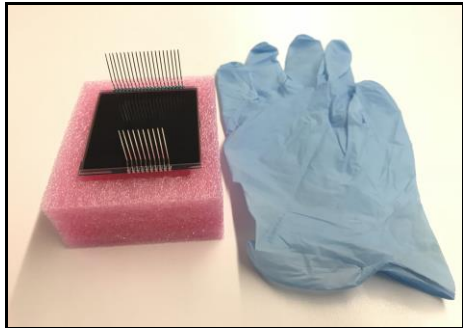
<p>96420-2L200QQH (Manual Transmission) (20 pins top row, 10 pins bottom row)</p>	1

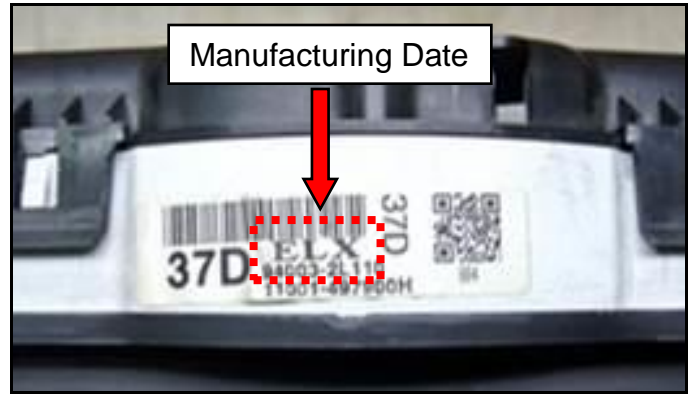
<p><i>Example:</i> <b>ELX</b></p>	<p>E: First digit represents the year. L: Second digit represents the month. X: Third digit represents the day.</p>	<p>E = 2009 L = December X = 24<sup>th</sup></p> <p>The instrument cluster was manufactured on December 24<sup>th</sup>, 2009.</p>
---------------------------------------	---	--

1. If the manufacturing date is on or within February, 2012 to November, 2015, then replace the instrument cluster LCD screen.

If the manufacturing date is not within the date range mentioned above, then do not replace the instrument cluster LCD screen. Reinstall the instrument cluster and campaign is complete. Use labor op 70C070R0.

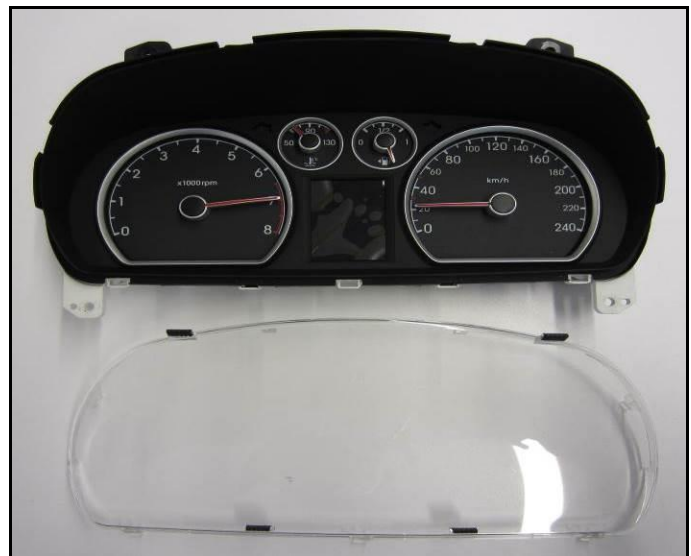
Image on the right illustrates the clear plastic cover removed.
