Blue Smoke from the Exhaust

Binder - Advanced Technical Information
This bulletin replaces bulletin Group 2,
#1705, dated 9-29-17.

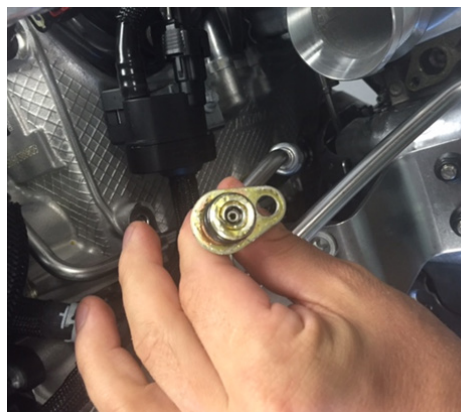
- Vehicle Type: **911 (991), excludes 911 Turbo (991)**
- Model Year: **2017 built before 08.17.2016**
- Part Number: 9A210722301 and/or 9A210722401 for supply. 9A210733301 and/or 9A210733402 for return.
- Issue: Blue smoke from the exhaust on engine start.
- Information: Debris from the production process can cause the check valves in the oil supply and return lines for the turbocharger to stick open. This allows either too much oil to enter or not enough oil to exit the turbocharger and will overwhelm the seal.
- Action required: **DO NOT** replace the turbocharger(s). Remove the pressure pipes from the turbochargers to determine which side is stuck open. Replace that line.

- References: Workshop Manual "217119 Removing and installing oil feed line for turbocharger"
