Technical Service Bulletin

87 Unpleasant odor from heating and ventilation system

87 14 47 2010146/10 February 27, 2014. Supersedes Technical Service Bulletin Group 87 number 12-27 dated April 24, 2012 for reasons listed below.

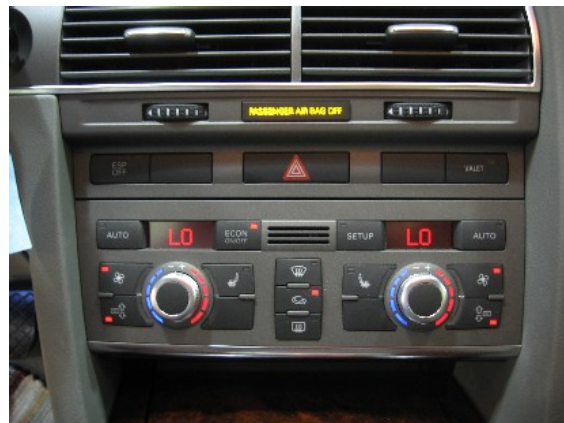
Figure 1. Climate control settings.

1. If the vehicle is equipped with an in-cabin pollen filter (such as in the A3, A6, and Q7), remove the pollen filter element and reinstall its cover before proceeding.
2. Start the engine.
3. Adjust the following climate control settings (Figure 1):
 - Set the temperature to its lowest setting.
 - Set the fan speed to its lowest setting.
 - Set the airflow direction to the dash vents only.
 - Activate recirculation and ECON modes.

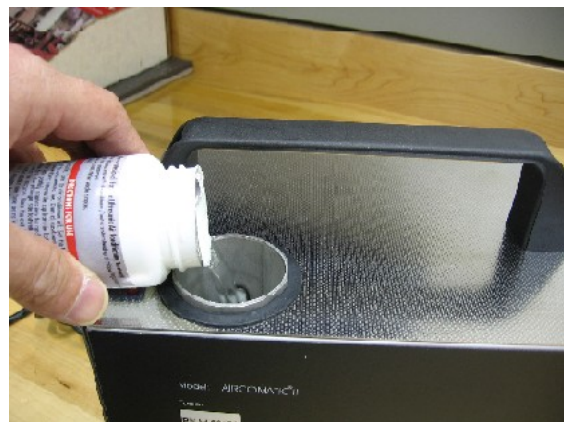
Figure 2. Pouring the treatment into the filling chamber.

4. Thoroughly shake a 100ml bottle of treatment and empty it into the filling chamber (Figure 2).

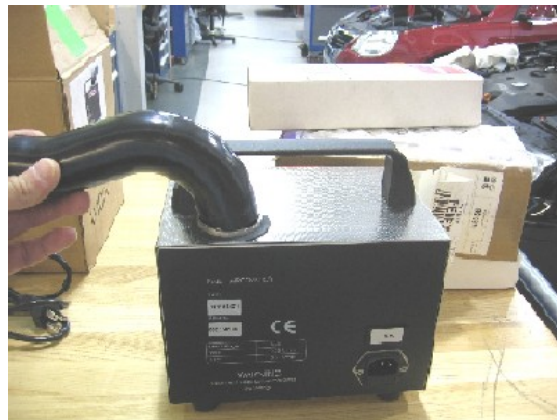
Figure 3. The connected outlet tube.

5. Connect the outlet tube (Figure 3).

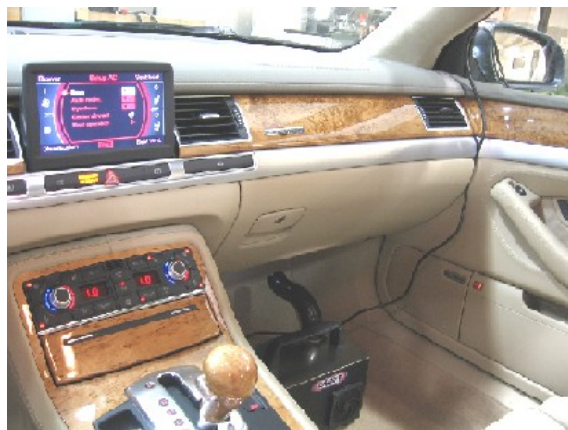
Figure 4. Window is slightly open so that the cord can pass through.

6. Place the cleaning unit into the passenger side footwell, ensuring that the unit is as level as possible.
7. Connect the unit power cord, and route it through one of the windows, which should be slightly open (Figure 4). All other windows and the sunroof should be completely closed.

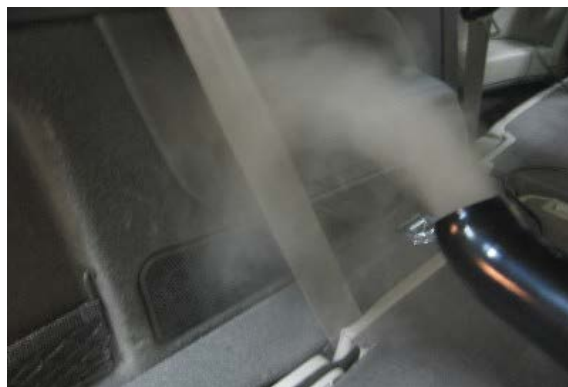
Figure 5. Correct positioning of the outlet tube.

8. Turn the unit on and position the outlet tube so that the vapor is drawn into the recirculation air intake (generally in the passenger side footwell area; see appropriate repair information for exact location).
9. Close all doors. The atomized cleaning fluid will begin to come out of the vents. After 15-20 minutes, the treatment is complete and the machine stops automatically.
10. If the vehicle is a Q7 with four zone climate control, repeat the procedure for the rear A/C unit before proceeding. Use the same A/C settings listed above. Position the outlet tube toward the vent on the left of the rear compartment (Figure 5).
