# Emissions Recall

## Code: 23Q3

<b>Subject</b>	2.0L TDI Engine (GEN 3) Emissions Control Software – <u>USA ONLY</u>											
<b>Release Date</b>	May 19, 2017											
<b>Revision Summary</b>	<b>Updated SVM Flash procedure.</b>											
<b>Repair Applicability</b>	The ONLY Vehicles eligible for repair under this action are: <ul style="list-style-type: none"> <li>• Customer owned vehicles</li> <li>• NEW vehicle inventory</li> </ul>											
<b>Affected Vehicles</b>	<p><b>U.S.A.: 2015 MY Volkswagen 2.0L TDI (Gen 3)</b></p>

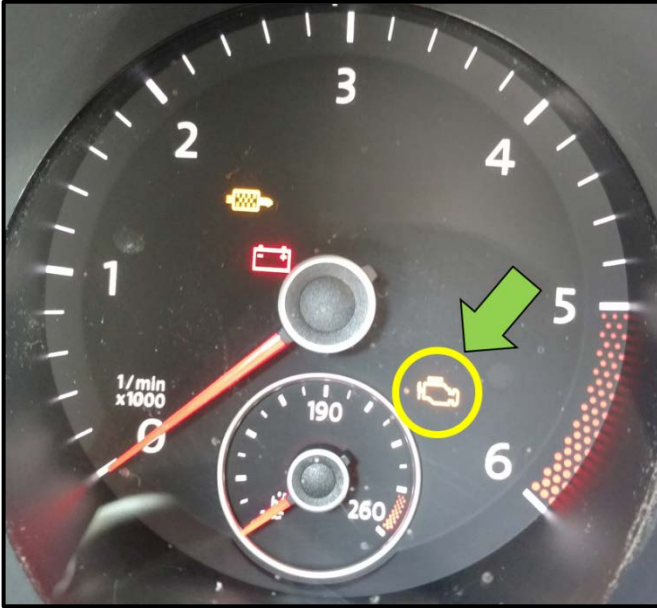
- Check for illumination of the MIL <arrow>.
  - If MIL is illuminated, STOP, obtain GFF diagnostic log, create a VTA ticket and contact the Volkswagen Technicians Helpline.
  - If MIL is not illuminated, continue work procedure.

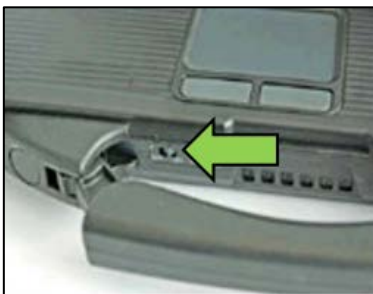
**VAS 6150 & VAS 6150A**  
(Front panel behind handle)

- Performing a software update using a Bluetooth connection increases the risk of losing connection during the update, which could result in damage to the control module. It also greatly increases the time required to perform the update. Requests for additional time or parts will be denied if the GFF log shows the update was performed using Bluetooth.
- ✓ **The Bluetooth function of the scan tool is physically switched off <see pictures below>.**

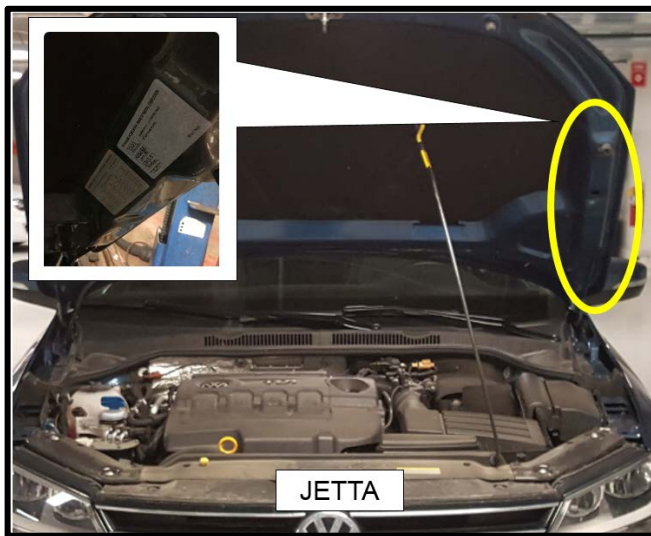
- Open the hood.
- Clean the surface where the label is to be installed <circle>.
- Install the Supplemental Vehicle Emissions Control Information Label, **03L 010 005 J**, in the location shown <circle>.

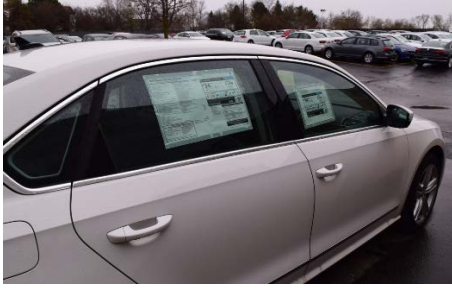
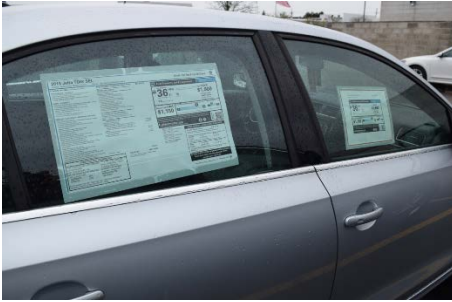
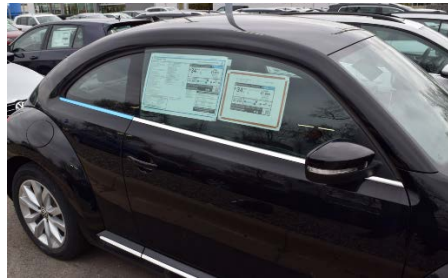
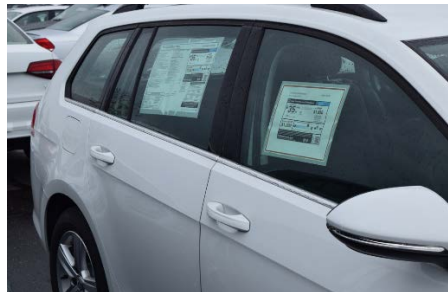
- Examples of properly Installed Monroney and Fuel Economy Labels <pictured left> on various vehicle models.

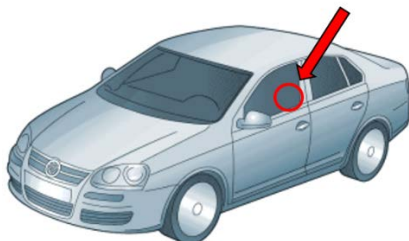
- Place the “more information” permanent window sticker <pictured left> on the front driver-side window in the lower right corner of the window <arrow>. Install the sticker from the inside of the window.
  - Affix the “more information” sticker to the front driver-side window as necessary either above, beside, or under any other required State and/or Local Labels (example, California Prop 65).
