<b>HYUNDAI</b> <b>Technical Service Bulletin</b>	GROUP <b>CAMPAIGN</b>	NUMBER <b>17-01-072</b>
	DATE <b>DECEMBER, 2017</b>	MODEL(S) <b>GENESIS (BH) EQUUS (VI)</b>
<b>SUBJECT:</b> 2009-2014 GENESIS (BH) AND 2011-2016 EQUUS (VI) ANCHOR PRETENSIONER LABEL INSTALLATION (SERVICE CAMPAIGN T2R)

This bulletin describes the procedure to install warning labels on the driver's and/or passenger's seat belt assemblies to prevent potential improper reattachment of the anchor pretensioners.

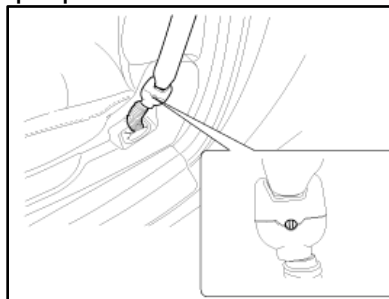
**Description:** The front seat belt assembly incorporates a seat belt anchor pretensioner fastened to the vehicle's front seat frame. During vehicle assembly, the anchor pretensioner is fastened to the front seat frame prior to being connected to the seat belt linkage. If, during vehicle repair, the connector does not fully latch when the linkage was pressed onto the connector, the seat belt can detach from the anchor pretensioner. If the seat belt linkage detaches from the anchor pretensioner in a collision, the risk of injury to the occupant is increased.

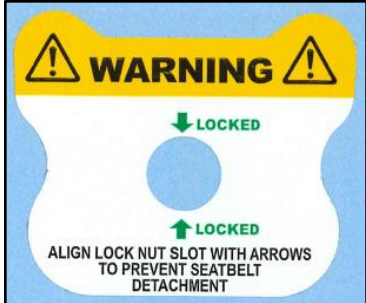
Part Name	Part Image	Part Number		Remarks
		Previous	New	
Warning Label, Anchor Pre-Tensioner

N/A	20114-1882R	1 label needed per Genesis (BH) vehicle

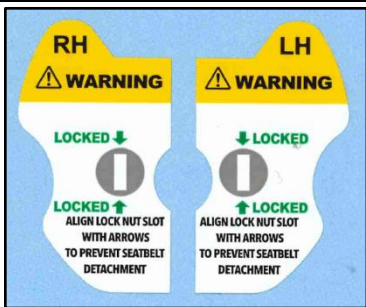
Part Name	Part Image	Part Number		Remarks
		Previous	New	
Warning Label, Anchor Pre-Tensioner RH&LH

N/A	20114-1883R	1 set of LH & RH labels needed per Equus (VI) vehicle

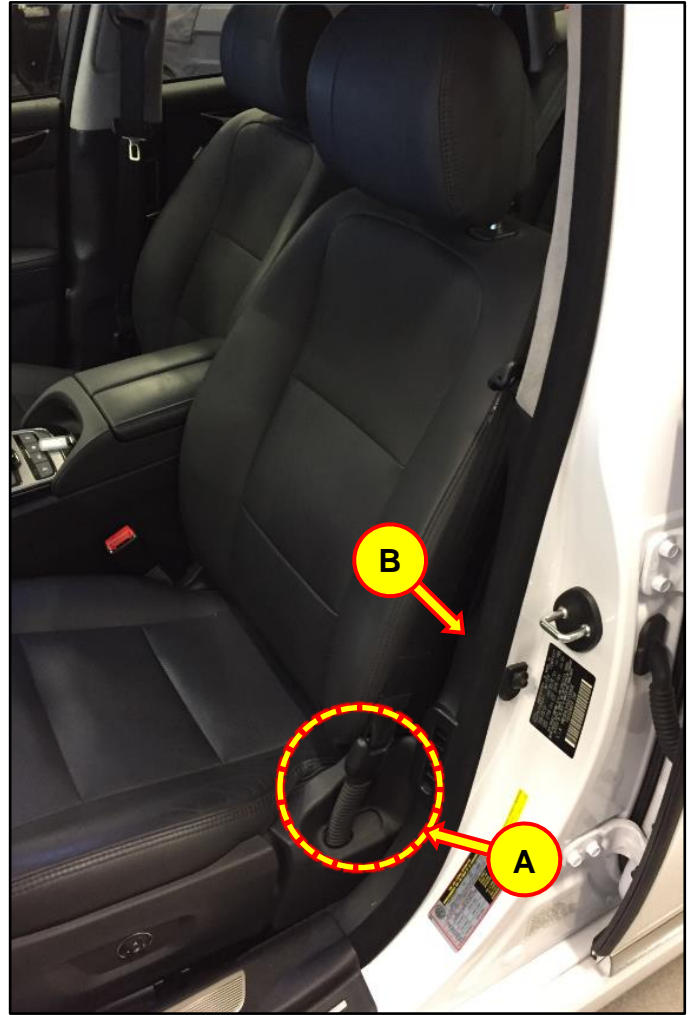
1. Locate the driver anchor pretensioner (A) near the lower B pillar trim (B) and move the front seat appropriately to easily access the anchor pretensioner.

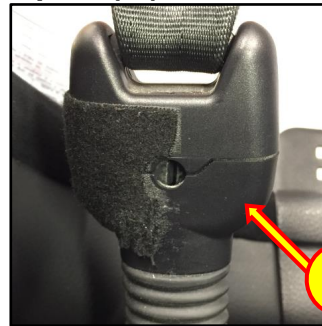
**Equus (VI):**

2. Visually inspect the inboard surface of the linkage element (C) and make sure the surface is free from any debris.  
**Note: if necessary, wipe the surface with a clean, dry cloth.**

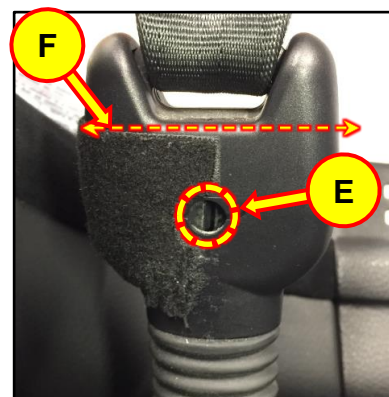
**Genesis (BH):**

3. Peel off the label (D) and align it with the center hole (E) and top horizontal line (F) of the linkage element.

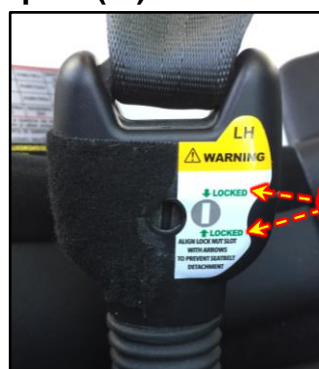
**Equus (VI):**

4. Firmly press down on the label to ensure it adheres to the surface of the linkage element.  
**Note: Green "LOCKED" arrows (G) should align with the latch slot.**

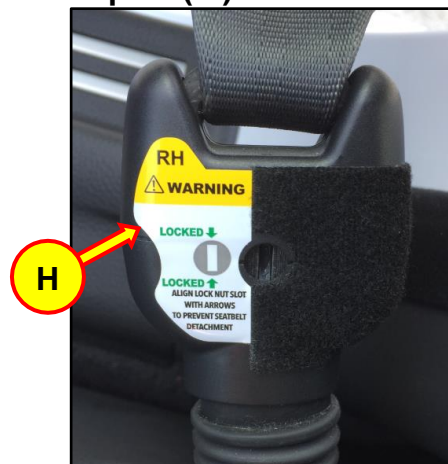
**Equus (VI):**

5. For **Equus (VI)**, locate the passenger's anchor pretensioner and move the passenger seat appropriately, and repeat Steps 2 through 4 to install the RH label (H).
