SERVICE BULLETIN

EL17-029

November 30, 2017

2009 – 2014 MAXIMA DOOR MIRROR TURN SIGNAL REPLACEMENT

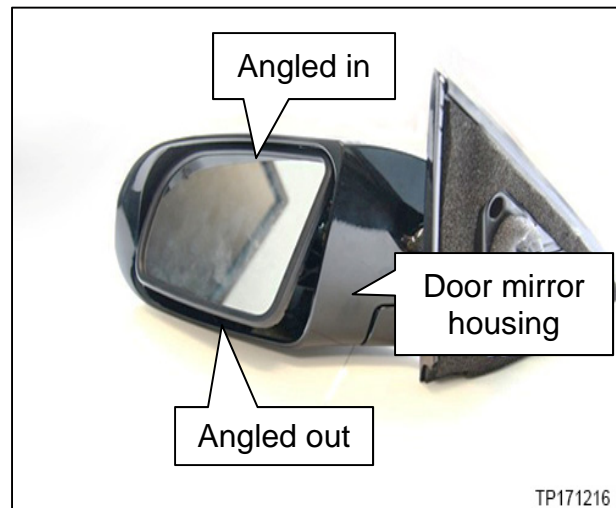
Figure 1

1. Angle the affected door mirror glass (mirror) as shown, with the lower half of the mirror pulled out and the top half of the mirror pushed in.

NOTE: Door mirror assembly has been removed for clarification purposes only. Door mirror assembly does not need to be removed to replace the turn signal.

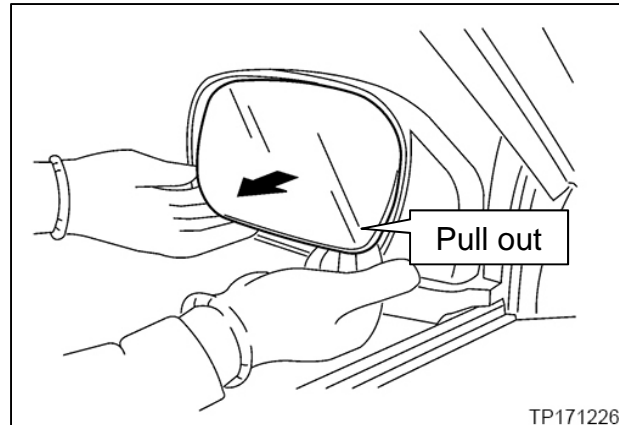
Figure 2

2. Pull from the bottom of the mirror to release the mirror lower clips.

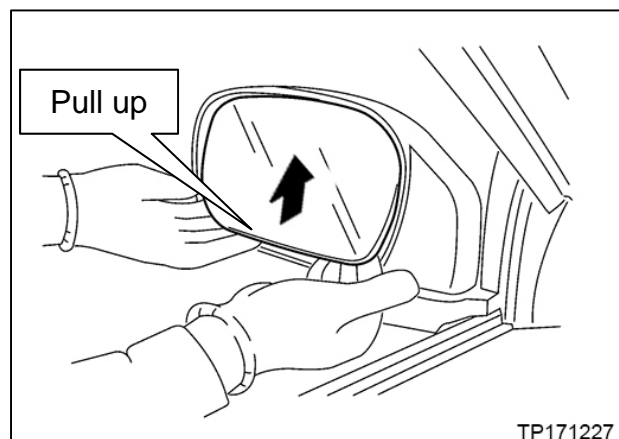
Figure 3

3. Once the mirror lower clips are released, lift the mirror to release the mirror upper hooks.

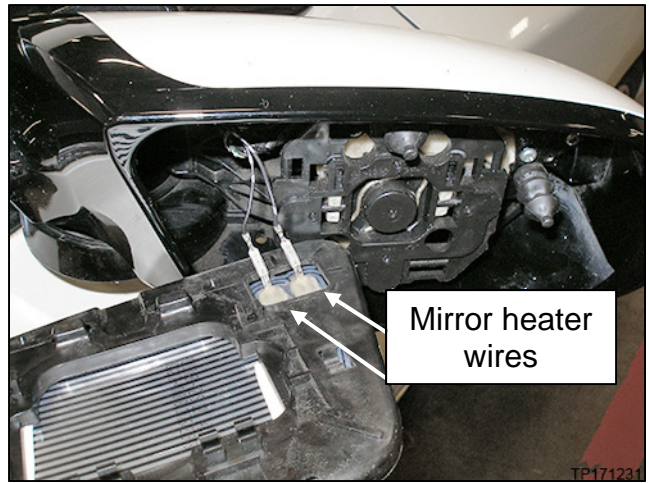
Figure 4

4. Disconnect the 2 mirror heater wires.

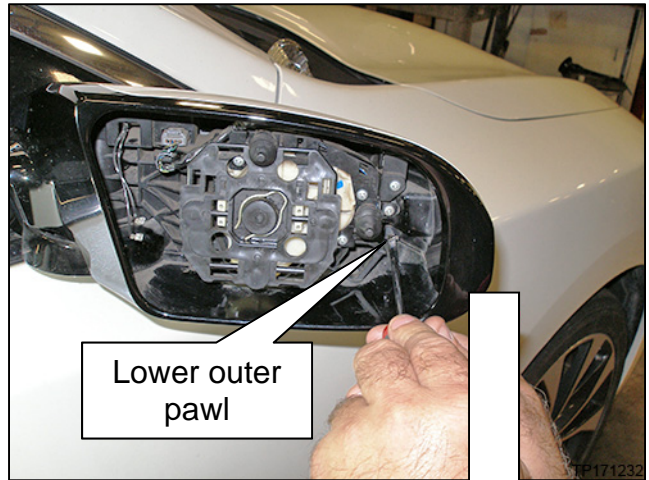
Figure 5

5. Look inside the mirror housing to locate the lower outer pawl.

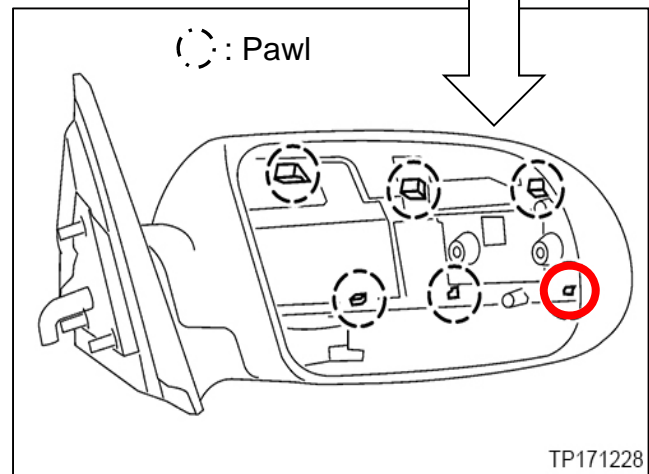
Figure 6

6. Using a small flat blade screwdriver or equivalent, release the lower outer pawl (circled in red) from the inside of the mirror housing.

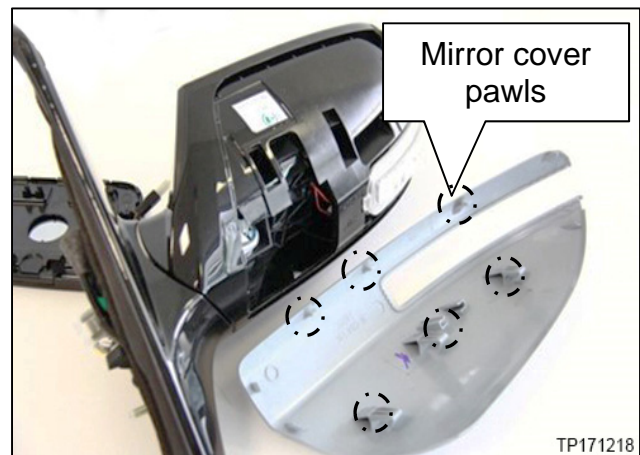
Figure 9

9. Inspect the 6 mirror cover pawls to ensure they have not been damaged.

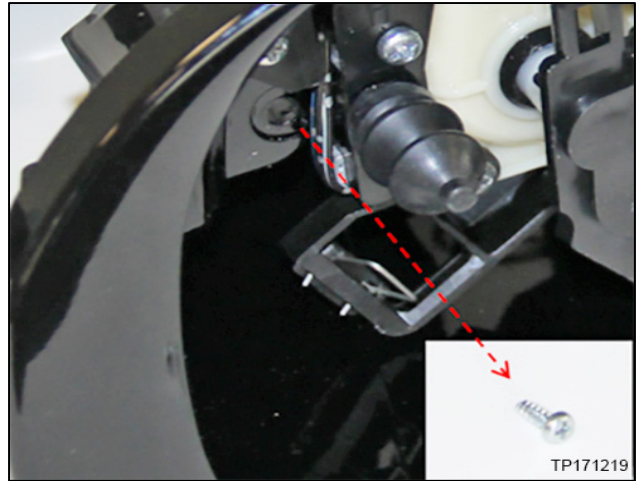
Figure 10

10. Remove the turn signal screw and set aside for use when installing new turn signal lamp.

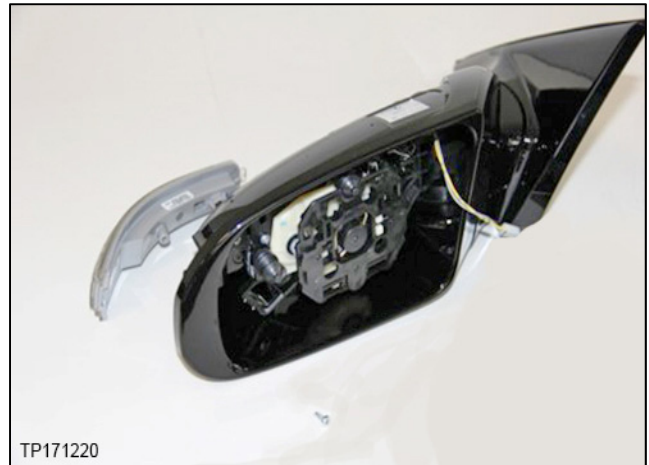
Figure 11

11. Remove the turn signal and disconnect the turn signal electrical connector.

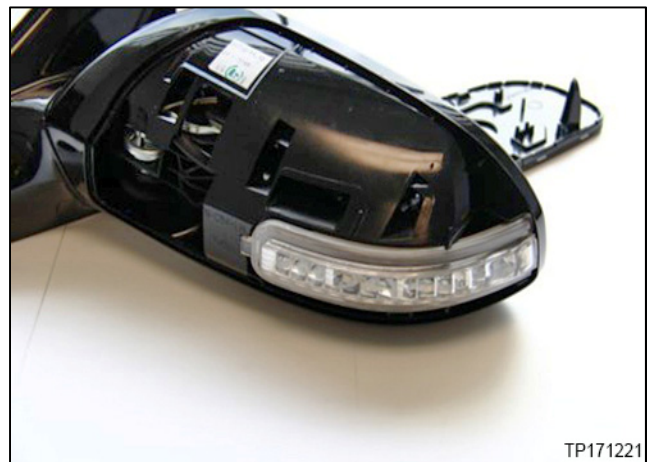
Figure 12

12. Install new turn signal.

13. Connect turn signal electrical connector.

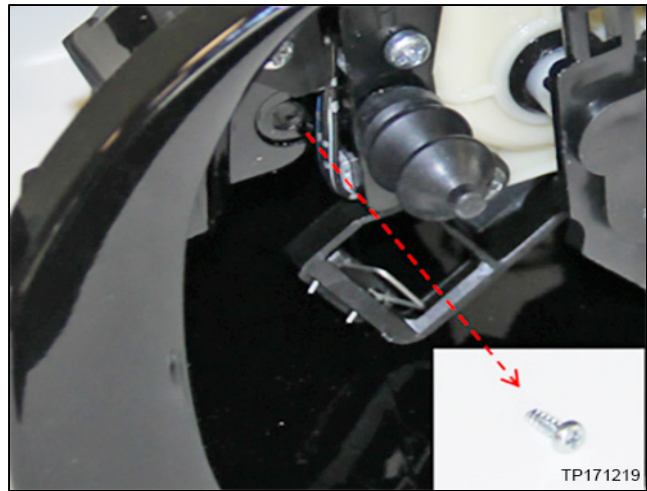
Figure 13

14. Reinstall the turn signal screw.

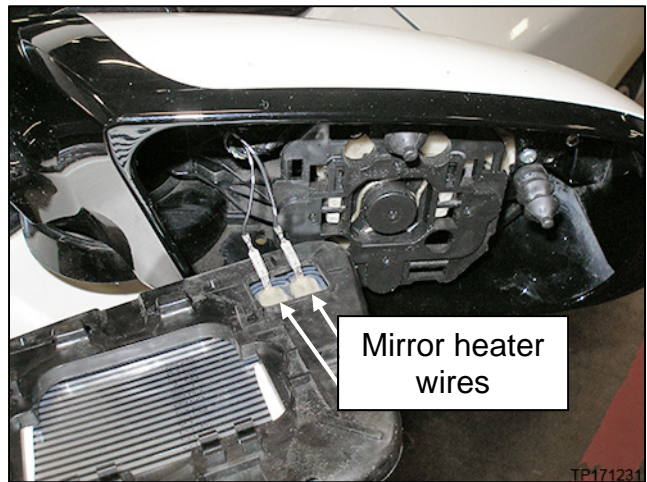
Figure 14

15. Reconnect the mirror heater wires.

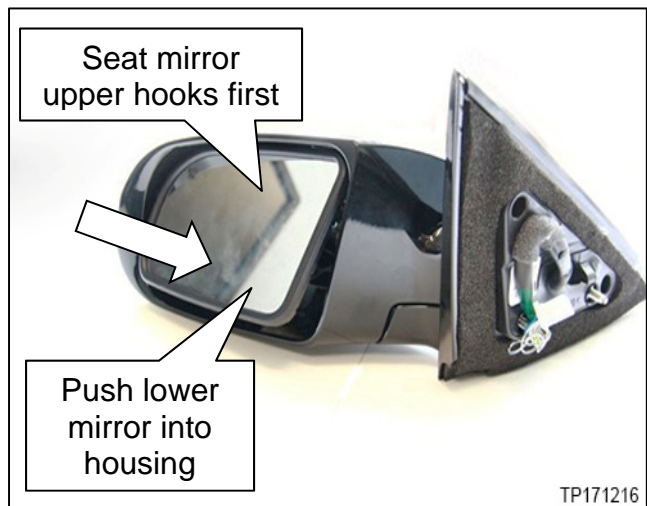
Figure 15

16. Seat the mirror upper hooks.

17. Gently push the lower mirror into the door mirror housing to secure the lower mirror clips.

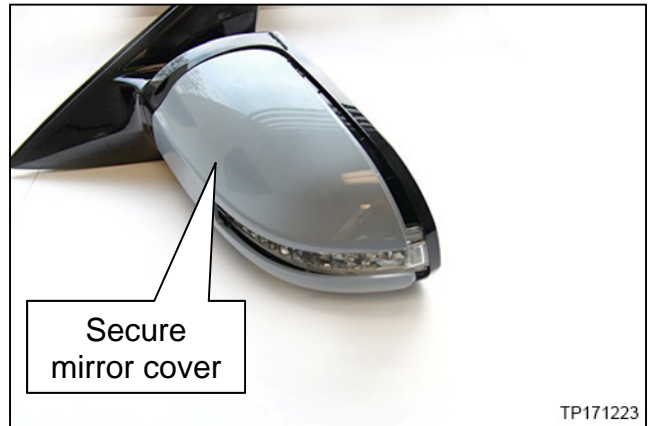
Figure 16

18. Gently seat mirror cover pawls into mirror housing.
