Models: Model Year 2016-2017 XDiavel (all model and

Recall Bulletin SRV-TSB-18-001

Date: Friday, Jan 19th, 2018

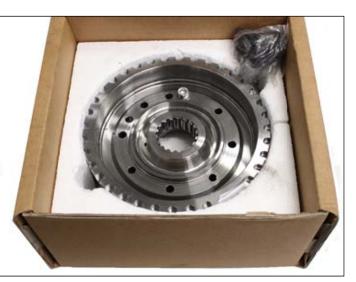
Flywheel and starter clutch kit part no. 69928312A

The flywheel and starter clutch assembly is pre-assembled with a service screw which must be removed; the kit also includes 8 M6x25 screws for the final assembly.

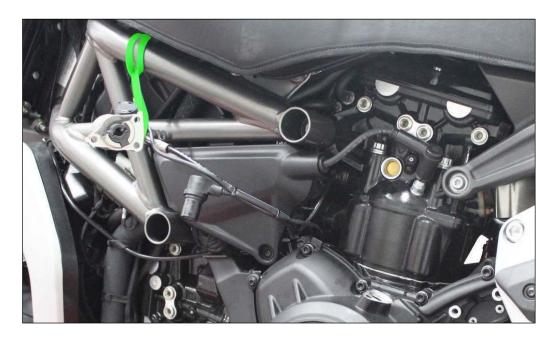
7) Move the gear sensor, the clutch slave cylinder and the engine rpm sensor away from the working area, tying them with an elastic band as shown in the figure.

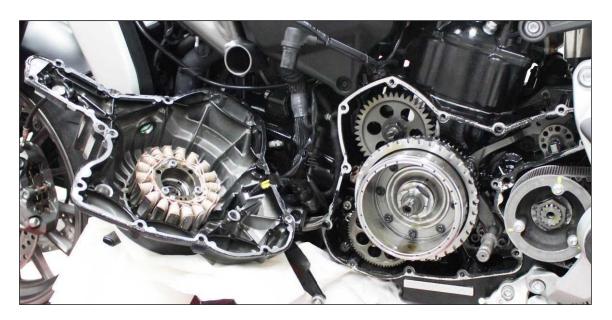
Using the LH rider footpeg and the gearchange lever as a bearing plane, position the generator cover and protect it with a cloth.

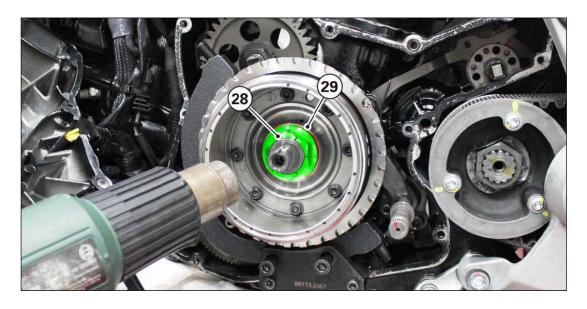
18) Remove nut (28) and washer (29).

To facilitate the removal heat the nut with an industrial heating gun.

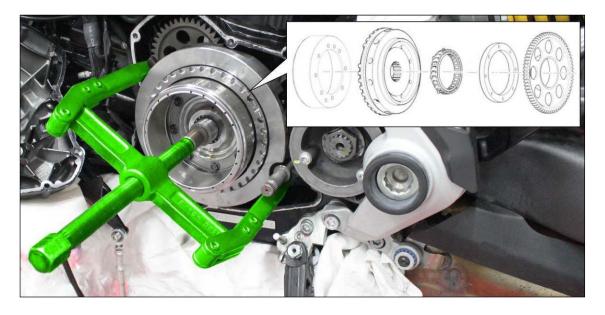
21) Using a sliding arm puller remove the driven gear, flange, starter clutch, flywheel and rotor assembly.

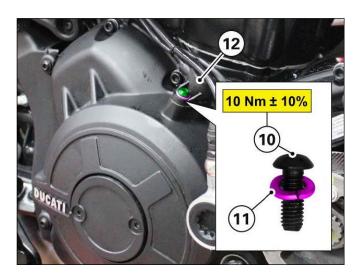
14) Fix **engine rpm sensor (12)** on generator cover by tightening **screw M6x16 (10)** with relevant **spring washer (11)** to a torque of 10 Nm ± 10%.

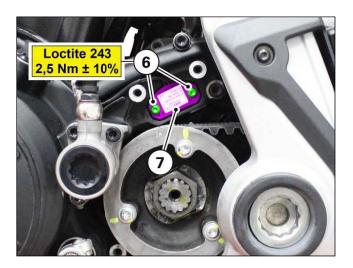
15) Position **gear sensor (7)** on the generator cover making sure that the label is visible, as shown in the figure.

Apply Loctite 243 on the threads of the 2 screw M4x16 (6) and tighten to a torque of 2.5 Nm ± 10%.
