Service Bulletin

SAFETY RECALL

2001-2012 GL1800 DRAGGING REAR BRAKE (INTERIM BULLETIN)

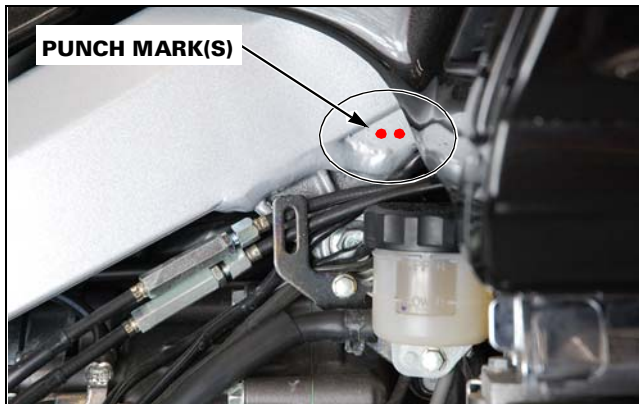
Look for a punch mark(s) on the right frame spar, just above the rear master cylinder reservoir as shown.

- **If there are two punch marks** and there is no customer concern about dragging brakes, no further action is necessary.
- **If there are two punch marks** and the customer has a concern about dragging brakes, contact TechLine.
- **If there is only one punch mark** and the customer has a concern about dragging brakes, proceed to INSPECTION PROCEDURE.
- **If there is no punch mark**, the vehicle has not been inspected/repaired according

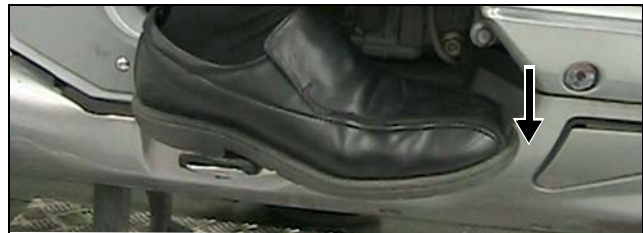
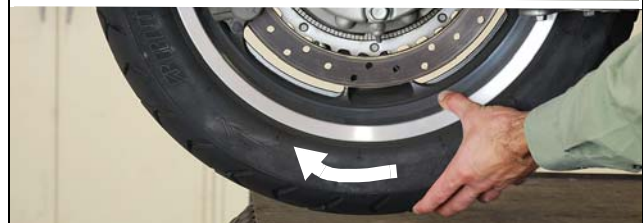
With the motorcycle in neutral on its center-stand, depress with normal foot pressure and slowly release the brake pedal five times, then with the pedal released, wait five seconds, then try to rotate the rear wheel as shown.

- **If the rear wheel drags or is locked**, contact TechLine for interim repair procedures.
- **If there are obvious visual indications of a dragging rear brake** (blue rotor, excessive brake component wear considering mileage), take photos of any

damaged parts, note your findings on the repair order, and contact TechLine for interim repair procedures.

- **If the rear wheel rotates freely**, confirm the brake performance by test riding the vehicle for 15 miles at varying speeds. Be sure to firmly apply both front and rear brakes several times during the test ride to get heat into the brake components and move fluid through the system. After the test ride, perform the INSPECTION PROCEDURE one more time from the beginning.
 - If after the test ride and second inspection procedure the rear wheel drags or is locked, contact TechLine for interim repair procedures.
 - If after the test ride and second inspection procedure the rear wheel rotates freely, apply the IDENTIFICATION punch mark to the frame and then return the vehicle to the customer. Advise the customer to continue performing pre-ride and post-ride inspections for dragging brakes until Honda contacts them about a final remedy.
