# Emissions Recall

## Code: 23Q3

<b>Subject</b>	2.0L TDI Engine (GEN 3) Emissions Control Software – Customer Only (Retail Sold) TDI Vehicles <u>USA ONLY</u>											
<b>Release Date</b>	January 13, 2017											
<b>Revision Summary</b>	Labor operation for criteria 02 updated.											
<b>Affected Vehicles</b>	U.S.A.: 2015 MY Volkswagen 2.0L TDI (Gen 3), Customer (Retail Sold) Only

## Campaign Work Procedure for Customer (Retail Sold) TDI Vehicles Only 23Q3 Emissions Recall

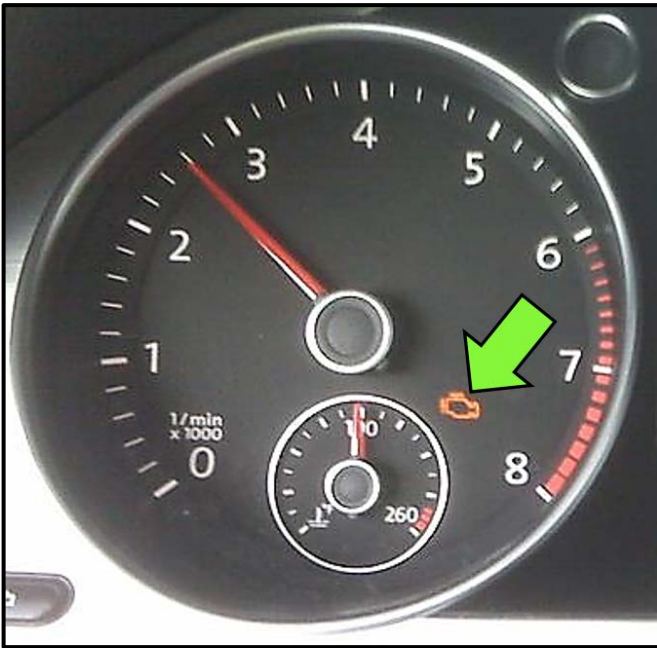
- Check for illumination of the MIL <arrow>.
  - If MIL is illuminated, STOP, obtain GFF diagnostic log, create a VTA ticket and contact the Volkswagen Technicians Helpline.
  - If MIL is not illuminated, continue work procedure.

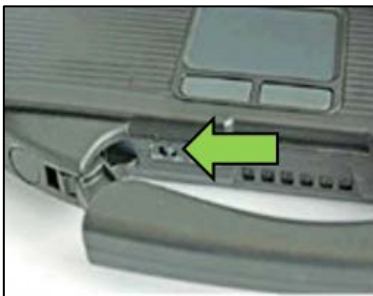
**VAS 6150 & VAS 6150A**  
(Front panel behind handle)

- ✓ **The Bluetooth function of the scan tool is physically switched off <see pictures below>.**

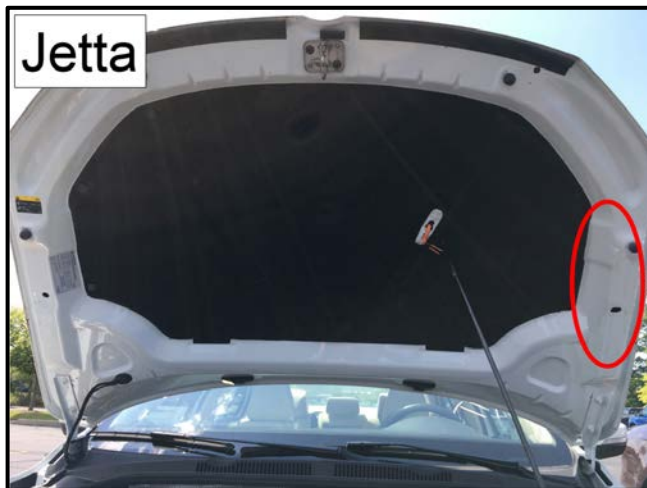
- Open the hood.
- Clean the surface where the label is to be installed <circle>.
- Install the Supplemental Vehicle Emissions Control Information Label, **03L 010 005 J**, in the location shown <circle>.

- The surface where the label is to be installed must be clean, dry, and free from oil residue prior to installing the label.
- Label must NOT cover any existing label(s).
- Label must be installed in locations shown.
- Photo documentation of label installed is required.
