Technical Bulletin

57 17 01 February 8, 2017 2042955 Supersedes Technical Bulletin V571601 dated January 22, 2016 to include model year 2016 and 2017 applicability.

Front Door(s) May Be Difficult to Close at Temperatures Below Freezing

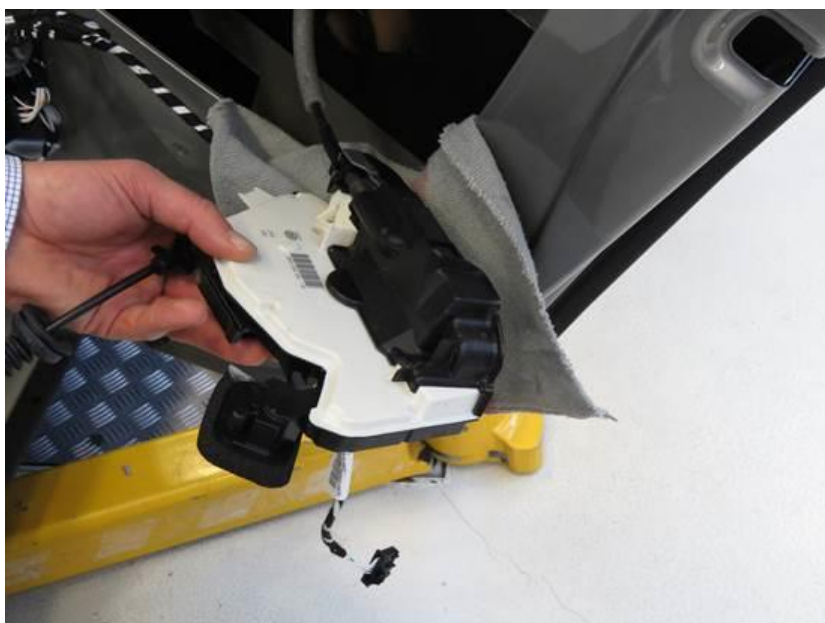
Figure 1) door lock and cap assembled

- Remove the affected door lock and cap. See Body Exterior. Repair Group 57 Front Doors and Central Locking Door Lock Removal and Installation in Elsa.
- Replace the door lock and the cap with new parts (See ETKA for the latest parts information).
- Assemble the new door lock and the new cap (Figure 1). See Body Exterior. Repair Group 57 Front Doors and Central Locking Door Lock Removal and Installation in Elsa.

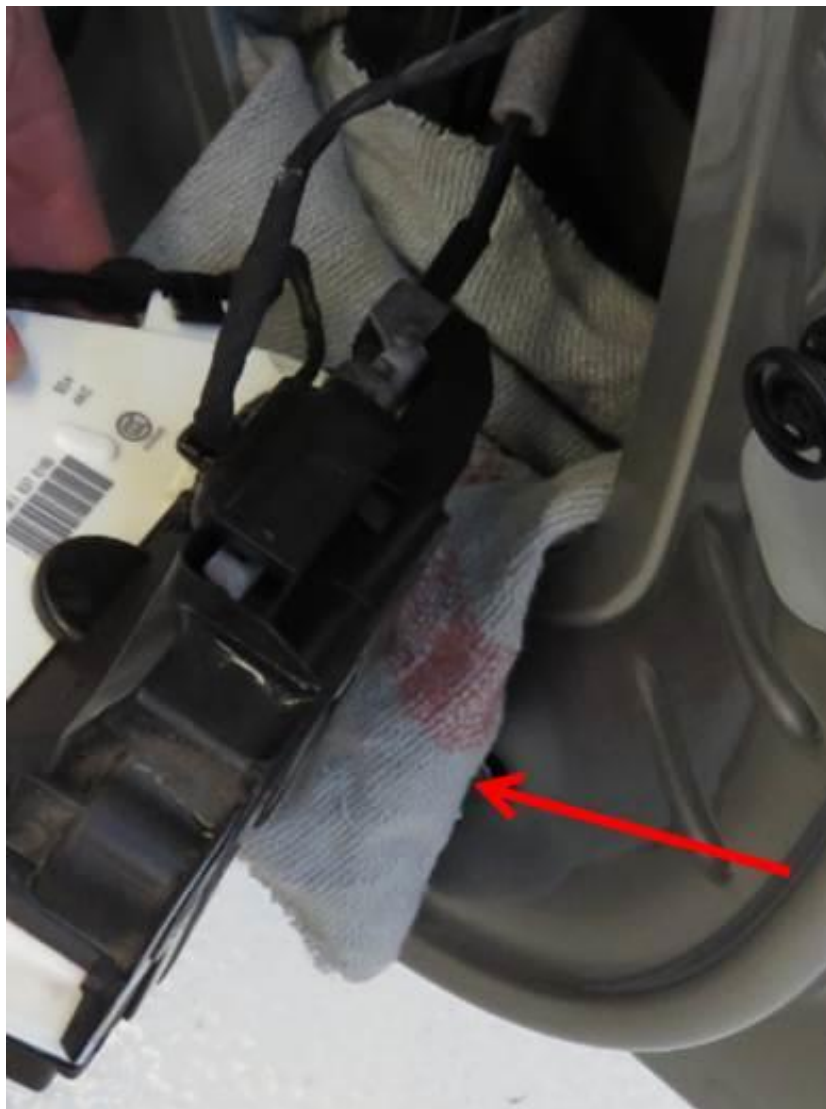
Figure 2) example of protected lower door area

- Using shop rags or suitable material, protect the lower section of the door against damage as shown in Figure 2.

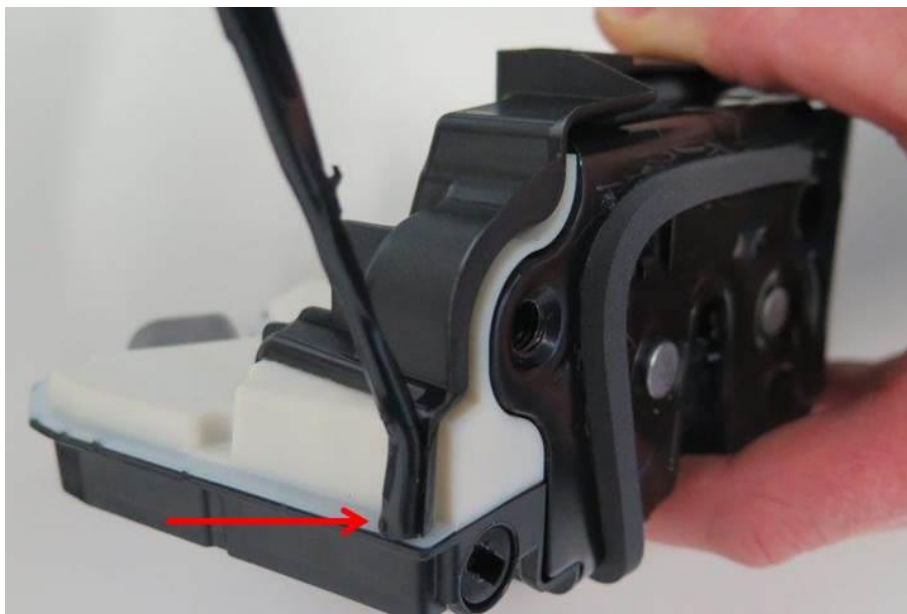
Figure 3) starting position for routing Butyl sealing cord

- Carefully route the butyl sealing cord, starting from position 1 (Figure 3, red arrow), along the cap (Figure 4, position 1 to 5) and press it down firmly.

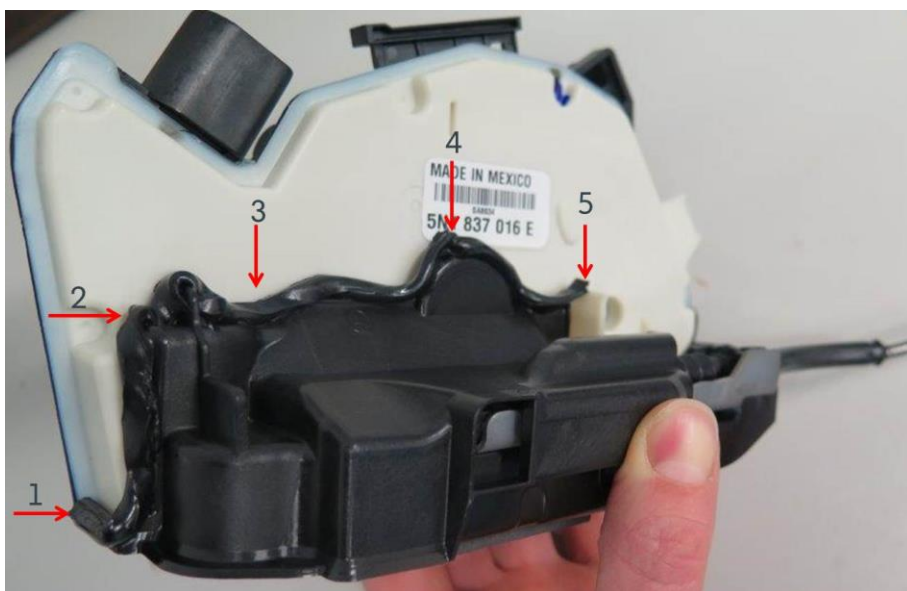
Figure 4) area where Butyl sealing cord has to be routed

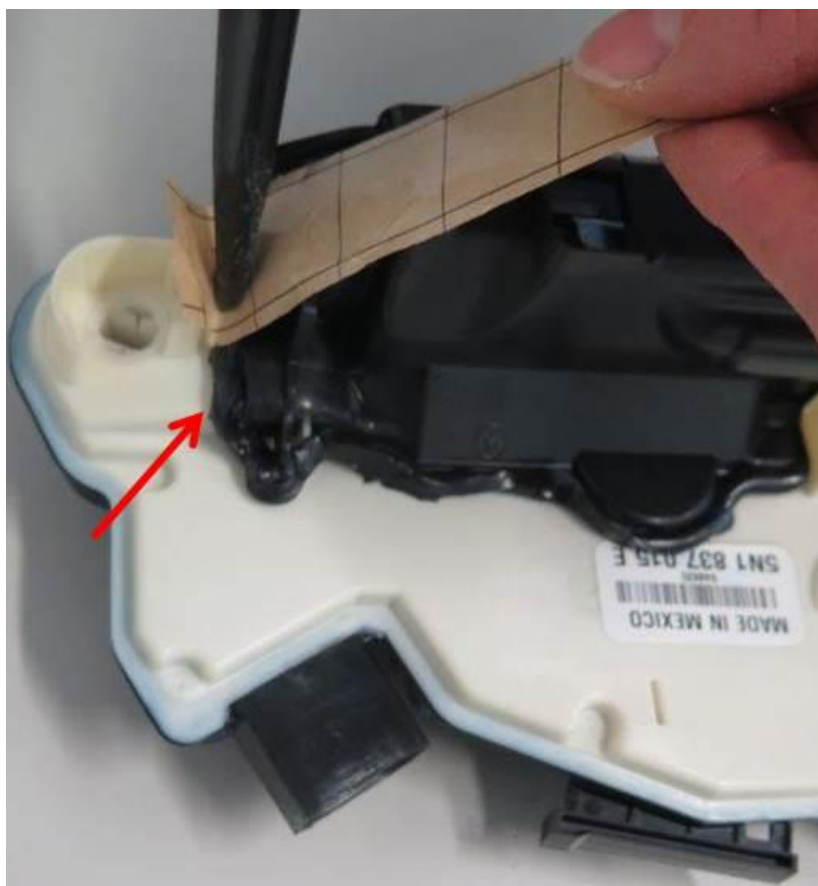
Figure 5: pressing down Butyl sealing cord with suitable tool

On the driver door lock the Butyl sealing cord must be pressed down in the area of the follower with a suitable tool, for example a wedge (Figure 5, red arrow).

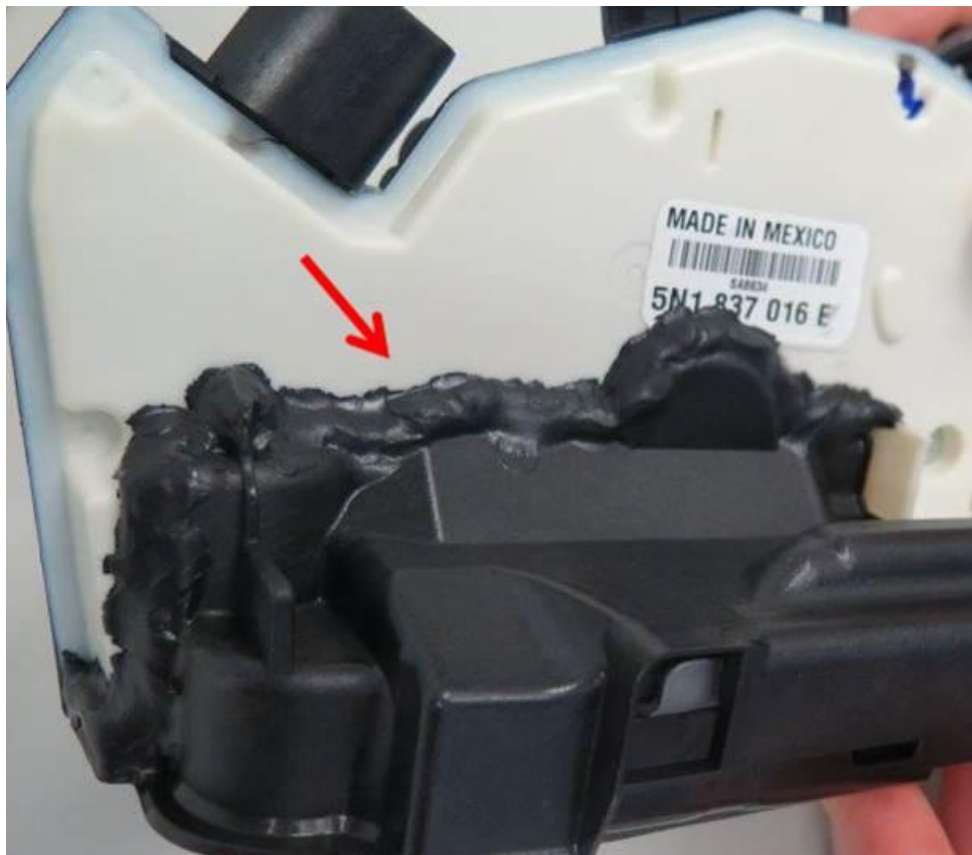
Figure 6 (example: butyl sealing cord pressed down/spread out by hand)

- Press down again on the Butyl sealing cord (spread the Butyl) to ensure proper sealing between the cap and the door lock (Figure 6).
