Technical Service Bulletin

46 Brake pulsation diagnostic guidelines

46 14 86 2022584/5 July 14, 2014. Supersedes Technical Service Bulletin Group 46 number 14-66 dated January 9, 2014 for reasons listed below.

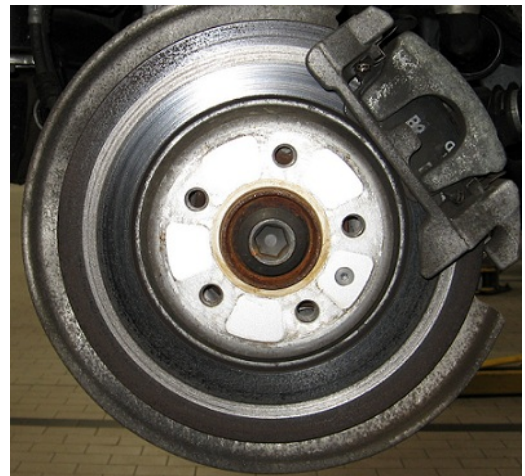
- **Condition C:** Corrosion/rust build-up on brake discs (Figure 3) because the vehicle was not driven for prolonged periods of time.
Service: Follow the procedure outlined in the *Brake Pulsation Service Tree*.
Any rust build-up that occurred because inventory maintenance (as outlined in the Inventory Maintenance Checklist) procedures were not performed will not be covered under Warranty.

Figure 3. Corrosion/rust build-up.

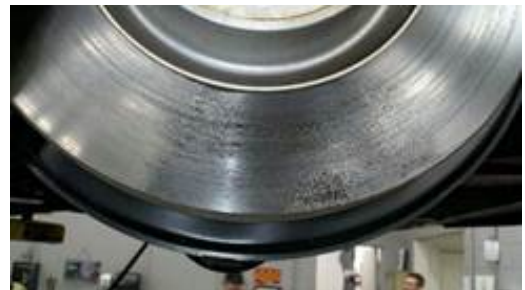
- **Condition D:** Corrosion marks from brake pads on the brake disc, also known as “pad marks” (Figure 4). These marks may appear if the vehicle has not been driven for a prolonged period of time.
Service: Follow the procedure outlined in the *Brake Pulsation Service Tree*.

Figure 4. Corrosion marks on the brake disc.

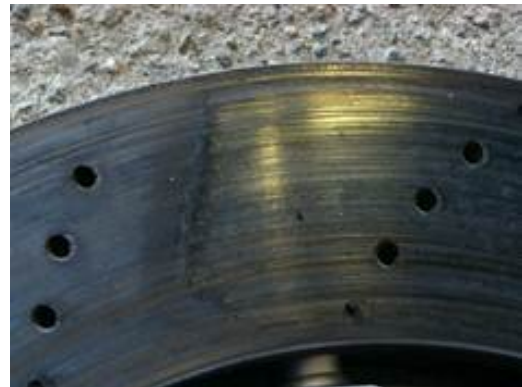
- **Condition E:** Deposits on the brake disc (Figure 5) due to thermal stress. Thermal stress is when the brake pads overheat as a result of aggressive driving,

Figure 5. Deposits on the brake disc.

**Tip:** If the vehicle is driven aggressively, the brakes must be cooled down before the vehicle is parked for an extended period of time. The driver can cool the brakes by driving around with minimal braking before parking the vehicle.

Service: Damage to the brake components due to aggressive driving is not covered under warranty.

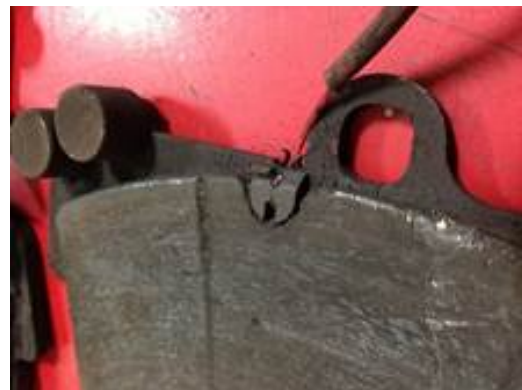
- **Condition F:** Worn brake pads and discs (Figure 6) have reduced dampening characteristics.
Service: Try replacing the brake pads if they are at least 50% worn. If the replacement brake pads do not improve the condition, replace the brake discs. Normal wear and tear of brake components is not covered under warranty.

Figure 6. Worn brake pad.

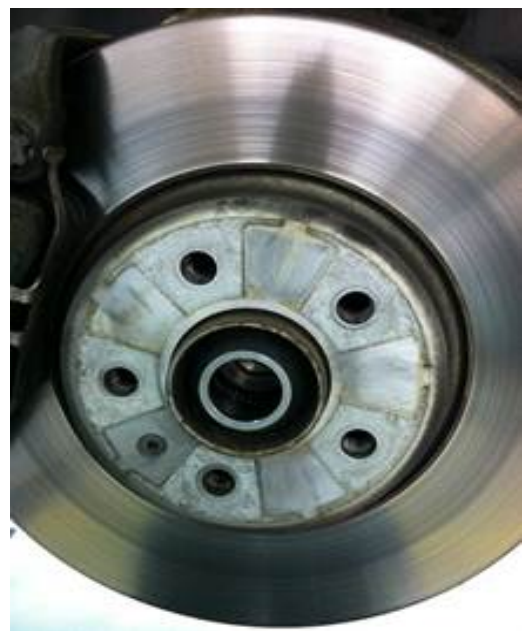
- **Condition G:** Blue-tempered brake discs or brake discs with heat marks (Figure 7) exhibit extremely high thermal loading of the brake system (with distortion and structural change of the brake discs). This high thermal loading results in permanent damage to the brake discs and brake pads.

Figure 7: Brake disc with heat marks.

**Tip:** If the vehicle is driven aggressively, the brakes must be cooled down before the vehicle is parked for an extended period of time. The driver can cool the brakes by driving around with minimal braking before parking the vehicle.

Service: Replace brake disc(s). This type of damage is not covered under Warranty.
