# Technical Bulletin

Model(s)	Year	Eng. Code	Trans. Code	VIN Range From	VIN Range To
Jetta	1999 – 2010	All	All	All	All

55 16 04 June 8, 2016 2038992 Supersedes Technical Bulletin V551602 dated February 8, 2016 to update Claim Processing comment.

### Corrosion on the Rear Lid around License Plate Lights

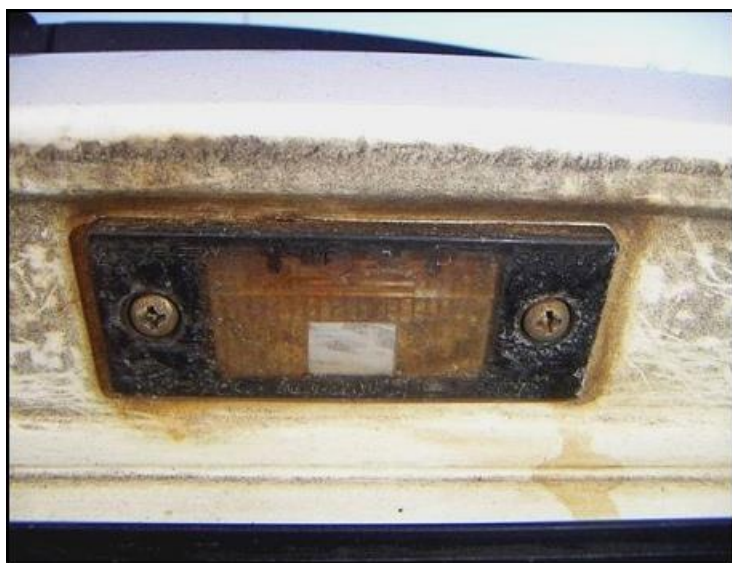
Figure 1: Corrosion on and around the license plate light

Electrolytic corrosion around the license plate lights (opening/contact surface, inside and outside) because of water ingress via the seal of the license plate lights.

#### 1a. Repair (Remove corrosion and restore paint structure).

#### 1b. Replace the rear lid.

#### 2. Seal off contact surface and screw holes of license plate lights with butyl sealing cord (part number: AKL 450 005 05).

- Remove the license plate lights from the rear lid according to the repair manual. See Repair Group 94 in Elsa.
- Remove all trim panels from the rear lid to prepare for corrosion removal according to the repair manual. See Repair Group 70 in Elsa.
- Remove the corrosion on the rear lid contact surface around the license plate light (inside and outside) with a pneumatic brush grinder.

- Prepare the rear lid for painting according to manufactures guidelines - it is not necessary to remove the glass.
- Apply a VOC compliant epoxy primer as an anti-corrosion treatment and primer (locally sourced).
- Repaint the rear lid according to manufactures guidelines.

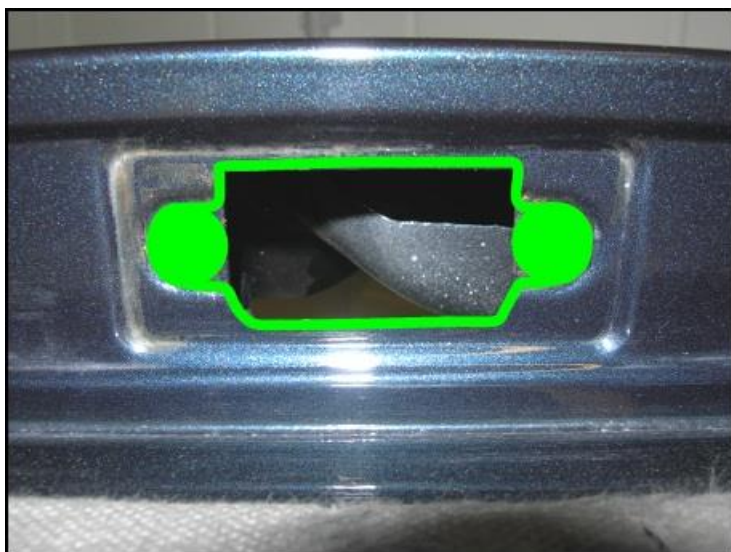
Figure 2) License plate light, butyl sealing cord areas

## 2. Additionally seal the contact surface of the license plate lights with butyl sealing cord (part number: AKL 450 005 05).

- Apply butyl sealing cord (0.2 cm x 20 cm) on the contact surface and attachment area of the license plate lights (Figure 2 and 3 in green).

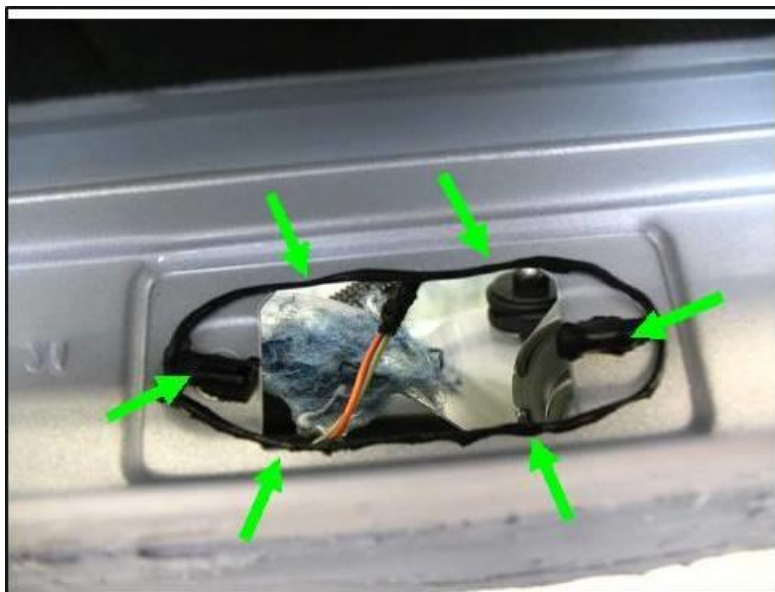
Figure 3) License plate light, contact surface and hole sealed with butyl sealing cord
