# Audi

## Technical Service Bulletin

#### 30 Clutch plate diagnosis guidelines

30 15 19 2019850/5 July 1, 2015. Supersedes Technical Service Bulletin Group 30 number 11-10 dated December 2, 2011 for reasons listed below.

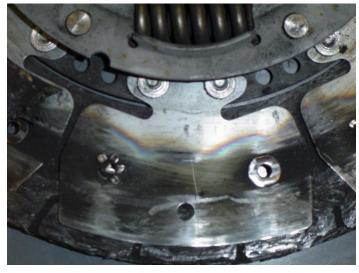
Lining partly removed due to overheating (Figure 1).

Figure 1. Lining partly removed due to overheating.

If any of the damage described below is present, it is due to outside influence and is not covered under warranty.

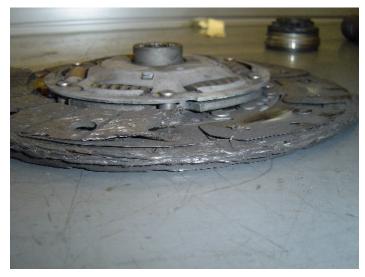
The lining burst off because of an overspeed condition (Figure 2).

Figure 2. Burst lining from an overspeed condition.

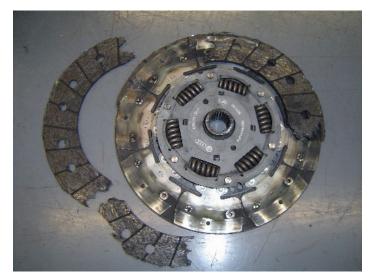
The lining is ground to the rivets, which causes a broken clutch lining (Figure 3).

Figure 3. Broken clutch lining.

All clutch damage shown in this TSB is due to outside influence and is not covered by any Audi warranty.
