ATB 51720-51896 REV2 (1407)

Safety Recall: Odyssey Fuel Pump

Supersedes 14-032, dated June 13, 2014, to revise the information highlighted in **yellow**.

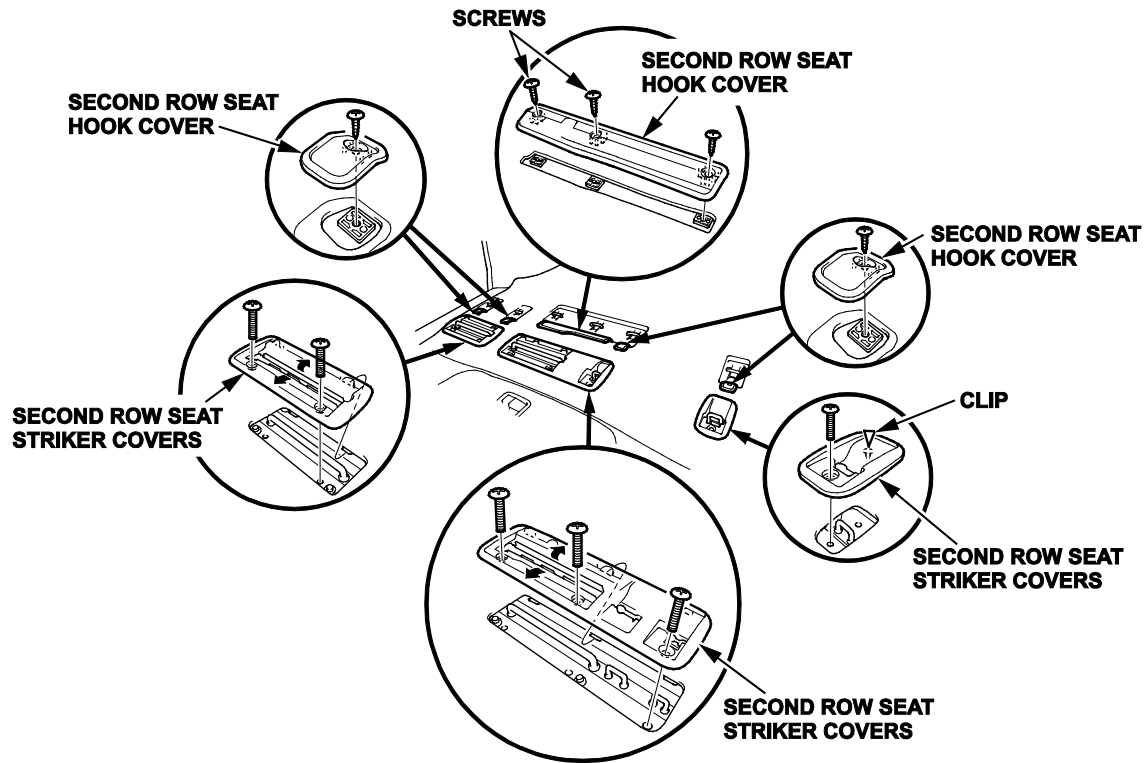
1. Remove the second row seats.
2. Fold down the third row seats.
3. Remove the screws (11) and detach the clip (1), then remove the second row seat striker covers and the second row seat hook covers.

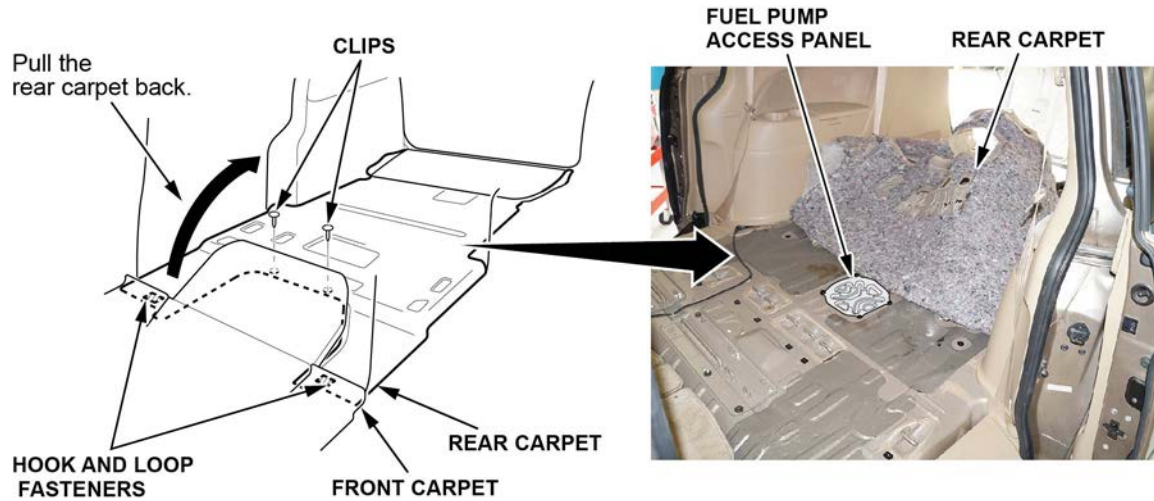
- Pull up the rear carpet to release the hook and loop fasteners and detach the clips. Continue pulling back the carpet to reach the fuel pump access panel and the fuel tank unit.

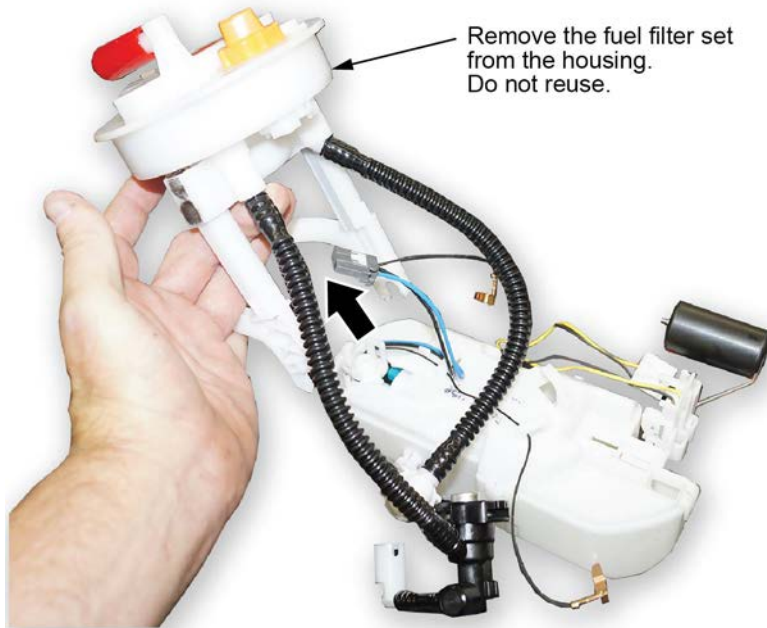
12. Remove the corrugated line connector from the fuel pump housing.
13. Disconnect the three wire harness connectors from the fuel filter set.
14. Remove the original fuel filter set from the fuel pump housing.
