HYUNDAI Technical Service Bulletin	GROUP CAMPAIGN	NUMBER 18-01-004
	DATE JANUARY, 2018	MODEL(S) GENESIS (BH) EQUUS (VI)
SUBJECT: 2011-2014 GENESIS (BH) AND 2011-2016 EQUUS (VI) ANCHOR PRETENSIONER LABEL INSTALLATION (SERVICE CAMPAIGN T2R)

This bulletin describes the procedure to install warning labels on the driver's and/or passenger's seat belt assemblies to prevent potential improper reattachment of the anchor pretensioners.

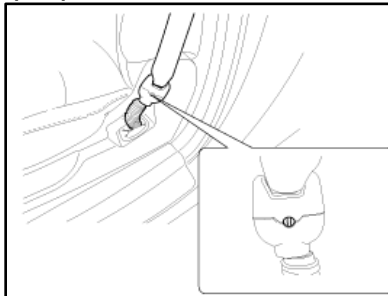
Description: The front seat belt assembly incorporates a seat belt anchor pretensioner fastened to the vehicle's front seat frame. During vehicle assembly, the anchor pretensioner is fastened to the front seat frame prior to being connected to the seat belt linkage. If, during vehicle repair, the connector does not fully latch when the linkage was pressed onto the connector, the seat belt can detach from the anchor pretensioner. If the seat belt linkage detaches from the anchor pretensioner in a collision, the risk of injury to the occupant is increased.
