## Brake Caliper Potential Problem

## Service Instructions

Doc. No. Y279696 (EN - Rev. 000)  
June 2017

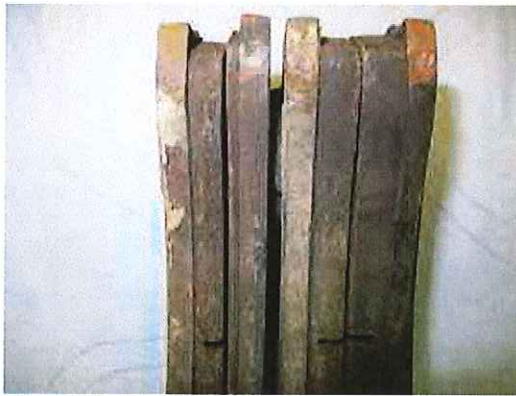
- Knocking or creaking noises when applying or releasing the brake. These noises may be audible only when the vehicle is stationary or if the actual brake pressure exceeds a certain value (typically 3.5-5 bar).
- Uneven wear of the two brake pads of the same disc brake. This can either be shown as
  - a) progressive wear of the outer pad while the inner pad wears less (difference > 3mm) or
  - b) by significant oblique wear at outer and inner brake pad material along the direction of rotation (difference between both ends of the same pad: > 2 mm).

Fig. 1: showing excessive wear of outer brake pad

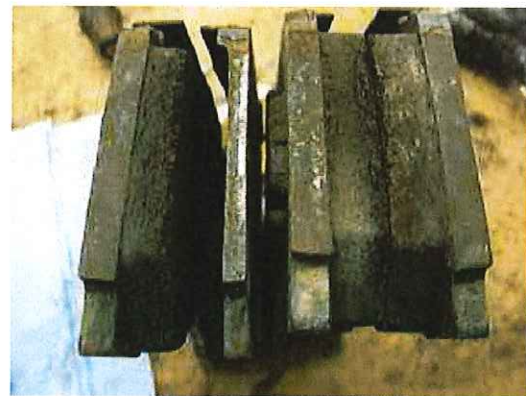
Fig. 2: showing excessive wear of outer brake pad

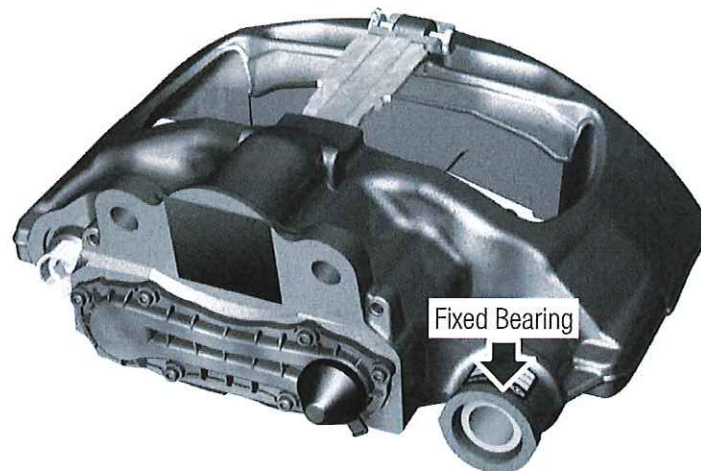
1. Carry out a complete functional and visual inspection of brake pads, brake disc and caliper guidance system. Description for execution and evaluation criteria can be found in the respective service instructions (For SN7/ SM7 / SL7 / SN6 see document No. Y006471, and for SB7 Radial see document No. C16352). It is essential that all basic technical instructions and safety precautions are followed as described in the service manual.
2. In the event that the caliper guide system is impaired or restricted, remove the cap from the fixed bearing side (long bearing). Then, by moving the brake caliper along the guides the inner surface of the bearing bushings can be examined.

Fig. 3: Typical Axial Disc Brake - Fixed Bearing with Cap removed

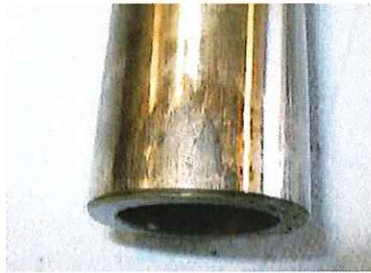
Fig. 4: Material contamination

3. If signs of wear, seizure, material transfer or discoloration are present, the caliper guides must be replaced. To do this please follow the instructions in the service manual.

**Please note: guide pins and bearing bushes must always be replaced together!**

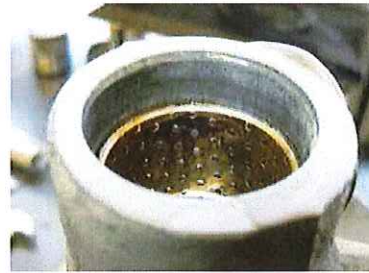
Fig. 5: Wear/Abrasion

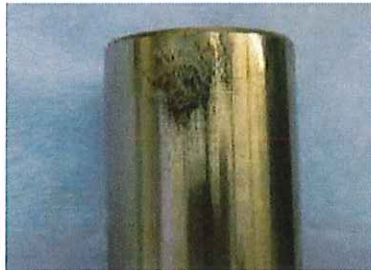
Fig. 6: Discolouration / Smoothing

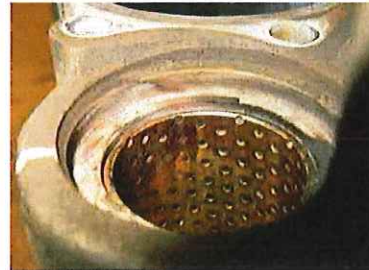
Fig. 7: Fretting

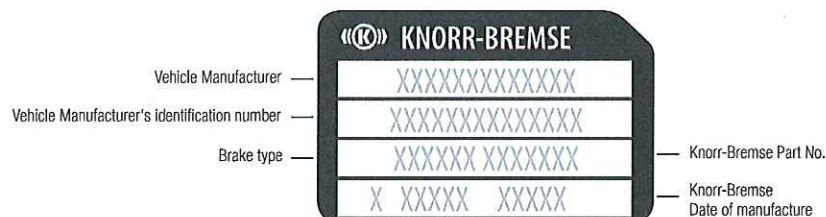
The production date of the disc brakes can be determined from the serial number. The first 6 digits of the serial number can be decrypted as follows:

- Digit 1: A, L, or C for the manufacturer
- Digit 2 + 3: Year of manufacture e.g. 15 = 2015
- Digit 4 + 5: Production week, e.g. 36 = 36th week in the year of manufacture
- Digit 6: Day in the production week - 1 = Monday, 2 = Tuesday, etc.

Parts manufactured during this period have a manufacturer code beginning with an A or L followed by 15xxx xxx and ending with an A or L followed by 170301 0001; i.e. the period from 01.01.2015 to 16.01.2017.

Fig. 6: Knorr-Bremse Identification Label
