Technical Service Bulletin

26 Chirping noise from rear of vehicle

26 17 31 2047565/1 April 18, 2017.

Model(s)	Year	VIN Range	Vehicle-Specific Equipment
R8	2016 - 2017	900001 - 904259	Not Applicable

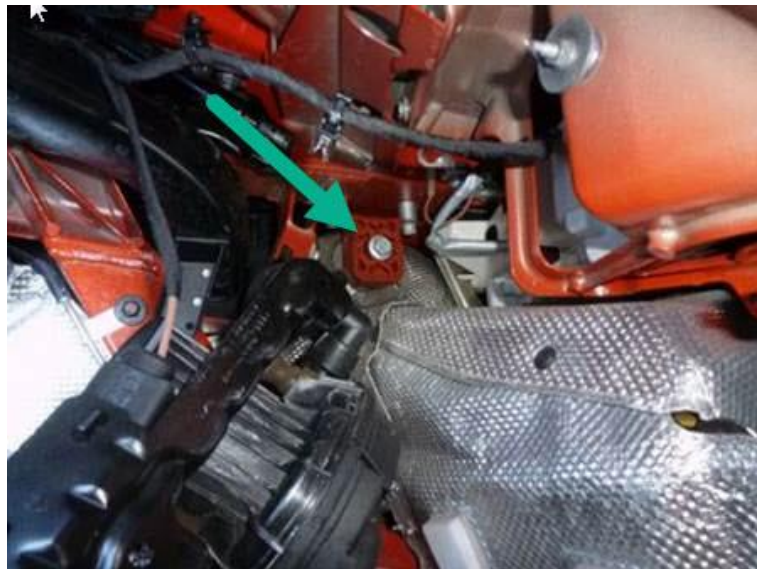
If the concern is caused by the washer, replace the washer on both sides of the muffler (Figure 2).

Figure 2. Bracket for exhaust system.

Modified washer. The new washer is coated on one side with graphite.

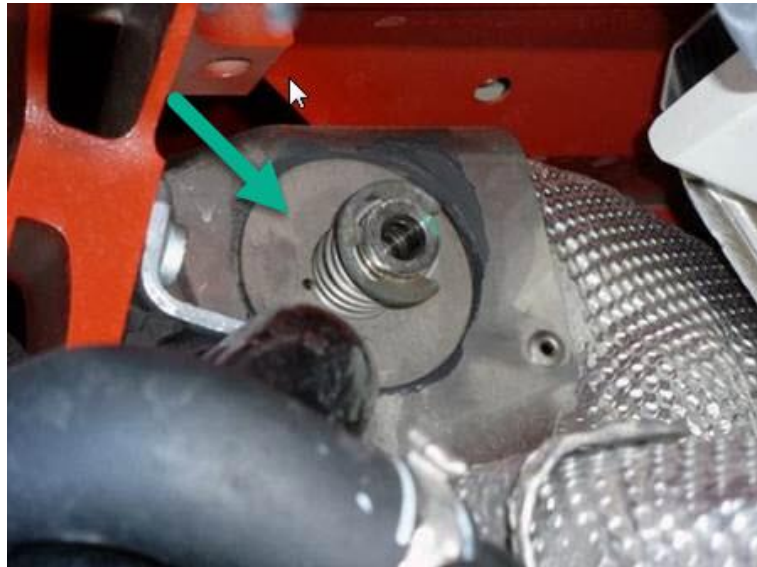
The graphite-coated side of the washer must face the heat shield (Figure 3).

Figure 3. Washer.
