**\* \* TECHNICAL INFORMATION NOTICE \* \***

**DATE:** February 5, 2018  
**TO:** Mitsubishi Motors US & Puerto Rico Dealer Service and Parts Managers  
**RE:** Coolant Leaking from Water Hoses at CVT8 Fluid Cooler  
**TIN NO.** TIN-18-23-001

**AFFECTED VEHICLES:** 2016-18 Outlander equipped with 4 cylinder (2.4L) engine and CVT8 transmission (F1CJC/W1CJC)

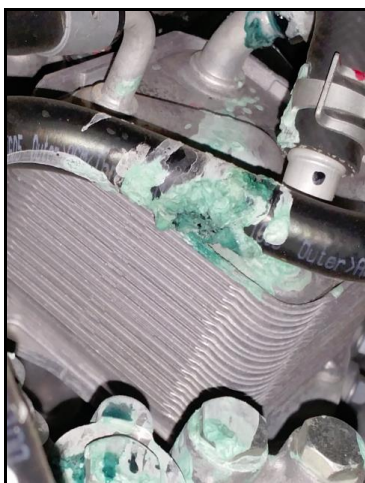
Dealers have reported coolant leaking from the water hoses at the CVT8 fluid cooler (see photo below). Normal dealer repairs have been to replace the water hose and/or clamps on the affected area.

(View looking up from the bottom of the vehicle)

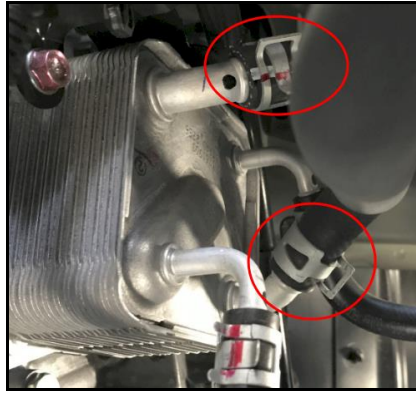
In order to investigate this condition further, MMNA is looking to collect 5 complete sets of CVT8 fluid coolers with the water hoses and clamps **undisturbed**. Please do not remove the water hose clamps indicated by the circled areas in the photo below (the other hoses are for the CVT8 oil, not coolant). This is important since MMC needs to perform a duplication test to confirm the area of leakage.

Please open a Techline case, attach photos of the condition, and contact Techline (800-446-6064) to review the findings. Product Support will then contact the dealership to arrange return of the original parts to MMNA.
