Document ID: IK1200357
Revision: 2
Created: 3/11/2009
Last Modified: 2/5/2014
Author: Octavio Ortiz

Title: Horton 2 Speed Drive Master Fan Clutch (12THT) missing or loose magnets

Applies To: All MaxxForce DT, 9 and 10 Engines with 12THT Horton Drive Master 2 Speed Fan Clutch

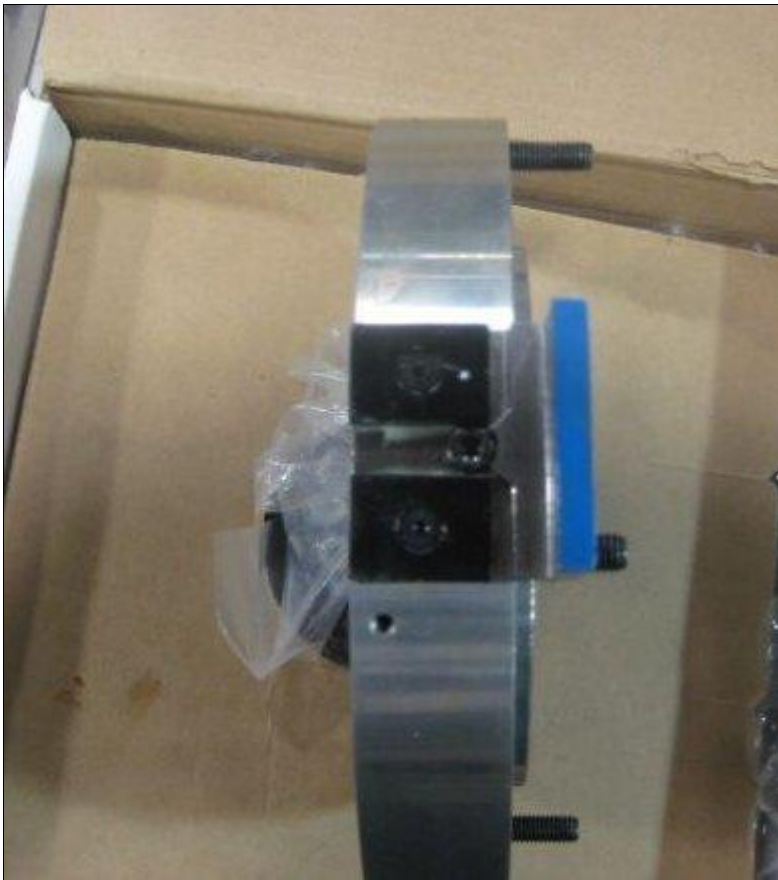
Photo 2 - HOR995539 Center section kit

1. If one or both of the magnets are loose or missing , replace the center section with HOR995539 Center Section Kit. Photo 2
2. Complete installation and repair instructions in the kit.

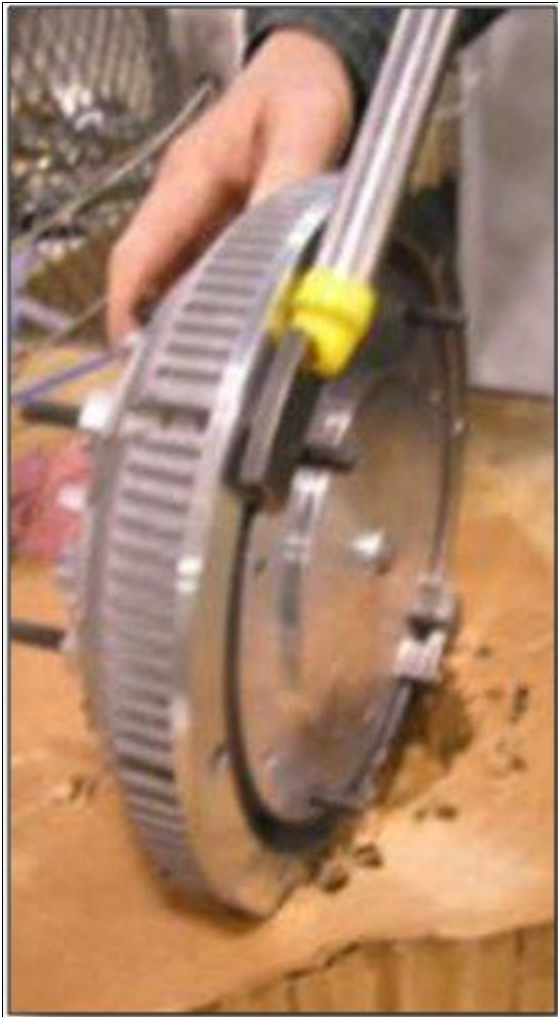
Photo 3 - Knock off both magnets flanges.
Can be performed in chassis

1. If one or both of the magnets are loose, knock **both** magnet flanges off the center section
2. If only one magnet is loose or missing remove **both** magnet flanges
3. This can be performed with the fan drive in chassis. Use a blunt punch and hammer to knock off **both** flanges. Photo 3
4. When repair kit is available replace the center section

NOTE : Without magnets the fan clutch will operate as a single speed on / off clutch.
