Buzzing Noise From LH Side Under Dash

Service Category Vehicle Interior

Section Heating/Air Conditioning

Applicability

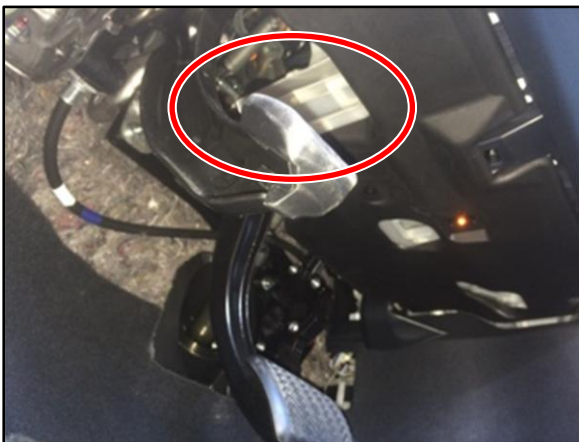
Figure 1.

Some 2016 model year Prius vehicles may exhibit a condition where there is a buzzing noise from the LH side under the dash while driving (see Figure 1).

Follow the Repair Procedure below to address this condition.

1. Verify that there is a buzzing noise from the LH side under the dash.
Is the noise present?
 - **YES** – Continue to step 2.
 - **NO** – This bulletin does NOT apply. Continue diagnosis using the applicable Repair Manual.
2. Remove the Air Duct.
Refer to the Technical Information System (TIS), applicable model and model year Repair Manual:
 - 2016 Prius:
Steering – Steering Column – “Steering Column: Steering Column Assembly: [Removal](#)”
3. Install the NEW Air Duct.
Refer to TIS, applicable model and model year Repair Manual:
 - 2016 Prius:
Steering – Steering Column – “Steering Column: Steering Column Assembly: [Installation](#)”
4. Confirm the condition has been addressed.

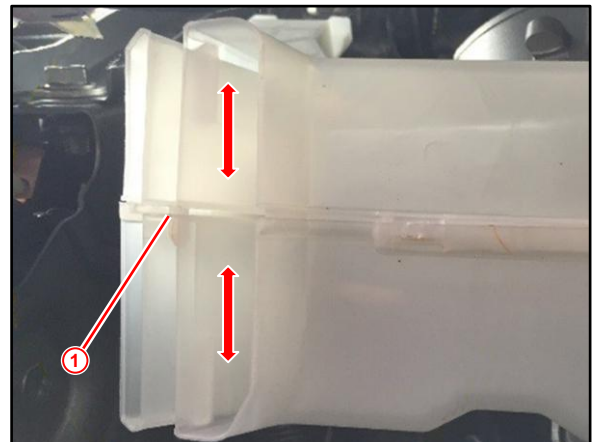
Figure 2.

The pin that secures the center section of the HVAC duct together may be loose, making a buzzing noise (see Figure 2).

1	Pin
----------	------------
