Rear Bumper Gap

Service Category Vehicle Exterior

Section Exterior Panels/Trim

YEAR(S)	MODEL(S)	ADDITIONAL INFORMATION
2014 – 2017	Yaris

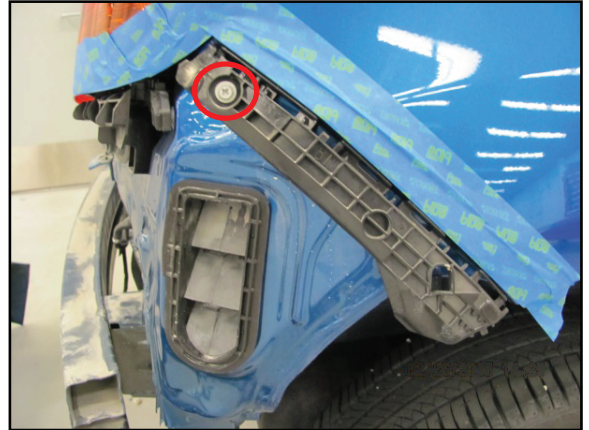
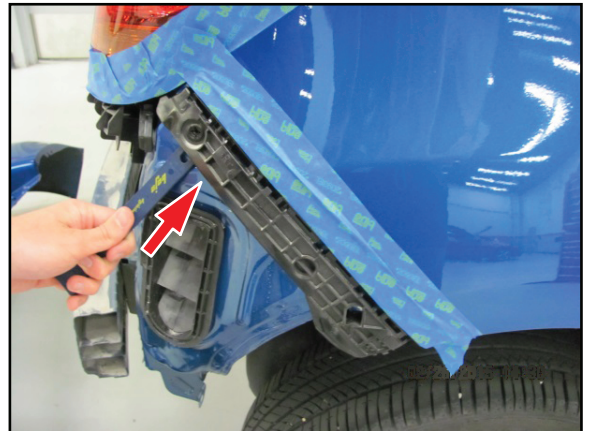
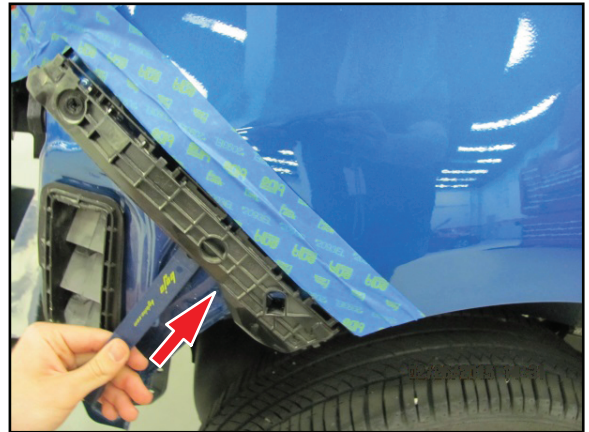
4. Remove the rear bumper cover retainer by uninstalling the (1) 10 mm screw (see Figure 3) and disengaging the retainer from the body by prying against the body as shown (see Figure 4 and 5).

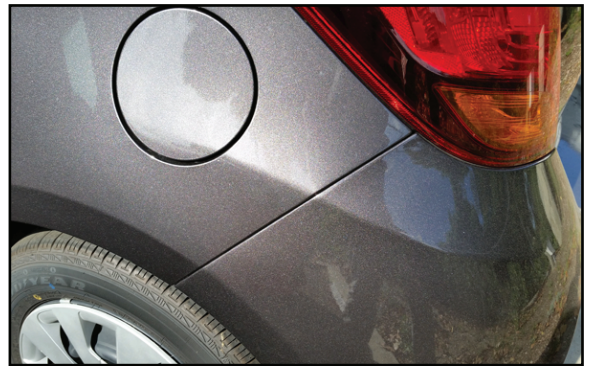
- 2016 Yaris:
Vehicle Exterior – Exterior Panels/Trim – “Exterior Panels/Trim: Rear Bumper (for hatchback): [Installation](#)”
 - 2017 Yaris:
Vehicle Exterior – Exterior Panels/Trim – “Exterior Panels/Trim: Rear Bumper (for hatchback): [Installation](#)”
10. Confirm rear bumper gap is less than 1.6 mm and is consistent. **Figure 8.**
