Subject		Market	
Navigation Head Unit Precautions		USA	
Service Category		Section	
Audio/Visual/Telematics		Audio/Video	
Applicability			
2010-2018, Lexus Models with Navigation Head Unit

This bulletin is regarding best practices when handling navigation systems that use Hard Disc Drive or Micro SD Card memory.

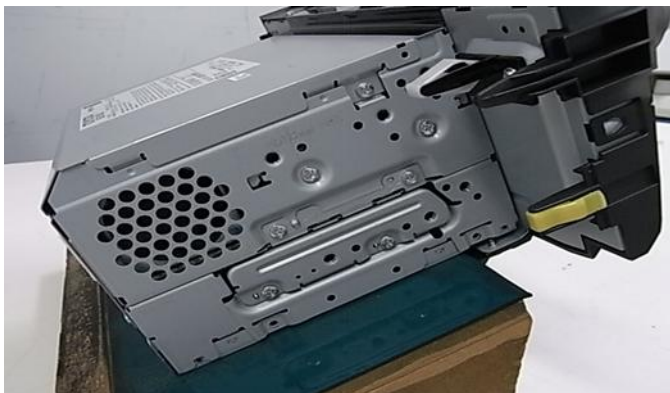
1. First type is generation 6 or 7 which utilizes HDD (Hard Disc Drive). Pioneer models that begin with **NXH**, have Map Data, Operating System and other Information in the Hard Disc Drive. With this system if a radio is being sent back for an exchange. The original Hard Disc Drive needs to be removed and installed into the newly serviced radio.

The HDD is inside this cover. The HDD needs to be removed when returning the Main Unit to Pioneer.

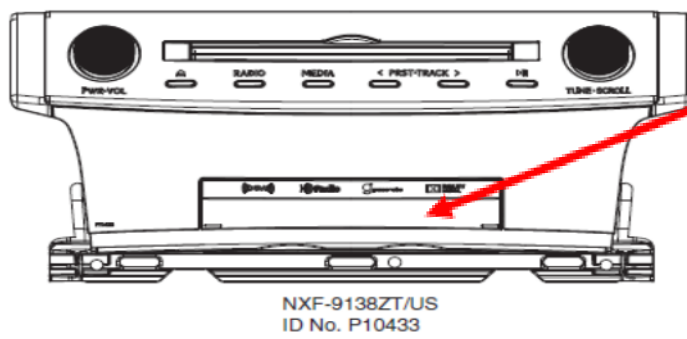
- The Second type is Generation 8 Navigation system which utilizes the Micro SD Card. Pioneer models that begin with **NXF**, have map data in the Micro SD card. This is a customer accessible Micro SD card which can be found behind the front flip cover. The original Micro SD card should be removed and installed into the newly serviced radio.

The SD card is behind this flip cover. The Micro SD needs to be removed when returning the Main Unit to Pioneer.

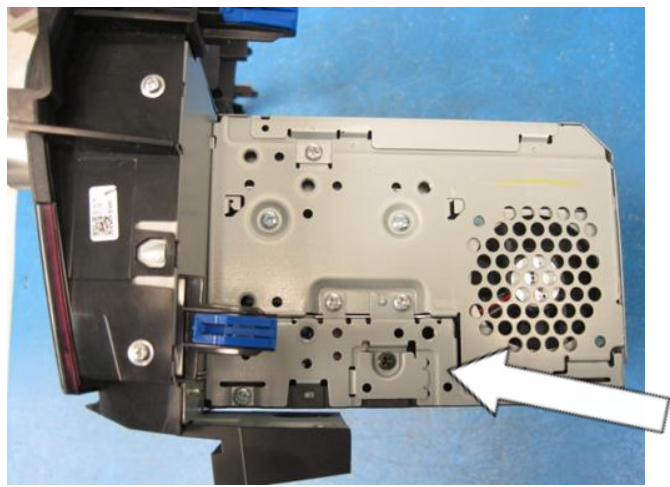
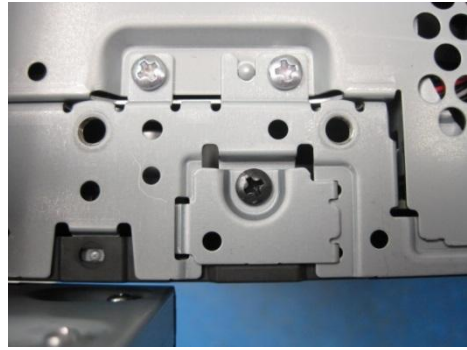
DO NOT REMOVE

There is another Micro SD card (*Operating System*) inside the Navigation Module. (Similar location to the Hard Disc Drive in the Generation 7 system). This micro SD Card **Should Not** be removed for any reason. Micro SD cards located in this internal slot need to be returned with the original radio.

This Micro SD card MUST NOT be removed.

This will void the Warranty status from Pioneer if removed and dealer will be debited the core credit.
