Power Steering Rack Leak from Right Side: Overhaul Procedure

YEAR(S)	MODEL(S)	ADDITIONAL INFORMATION
2004 – 2010	Sienna	Drive Type(s): 4WD, 2WD Engine(s): 3MZ, 2GR

The information contained in this bulletin supersedes SB No. T-SB-0097-12.

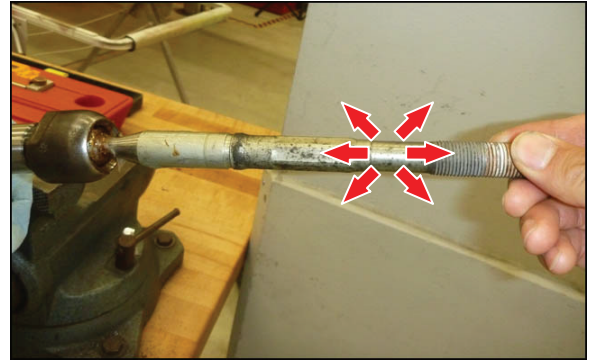
Figure 7.

14. Inspect the left-hand and right-hand tie rod ends for excessive wear and play. Push and pull the tie rod to confirm condition. Replace as necessary.

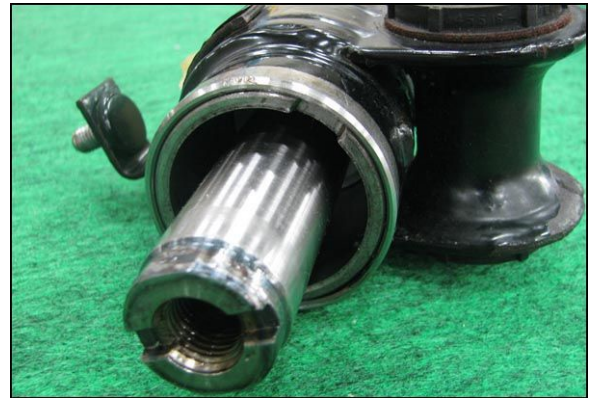
Figure 8.

15. Thoroughly clean the steering rack assembly.

Be sure to clean the inside of the rack assembly to prevent foreign material from damaging the rack surface (for example, when boot has torn and allowed debris to collect around the inside of the rack).

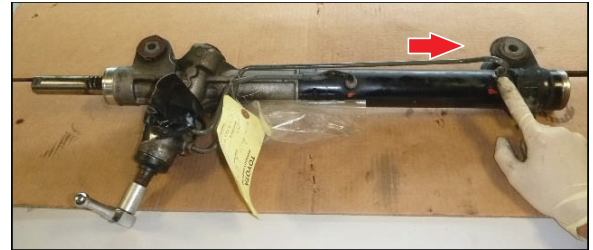
Figure 11.

Plug the port while simultaneously turning the input shaft counterclockwise.

The internal air pressure will cause the rack bushing to get pushed out.

Do NOT turn the input shaft clockwise; it may cause damage to the center seal on the rack bar if it goes beyond its normal travel.

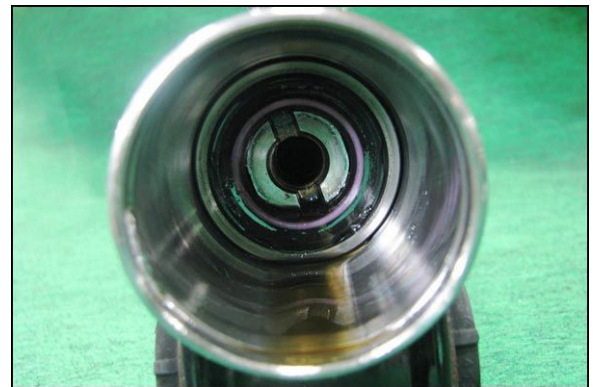
Figure 14.

21. Inspect and clean the inside of the rack housing.

Look down inside the rack housing to confirm it is clean before reinstalling the rack bushing.

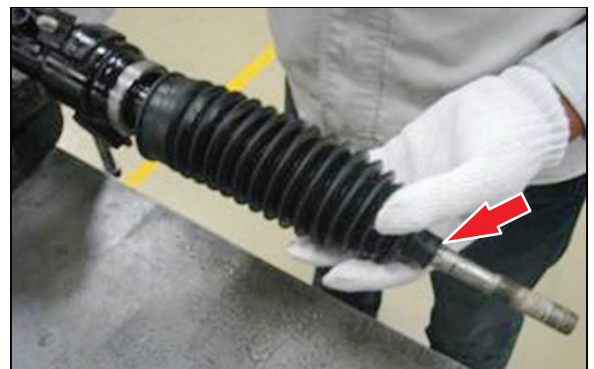
Figure 22.

4. Install the steering rack boot.
 - A. Apply a small coat of silicone grease to the inside clamping surface of the small end of the boot as shown.
 - B. Install the steering rack boot.
 - C. Install the steering rack boot clip using pliers.
