# Abnormal Power Door Lock Operation (Cycle)

YEAR(S)	MODEL(S)	ADDITIONAL INFORMATION
2009 – 2011	Corolla, Matrix	WMI(s): 2T1

Some vehicles may exhibit a condition where the door locks cycle without any operator input of a door lock switch or keyless remote assembly. In limited cases this condition may be caused by grease contamination in the door lock switch. The following procedure is available to inspect and diagnose this condition. Replacement instructions for the door wire harness and door lock actuator are also provided in this bulletin.

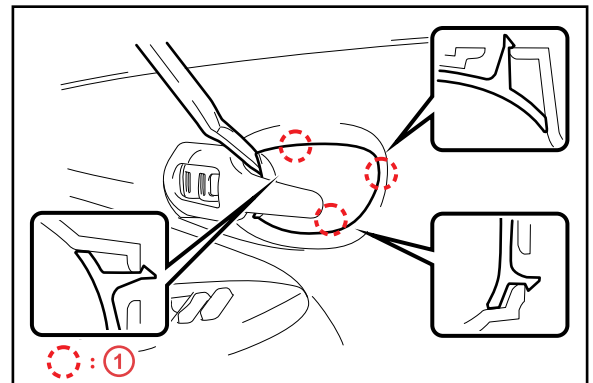
**Figure 1.**

2. Using a plastic pry tool, disengage the 3 claws and remove the driver door inside handle bezel.

<b>1</b>	<b>Claw</b>
----------	-------------

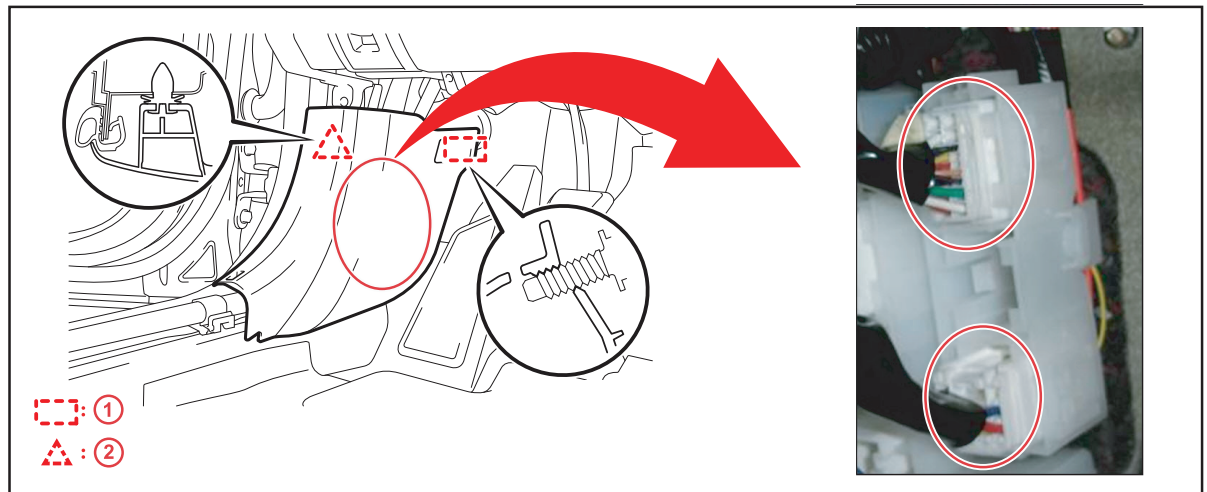
**Figure 14.**

- A. Disengage the clip and guide, and remove the cowl side trim board LH.

<b>1</b>	<b>Guide</b>
----------	--------------

<b>2</b>	<b>Clip</b>
----------	-------------

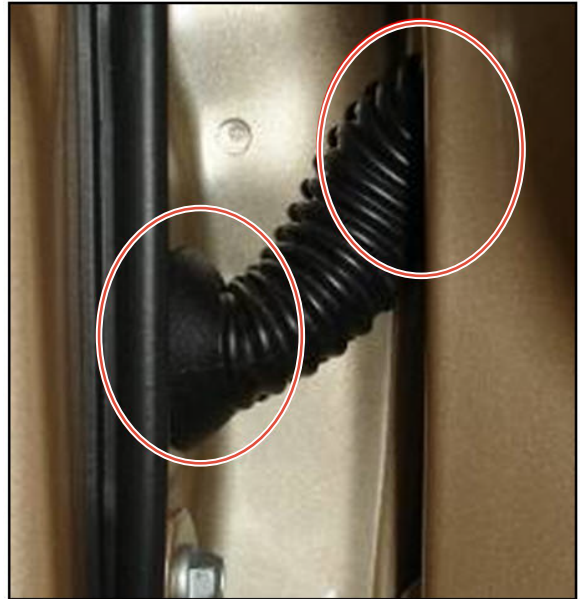
2. Loosen the rubber boot in door jamb (at bottom of A pillar and leading edge of door). **Figure 15.**

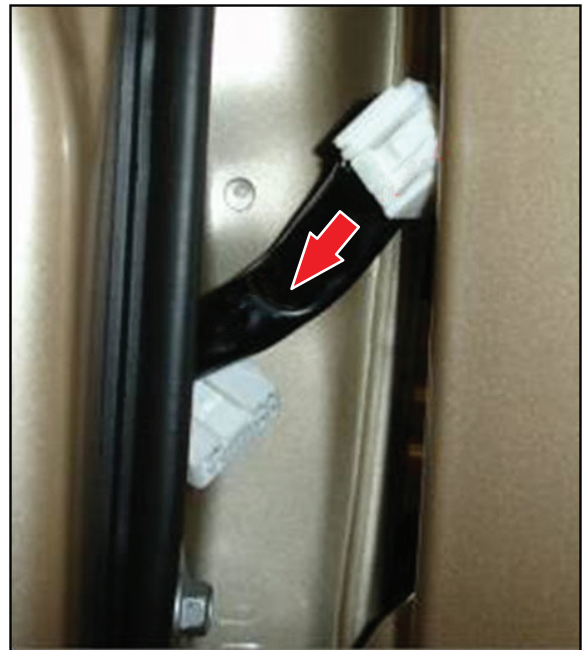
**Figure 16.**

3. Pull door harness into door from kick panel and door jamb to remove from the door.

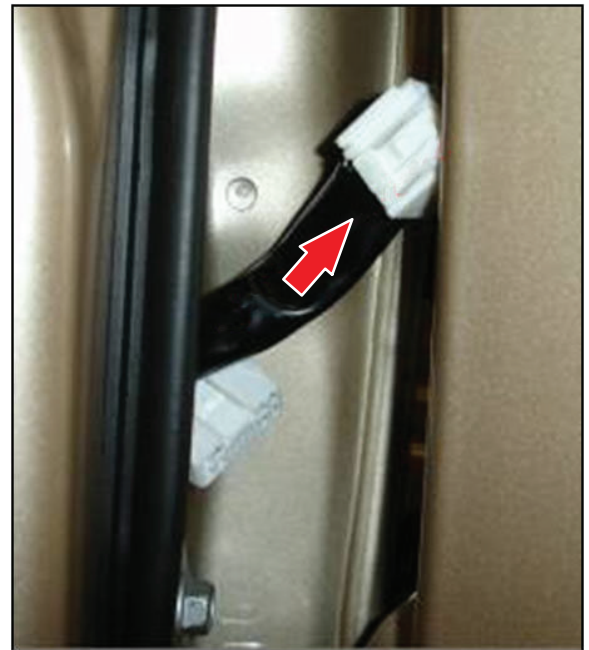
**Figure 27.**

1. Install the NEW door wire harness by pulling the leading edge connectors of the door harness from inside door, through the hole in front of the door, and into the hole to access the kick panel.

**Be careful NOT to chafe wires on metal edges when pulling harness through the holes.**

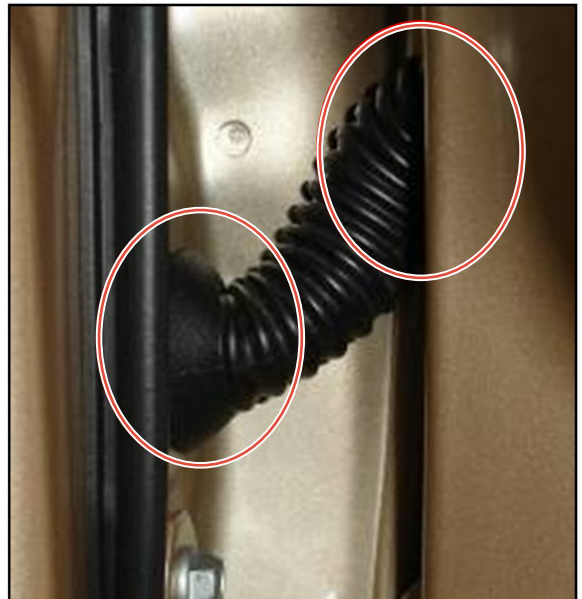
Figure 28.

2. Secure the rubber boot on both sides of door jamb.

Be sure both rubber boots are completely seated in the door jamb and base of the A pillar.
