Subject Spots in Window Glass		Market USA
Service Category Vehicle Exterior	Section Window/Glass	
Applicability All Models

Spots in Window Glass

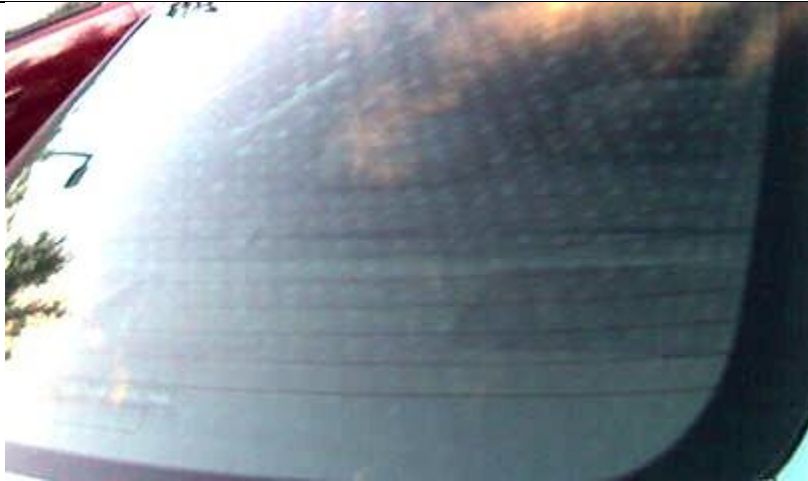
The appearance of spots in tempered glass (when viewed at certain angles) is the result of the heat treating and quick quenching process during manufacturing.

- The condition appears as faint shadowy spots and or lines in the glass.
- They become visible in the transmission and in reflection of light off the glass surface.
- The condition is more visible when viewed from an angle, rather than directly facing the glass.
- When polarized sunglasses are worn, they can dramatically enhance the appearance of the spots and lines.
- The spots seem to be easier to see on a sunny day when the light comes from a blue sky or is reflected from clouds. They are less visible on a gray, cloudy day.
- Tempered or heat treated glass can be found on the vehicle side and the back glass areas.
- An example of how the phenomenon appears is shown in this document.

This is a normal phenomenon for tempered glass and glass exhibiting the condition outlined above should not be replaced.
