# HID Headlamp Housing Paint Bubble / Poor Appearance

YEAR(S)	MODEL(S)	ADDITIONAL INFORMATION
2011 – 2013	IS F, IS250, IS250C, IS350, IS350C

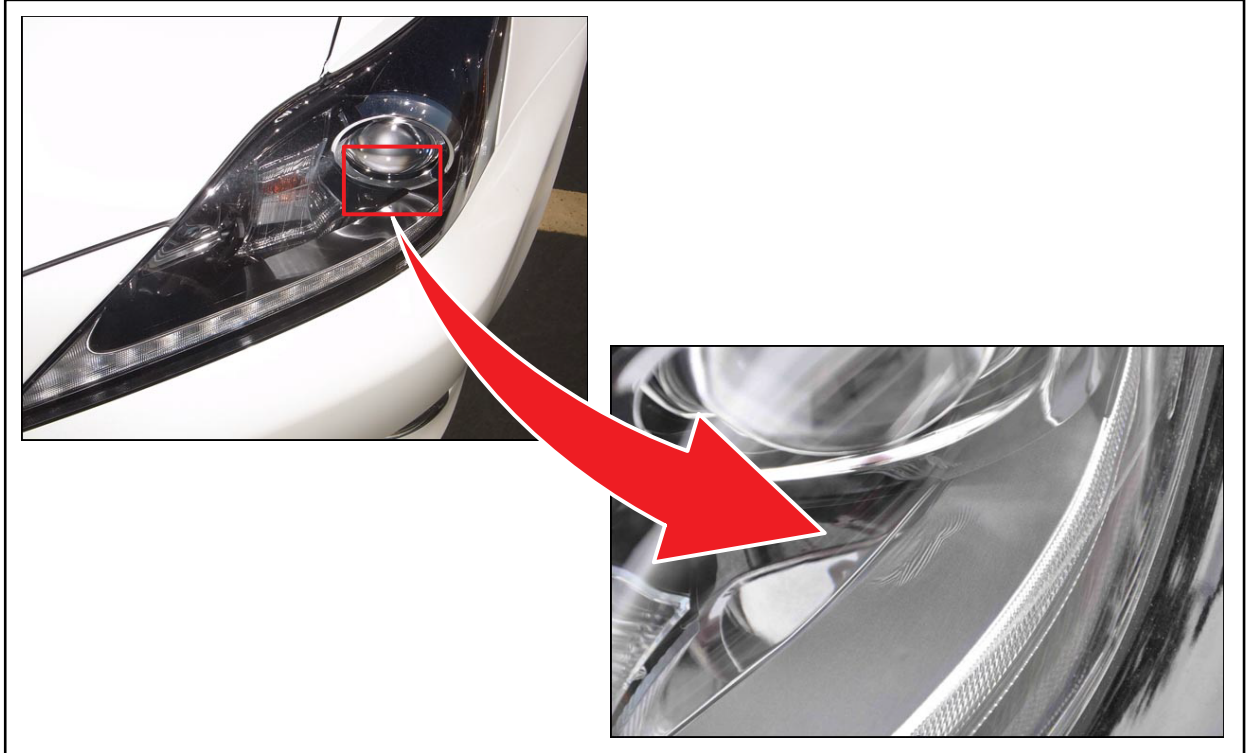
Figure 1.

Some 2011 – 2013 model year IS 250/350/250C/350C and IS F vehicles equipped with HID (High Intensity Discharge) headlights may exhibit a paint bubbling/wrinkling condition on top of the LED strip within one or both of the headlight housings. Newly designed headlight units have been developed to address this condition. Follow the procedure in this bulletin to install the updated headlight units.

1. Confirm vehicle has the headlight housing paint bubble condition (see Figure 1 for an example).  
If a poor appearance is found, continue to step 2. If not, this bulletin does **NOT** apply.

2. Replace both headlight units.
  - A. Remove both headlights.

C. Reassemble the headlight assemblies using the new headlight units.
