Front Brake Vibration

YEAR(S)	MODEL(S)	ADDITIONAL INFORMATION
2007 – 2015	LS460

Some 2007 – 2015 model year 2WD LS 460 standard (non F-Sport, non AWD) and LS 460L vehicles may exhibit vibration/pulsation in the brake pedal and/or steering wheel while lightly applying the brake pedal at high speeds (65 – 75 mph). Follow the procedures in this bulletin to address this condition.

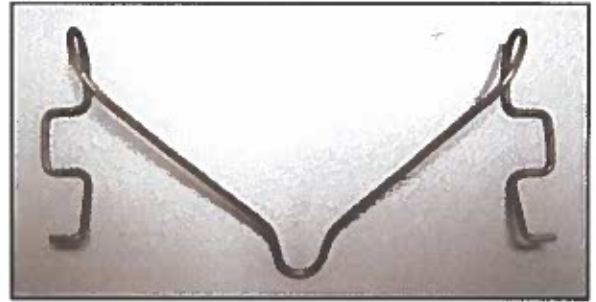
M-Spring shown at right.

Figure 1. M-Spring/Anti-Rattle Spring (P/N 47748-50200)

5. Install the additional M-Spring.

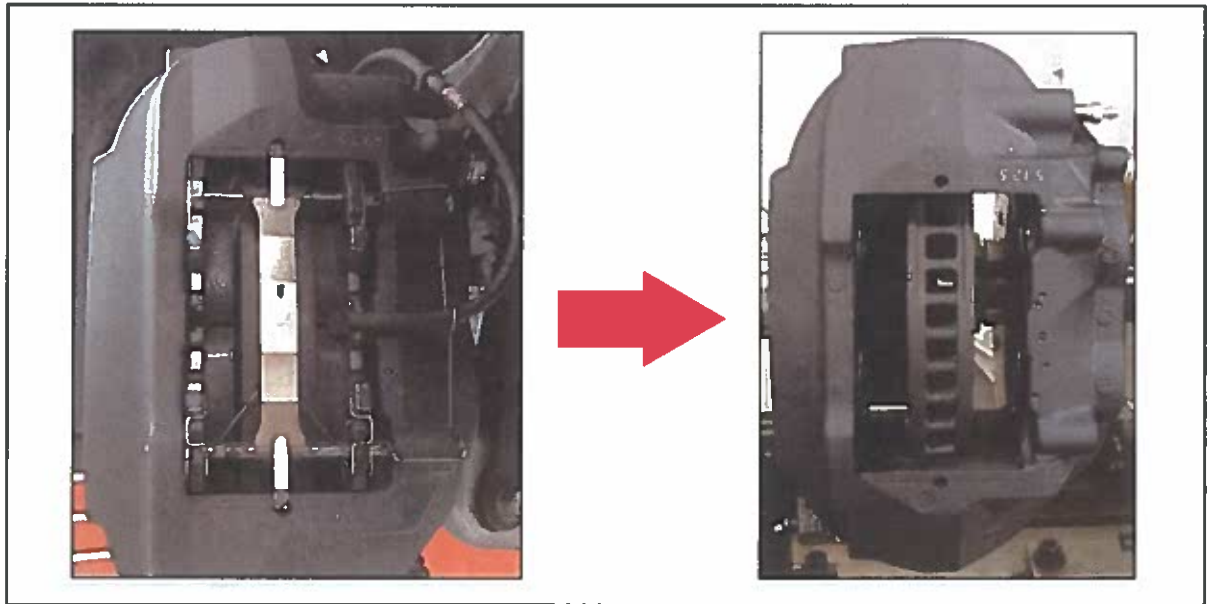
Figure 2.

- A. Remove all components from the calipers (including brake pads and all fitting kit components).

Check brake pad surface. If there is any abnormal surface condition, such as wear or streak marks, replace the brake pads.

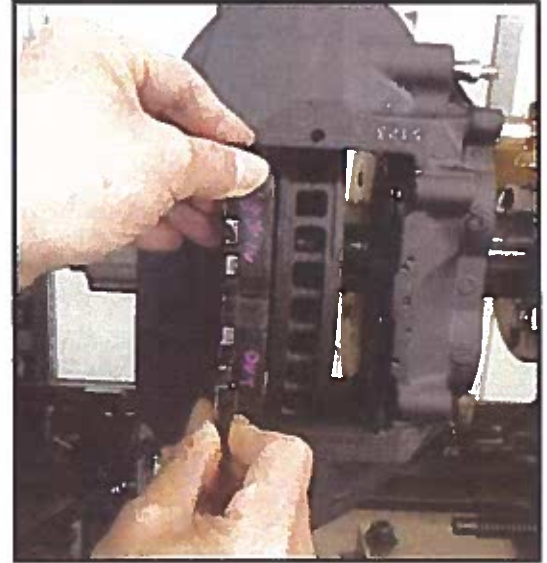
Figure 3.

- B. Install the outer brake pad (with new or original pads).

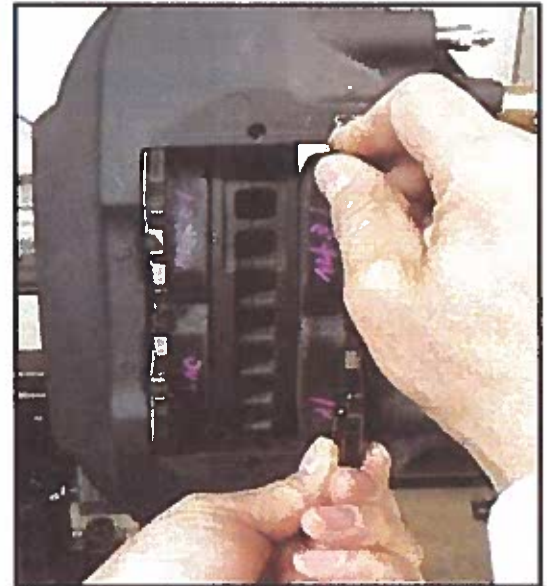
Figure 4.

- C. Install the inner brake pad.

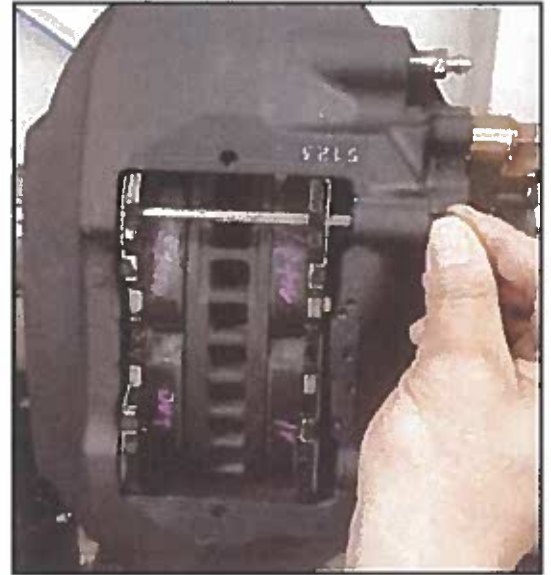
Figure 5.

- D. Temporarily install the slide pin on the trailing side of the caliper to secure the brake pads.

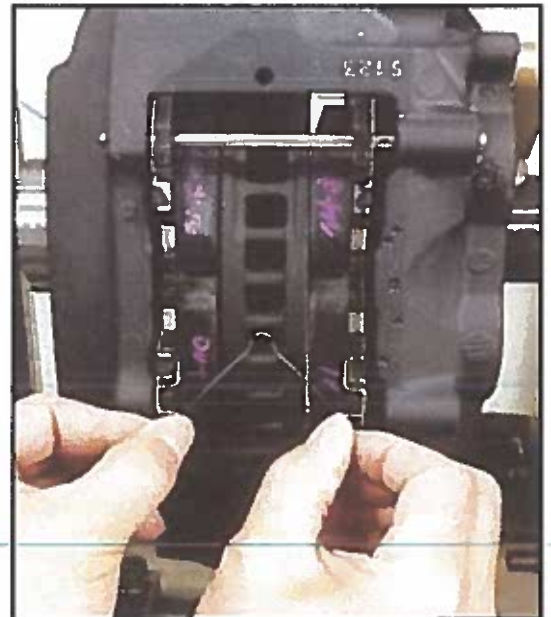
Figure 6.

- E. Reinstall the original M-Spring onto the leading side of the caliper.

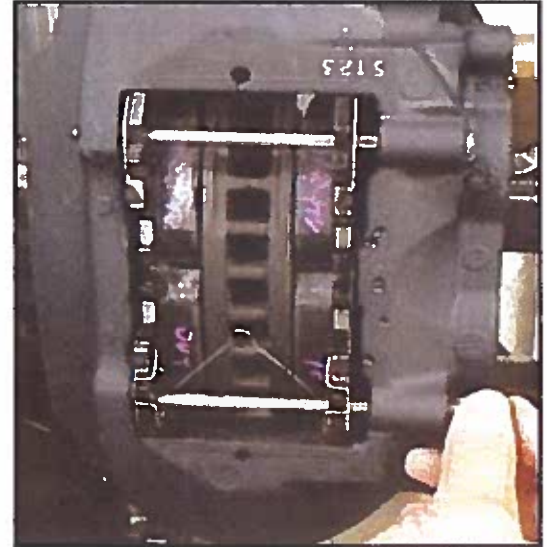
Figure 7.

- F. Insert the slide pin on the leading side through the M-Spring.

Make sure that the slide pin is inserted through the spring.

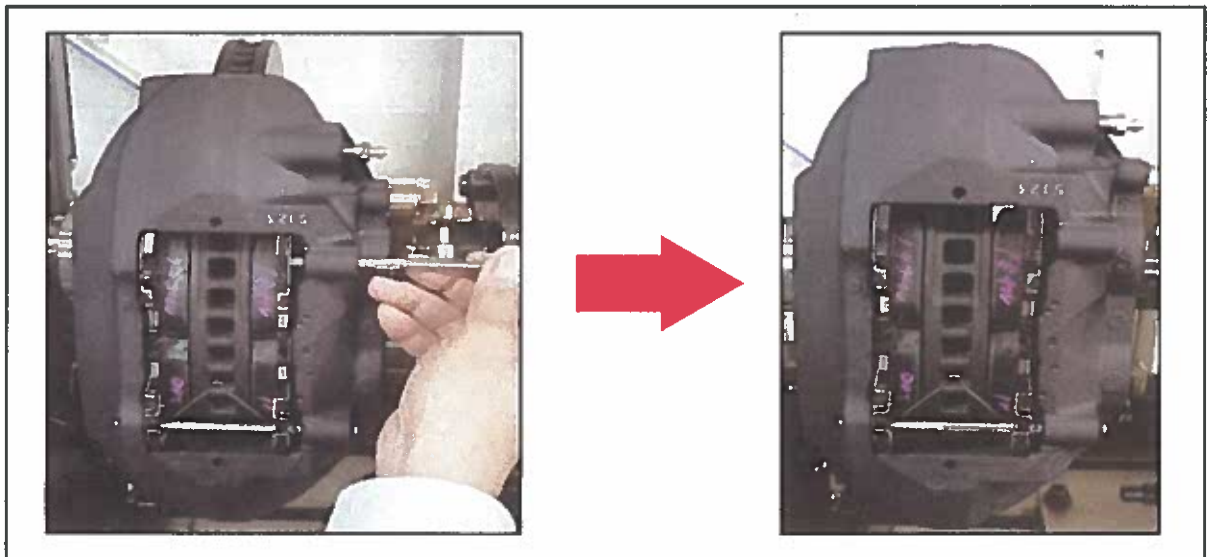
Figure 8.

- G. Remove the trailing side slide pin that was previously inserted to secure the brake pads. The leading side installation is now complete.

Confirm proper installation before proceeding.

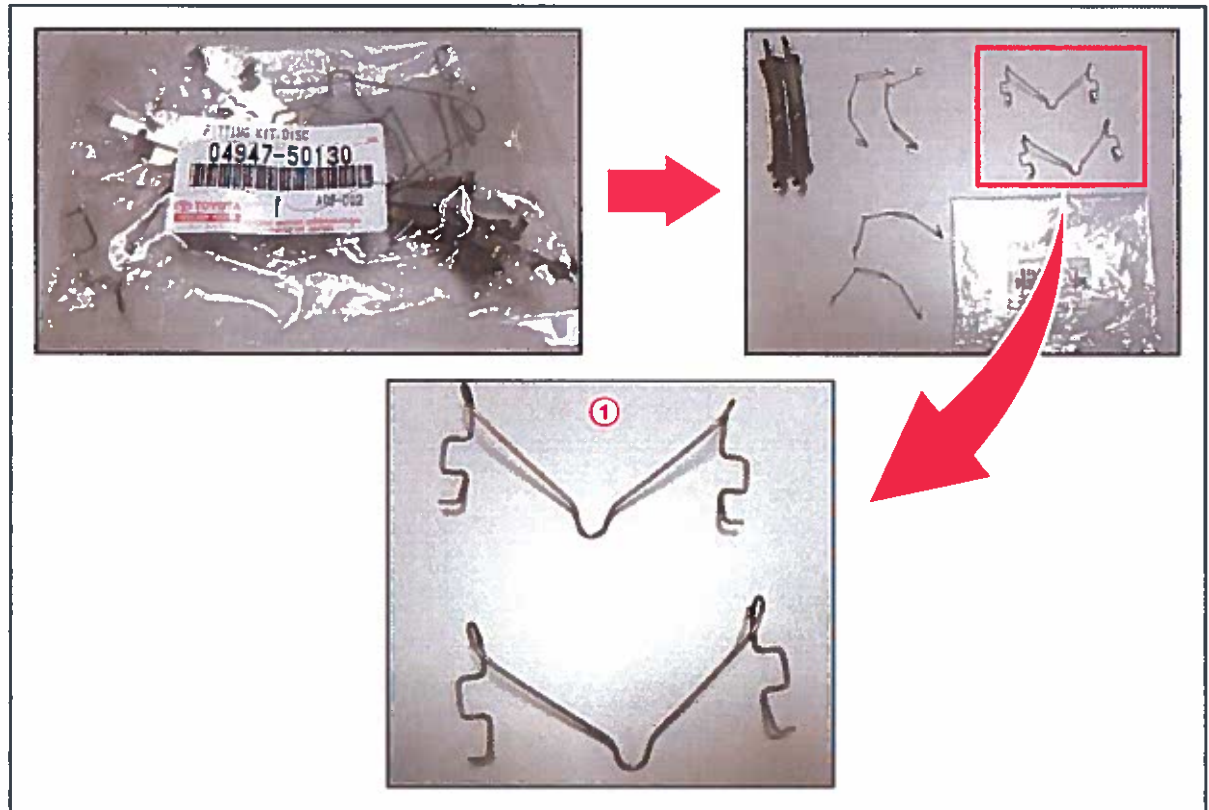
Figure 9.

H. Take out ONLY the M-Springs/Anti-Rattle Springs (P/N 47748-50200) from the Disc Fitting Kit (P/N 04947-50120 or 04947-50130).

1	M-Springs/Anti-Rattle Springs (P/N 47748-50200)
---	---

NOTE
Only ONE spring per side is required.

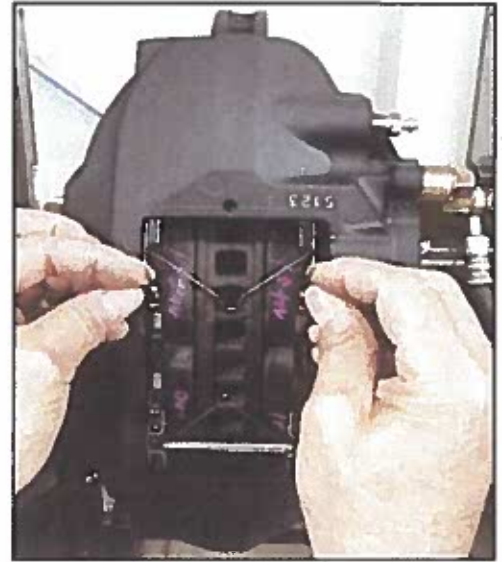
Figure 10.

- I. Install the NEW M-Spring onto the trailing side of the caliper.

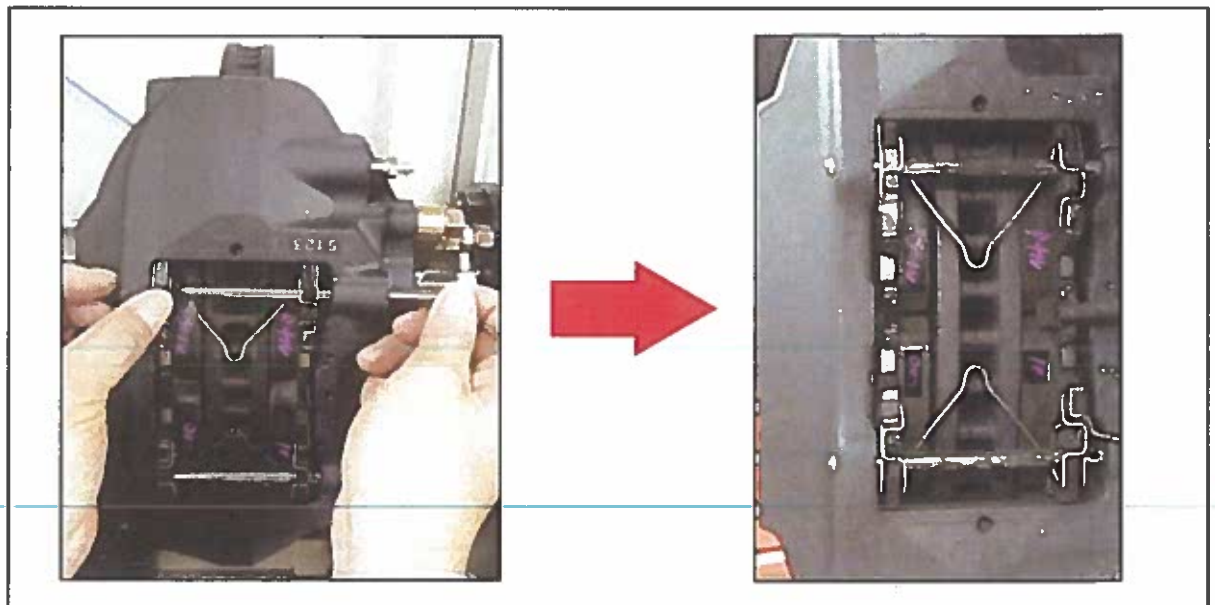
Figure 11.

- J. Insert the trailing side slide pin through the M-Spring. The dual M-Spring installation is now complete.

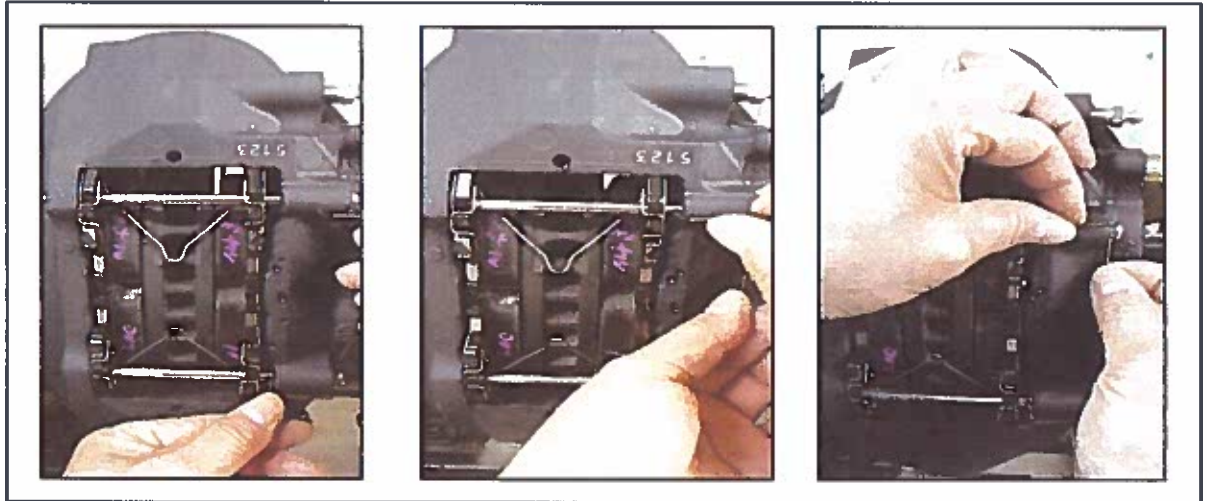
Figure 12.

- K. Install the original pad wear indicator retainer.

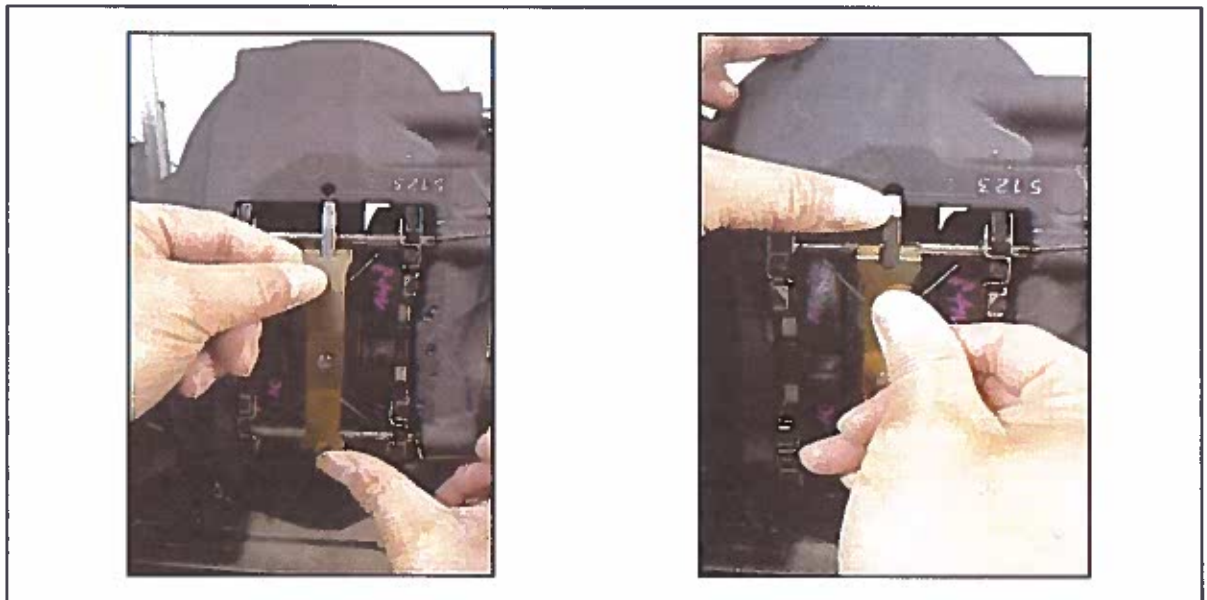
Figure 13.

- L. Install the original anti-rattle spring.

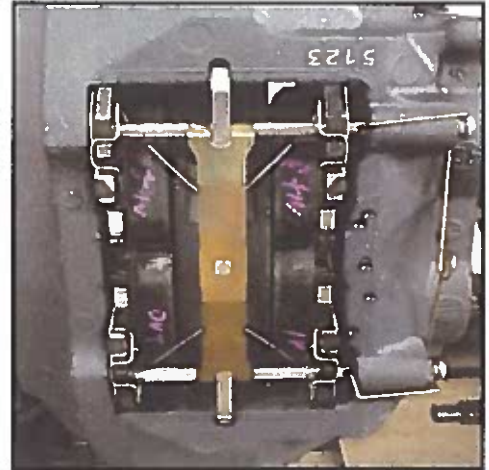
Figure 14.

M. Repeat the steps on the opposite side.

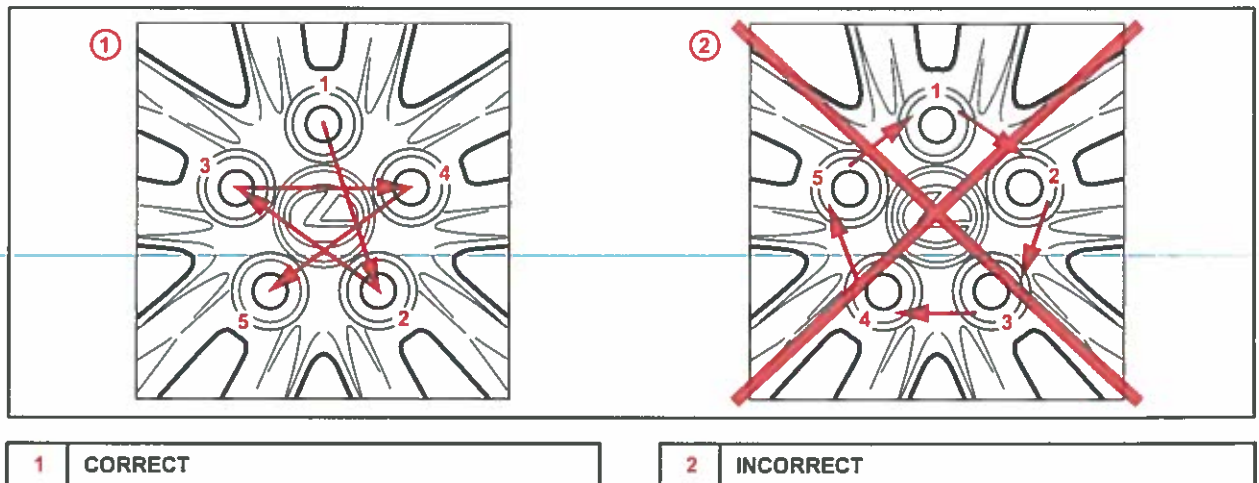
6. Reinstall the front wheel and torque to specification using the correct tightening sequence shown in Figure 15.

It is **ESSENTIAL** to install the front wheel lug nuts with the correct torque specification using a torque wrench, in the correct star pattern sequence (shown in Figure 15).

Figure 15. Star Pattern Sequence

Do **NOT** use an impact gun to tighten the lug nuts.

Torque: 140 N*m (1428 kgf*cm, 103 ft*lbf)
